IN FOCUS: Abrasion

Issue 108

LONG-LASTING POLYMER TECHNOLOGY

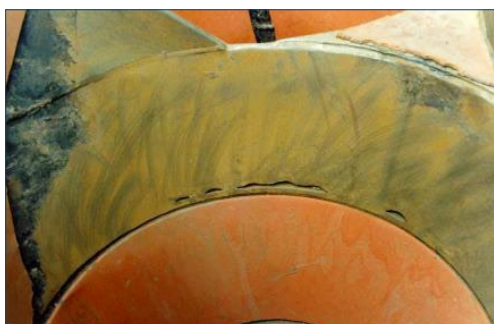
Failed rubber lining

Of the predominant abrasive wear conditions, low-stress abrasion and erosion-corrosion can be successfully mitigated with the use of sacrificial lining technology. If left unprotected or if protection is not suitable for the service environment, then equipment could incur costly repairs or replacement may be in order.

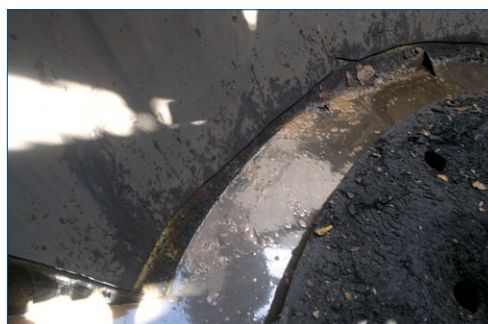
Floatation cell damaged by erosion-corrosion

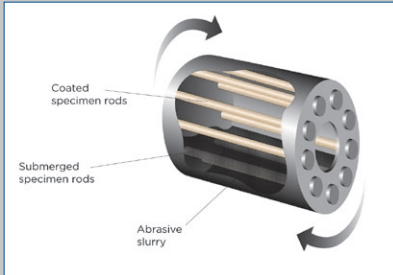
Slurry Abrasion Testing according to ASTM G6

There are numerous test methods available to determine the wear resistance of a material. Belzona materials are extensively tested using the Taber Abrasion (ASTM D4060) and Slurry Abrasion (ASTM G6) tests to name a few.

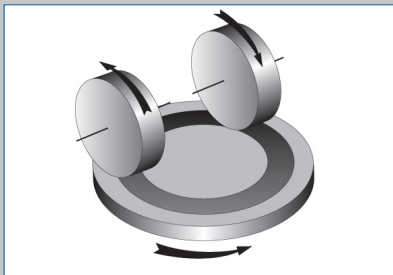
Taber Abrasion Testing according to ASTM 4060

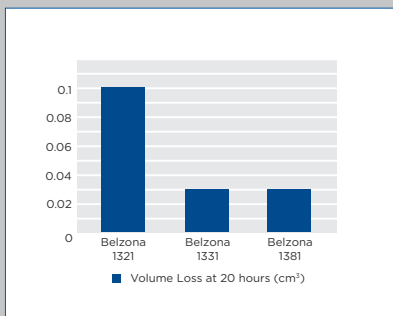
Ductile erosion – low angle of impact

In order to combat ductile erosion, a hard coating is often prescribed. Belzona supply a range of hard wearing lining options optimised for dry abrasion and for immersed situations.

Material selection is primarily influenced by impingement angles. At 10° to 30°

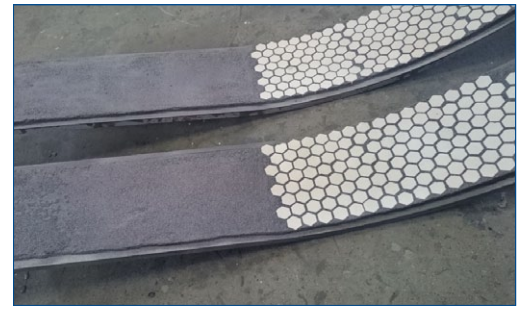
Brittle erosion – high angle of impact

In the case of brittle erosion, due to higher impact angles, elastomeric type products are frequently specified. Tough, elastomeric materials will absorb the impact forces and deflect impacting materials.

impingement angles, hard, brittle materials usually perform better, whereas elastomeric materials cut and tear more readily, leading to increases in wear rates. At high impingement angles (60° to 90°), brittle materials typically experience elevated wear rates, resulting from increased fragmentation and spalling. Elastomeric materials are more effective under these conditions because much of the impact energy can be dissipated through elastic deformation.

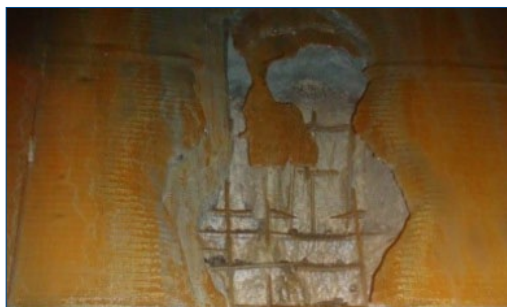
Damaged areas of the concrete sump

Belzona's abrasion resistant system was successfully applied to the concrete channels and sumps at a copper mine in Brazil. These areas presented widespread wear due to erosion caused by the flow of copper ore pulp leading to loss of thickness and profile. Due to the severity of the damage, the surfaces of the channels and sumps required major reconstruction.

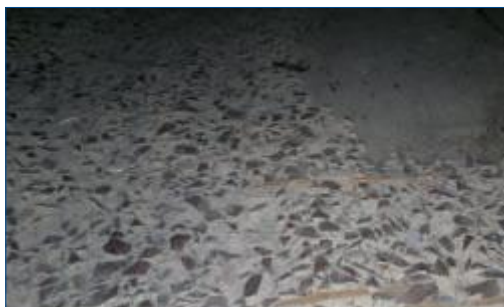
Worn reinforced concrete channel

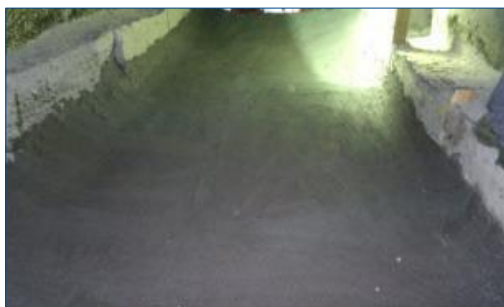
Completed application on a channel

A previously used system required 96 hours to apply and failed every 3-4 months. The client was very satisfied with the results provided by the Belzona solution which is inspected every 2 years during planned turnarounds. ■

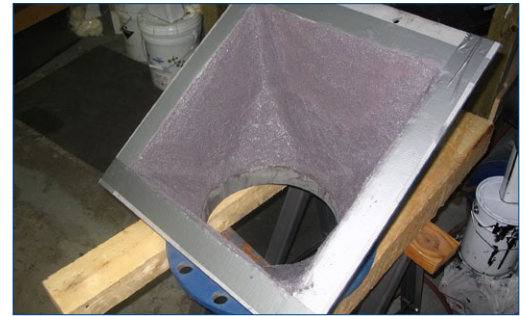
Application of Belzona 1812

Upon carefully reviewing the operating conditions of the hoppers, a durable and lasting Belzona system was specified, which consisted of [Belzona 1812 \(Ceramic Carbide FP\)](#) and [Belzona 2111 \(D&A Hi-Build Elastomer\)](#). Belzona 1812 was applied to profile the hopper before overcoating with [Belzona 2111](#). Both the mild steel hopper substrate and [Belzona 1812](#) were grit blasted before coating.

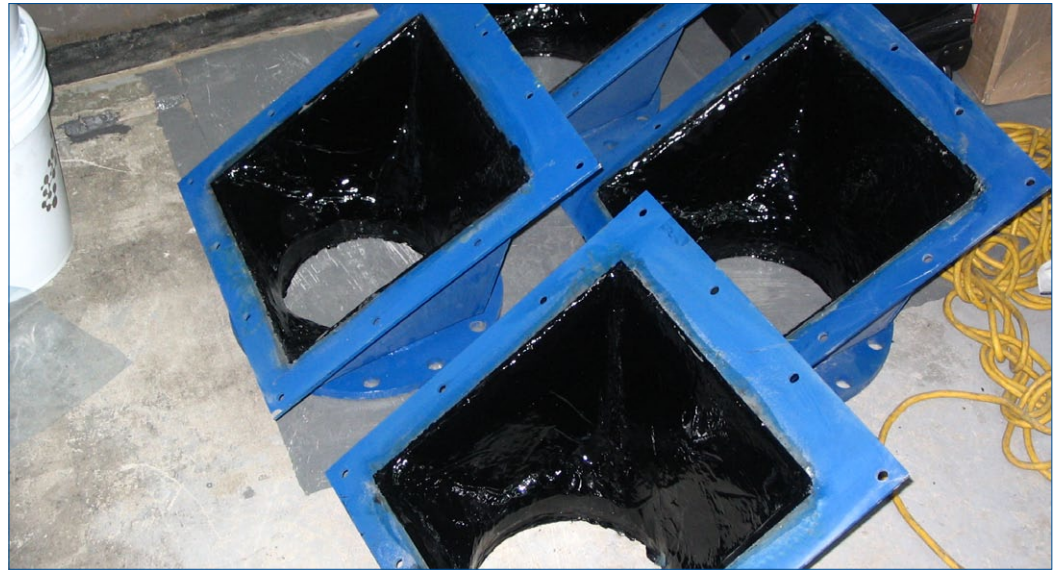
Hoppers lined with Belzona 2111

With the Belzona solution equipment now operates for a period of 18 to 24 months maintenance free. The client also approved [Belzona 1812](#) as an inventory product, which is used in other applications. ■
