## Belzona Rebuilds Bearing Supports on Huge Excavator

Crown bearings of rotational platform of large excavator

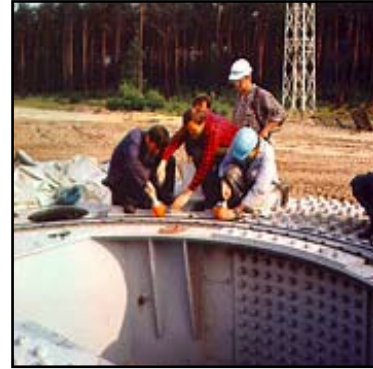
*A team of applicators was required to apply all the Belzona® 1111 quickly, to allow time for the rings to be located*
