Belzona Repairs Badly Worn Chillers

3 chiller units for air conditioning of terminal buildings.

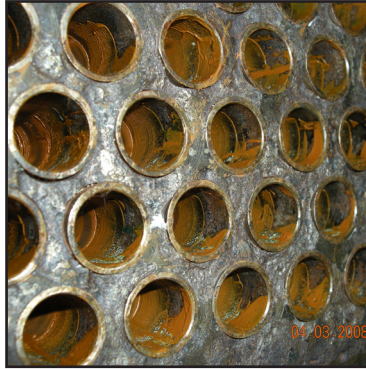
Close up of erosion on tubesheet

Corrosion on tubesheets (4) from one of the chillers was noticed in 2005. Cooling water comes from a local lake which together with galvanic effects was the cause of the corrosion.

Application was carried out in accordance with Belzona System Leaflet HEX-1. Surface preparation included steam cleaning to remove salt contamination.

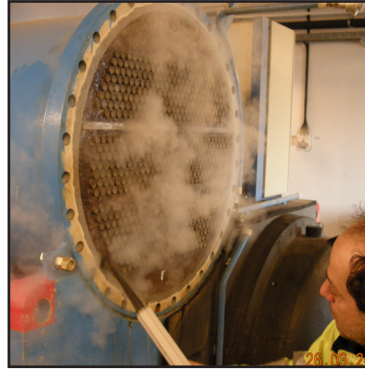
Steam cleaning
