Cavitation is defined as the phenomenon of formation and consequent implosion of vapor bubbles in a region where the pressure of the liquid falls below its vapor pressure. Cavitation can occur in any fluid handling equipment, especially in pumps, one of the most important components of industry today. Technological advances in industrial protective coatings and repair composite materials have made it possible to repair pumps suffering from cavitation rather than simply replacing them. Cavitation Resistant (CR) retain adhesion under long-term immersion, dissipate energy created under high intensity cavitation, and provide outstanding resistance to corrosion and other forms of erosion.

### Solution

### Application

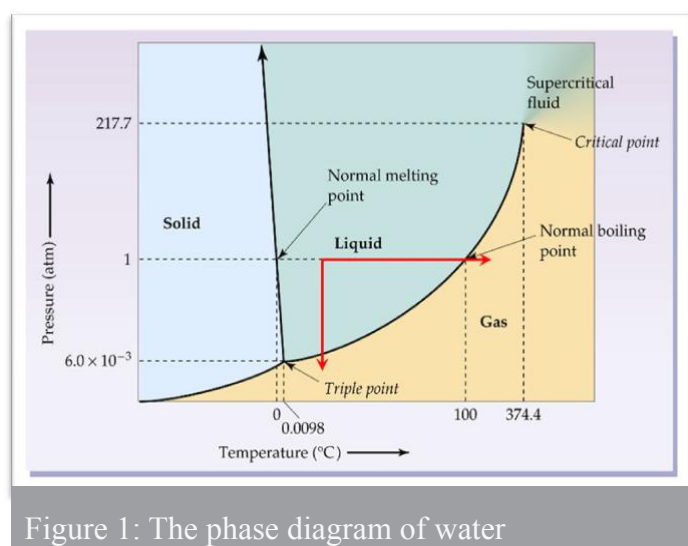
Figure 1: The phase diagram of water

This diagram shows the three physical states of water at different temperature and pressure values. The

curves on the graph represent equilibrium states. The curve bordering the liquid and gas phases is referred to as vaporization curve. At normal conditions of pressure and temperature, a fluid is at 1 atm (14.7 psi) and 25°C (77°F). Water is most commonly boiled by heating it at a constant pressure such as boiling a pot of water on a stovetop (Follow white arrow). As temperature increases at constant pressure, water remains in a liquid phase until it reaches the normal boiling point (100°C at 1 atm), at which point, it starts to boil.

What is less intuitive but equally true, is that water can also be boiled by dropping the pressure at a constant temperature (Follow red arrow in Figure 1). This is exactly what occurs just behind the leading edge of a pump impeller vane. As water (or any other fluid) enters the pump, it is deflected by the vane. Above the leading

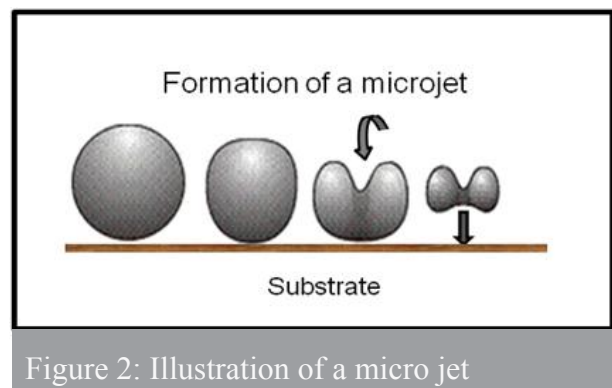
Figure 2: Illustration of a micro jet

“micro jet”. Figure 2 illustrates the implosion of the vapor bubbles. The top of the bubble becomes unstable and collapses towards the substrate.

During this process, the pressure has been recorded as high as 145,000,000 psi, which exceeds the elastic limit for any exotic alloy, thus proving that not even the most exotic alloys can prevent cavitation. These vapor bubbles are responsible for the mechanical damage found on pump impellers after extreme service.

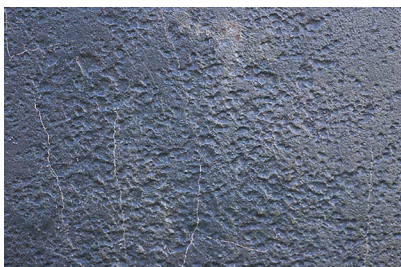
In this particular case, the sides and the trailing surfaces of this large impeller had suffered from cavitation and significant metal loss (Figure 3). The application work was carried out by an authorized coating applicator. The methodology followed is described as follows:

Figure 3: Close up of damage caused to a pump impeller from cavitation

- All the surfaces to be coated were grit blasted using an angular abrasive to NACE No.2 (Near White Metal), ensuring a minimum 3 mil (75  $\mu$ m) angular profile.
- All the surfaces were consequently washed down with a recommended cleaner degreaser to remove residual blasting debris and contaminants.
- Masking tape was placed at the outer edges of the areas to be coated to give a neat and clean finish.
- The substrate was rebuilt and brought back to factory specification. To rebuild such a large area,

an extended working life paste grade polymer from a reputable manufacturer was utilized.

- To protect the freshly rebuilt substrate, an efficiency improving abrasion resistant polymeric coating was applied using stiff short bristled brushes to a maximum wet thickness of 10 mils (250  $\mu$ m). Two coats of this material are required to ensure holidays are eliminated. This coating is used to prevent the effect of erosion and corrosion.

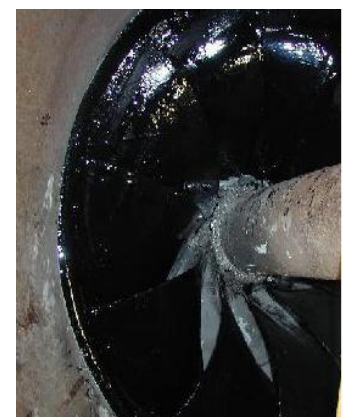
- With the pump rebuilt, a CR coating was applied to the entire impeller (Figure 4). Alternatively, another solution would be to weld numerous damaged areas, or cut out a large section and weld it in a new plate.

Figure 4: Finished Application

- All the coated surfaces were allowed to cure and the coating was inspected for

continuity.

- The pump was put back into service.
