BELZONA® IN WATERWORKS' PUMP SAVES OVER \$7,200 ANNUALLY

Des Moines Water Works, Des Moines, Iowa USA

17 million gallons/day water pump

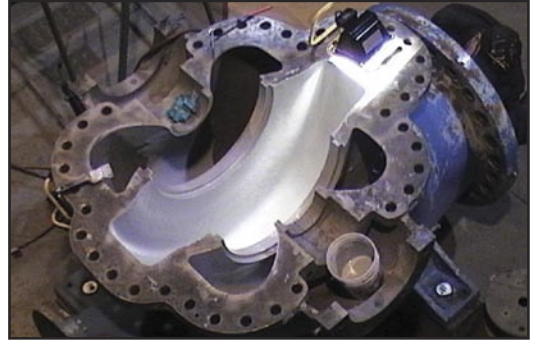
1. Surface prepared for application.
2. The impeller was also repaired/protected with Belzona.
3. In progress.
4. Complete, and ready for re-assembly.

Repair of erosion damage with Belzona® 1221 (Super E-Metal). Then a two-coat application of Belzona® 1341 (Supermetalglide) was applied. Belzona® 1341 is approved by NSF for potable water contact. Performance tests showed an average increase of wire to water efficiency of 7.2%, which will save over \$7,200 annually.
