Liquid Applied Coating Protects 28 Roofs at Housing Association

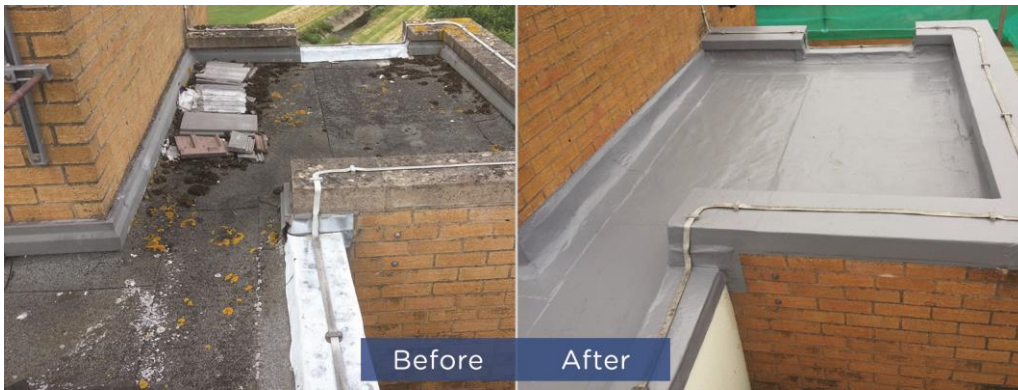
Long-term roof protection

Following an inspection by a Belzona representative, a cold applied liquid coating for long-term roof protection, Belzona 3111 (Flexible Membrane), was specified to repair the damaged roof areas. This coating was prescribed in conjunction with Belzona 9311 (Reinforcing Sheet), a specially woven, open mesh fabric designed to give the repair added durability and strength.

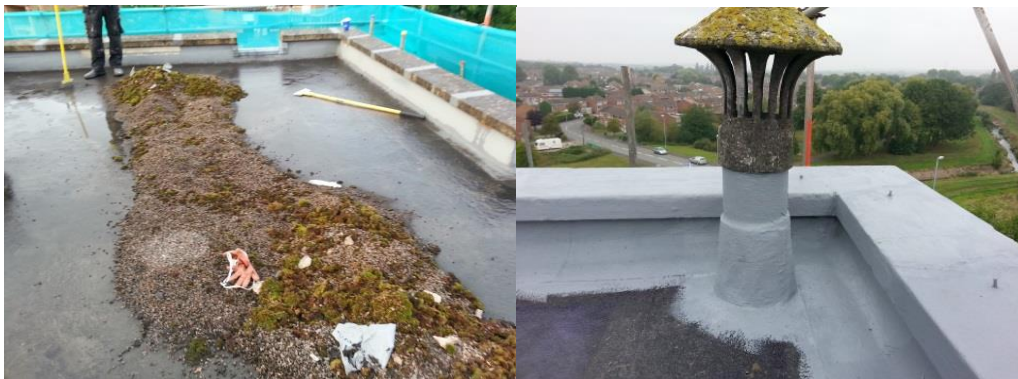
Removal of debris and vegetation

Application onto complex contours

Firstly, all surface water, fungal growths, vegetation and loose debris were cleared away from the application area prior to conditioning with Belzona 3911 and Belzona 3921. The failed flashing strips were also removed from the roofing area.

After all the debris was cleared away, the Belzona conditioners were applied using a roller to provide a quick coverage. Once the conditioner had dried, the reinforcement sheet was laid out and coated with Belzona 3111. A soft bristled brush was used to apply this material, smooth over the system for complete wetting and to leave a finish free from stretches or creases.
