Facilitate

Issue 7 — Spring 2016

DURABLE POLYMERIC SYSTEM REPAIRS OVER 300 SPALLED SURFACES

Falling debris and concrete tackled with hard-wearing rebuilding system

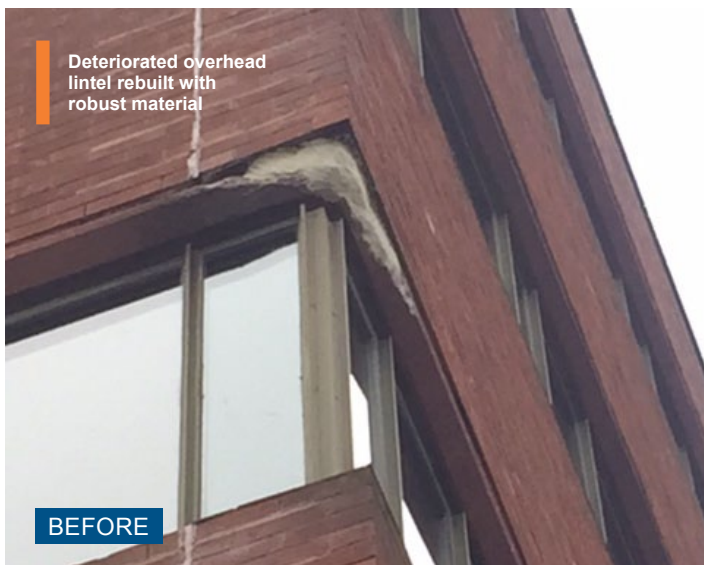
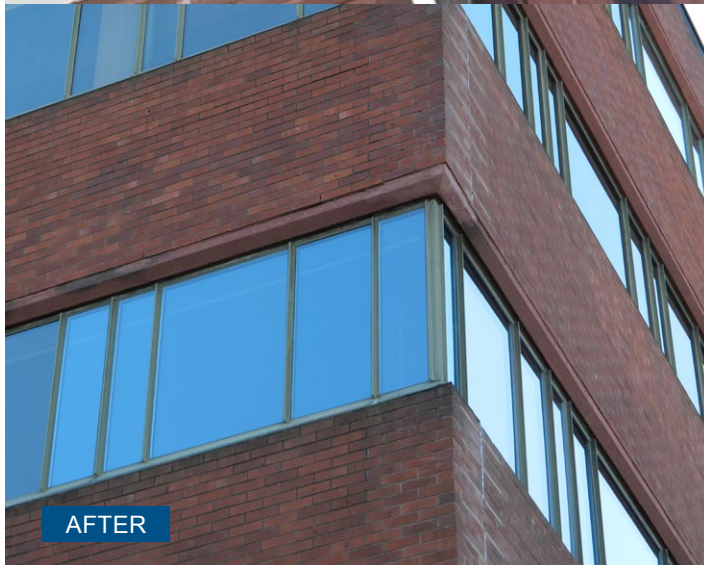
Deteriorated overhead lintel rebuilt with robust material

BEFORE

AFTER

Due to its lightweight properties, Belzona 4141 (Magma-Build) was specified to repair vertical and overhead concrete areas while the non-porous polymeric screed, Belzona 4131 (Magma-Screed) was specified to repair larger areas. The elastomeric expansion joint sealant, Belzona 4521 (Magma-Flex Fluid) was selected to repair damaged expansion joint areas. For the damaged drain areas, these would be firstly rebuilt with a Belzona 4000 Series material. They will then be coated with Belzona 3131 (WG Membrane) to provide additional protection from rainwater, followed by the incorporation of a Belzona safety aggregate to create a grip surface.

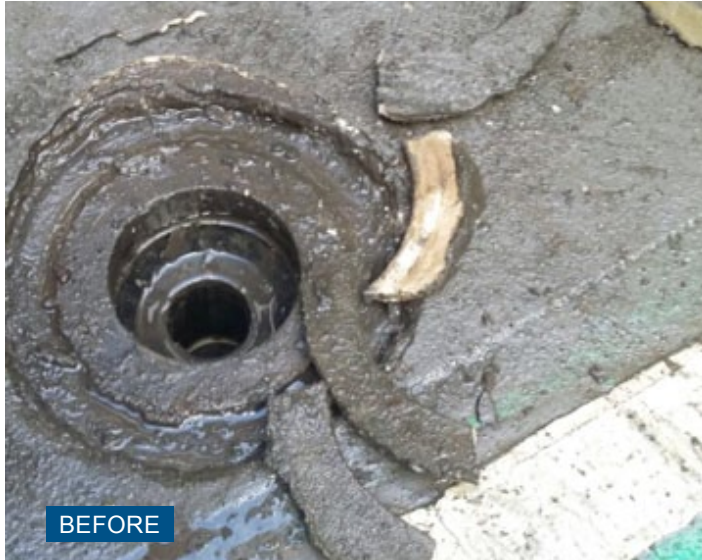
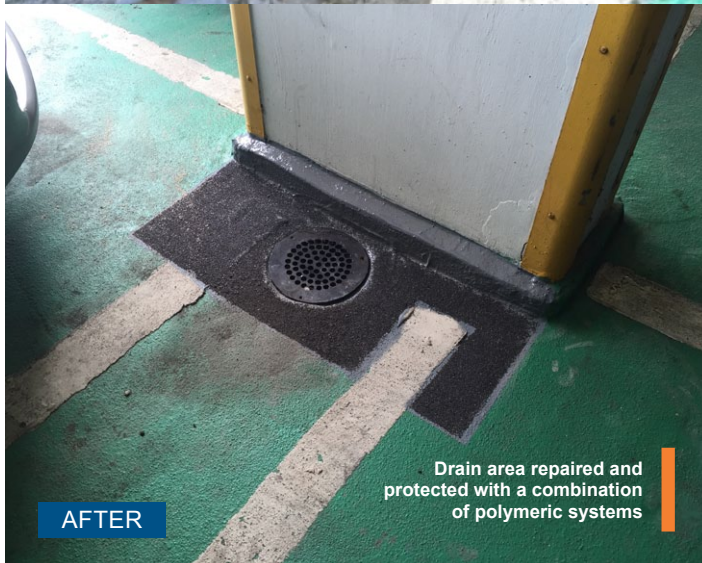
BEFORE

AFTER

Drain area repaired and protected with a combination of polymeric systems

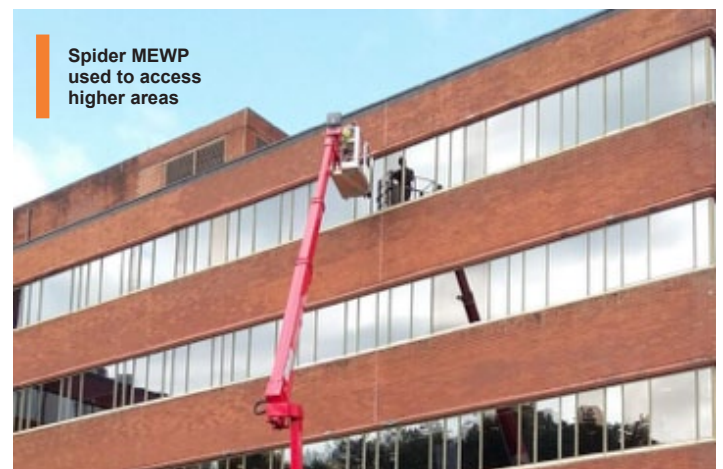
Spider MEWP used to access higher areas

In order to access exterior areas high up on the building, a Spider MEWP was used. For the application, after preparation and conditioning of all surfaces to be rebuilt, each Belzona rebuilding material was mixed and firmly pressed into the repair area. To ensure air pockets did not form, the concrete repair system was firmly compacted into each area. As the building's façade is made of red brick, Belzona was able to add a powder tint to the construction polymer, ensuring the system blended in with the surrounding substrate and provided an aesthetic finish.

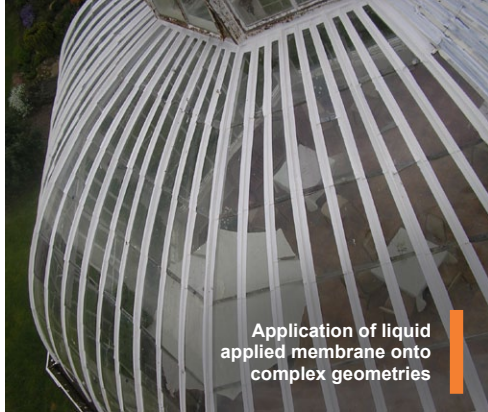
Application of liquid applied membrane onto complex geometries

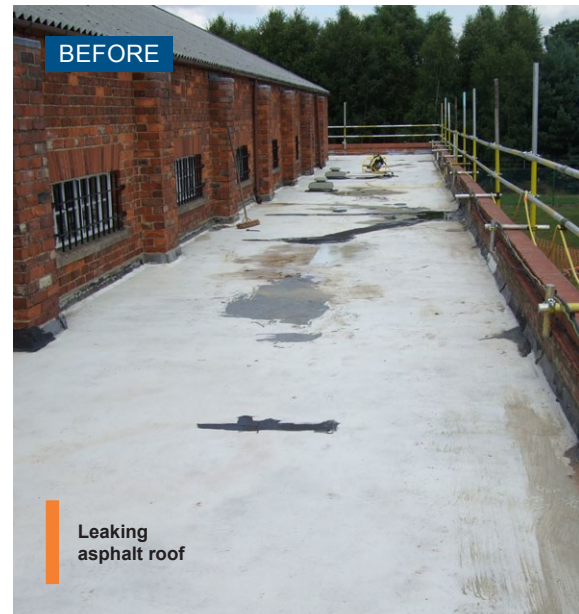
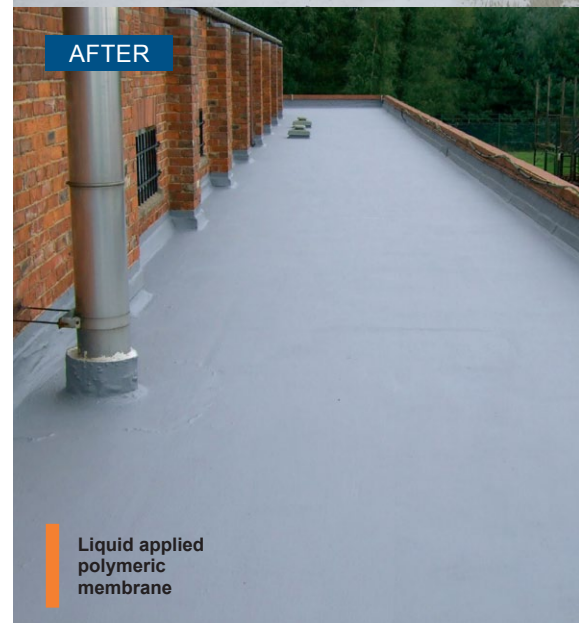
BEFORE

Leaking asphalt roof

AFTER

Liquid applied polymeric membrane

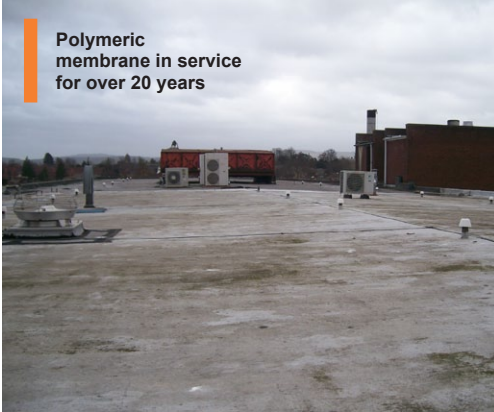
Polymeric membrane in service for over 20 years

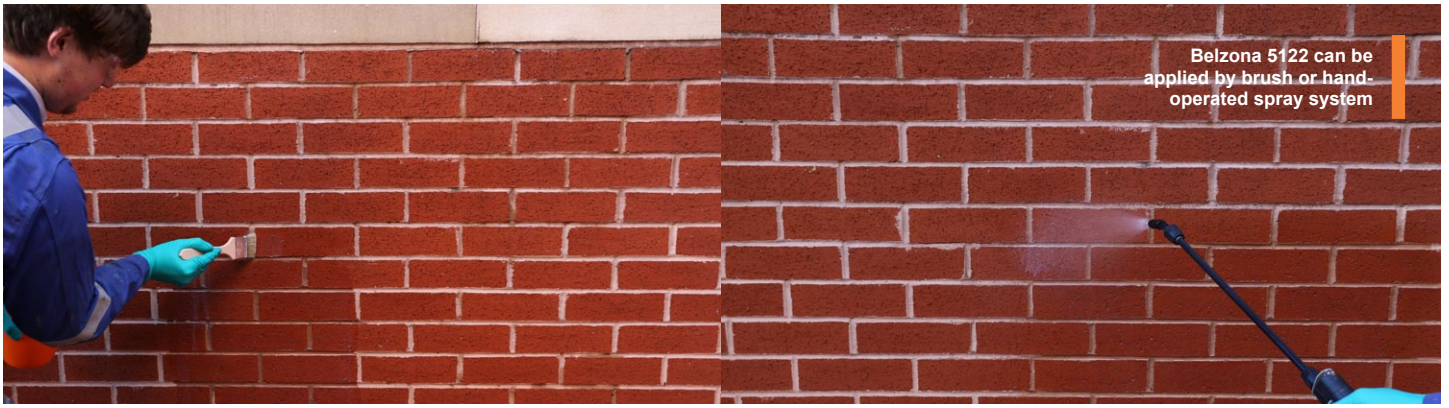
Belzona 5122 can be applied by brush or hand-operated spray system

When brush or spray-applied to porous surfaces, Belzona 5122 (Clear Cladding) forms an invisible, micro-porous, water repellent barrier that allows the passage of air and water vapour, ensuring that moisture is not trapped in the wall. This single component material is supplied as a concentrate for dilution with water prior to use.

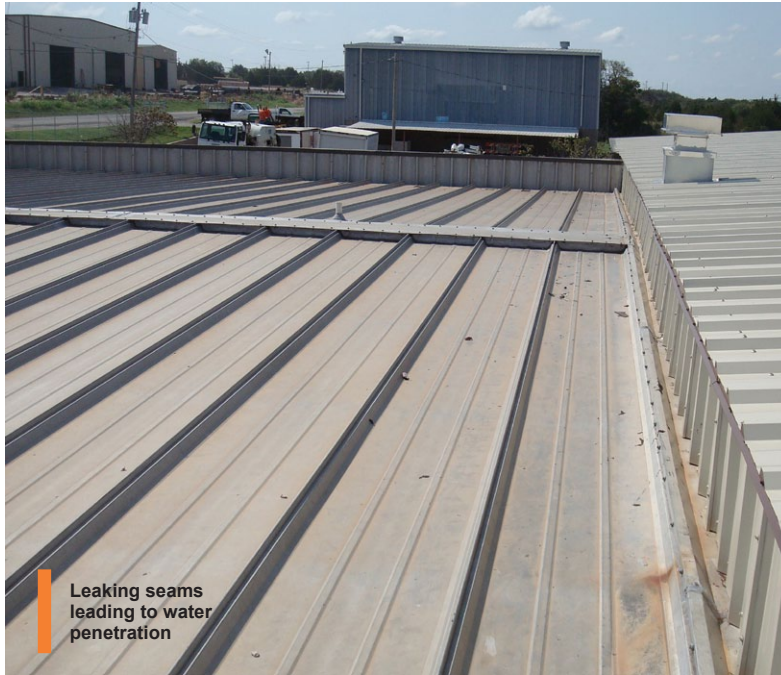
Leaking seams leading to water penetration

On metal roofs, seams are one of the main areas of concern as they can quickly develop leaking problems. Being usually the weakest part of the roof, leaking seams require correcting at the initial stage of the problem in order to avoid further deterioration and costly consequences. At a government building in Guthrie, Oklahoma, several leaks had arisen due to a number of deteriorated seams on a galvanised metal roof. 365m (1,200ft) of seams had severely deteriorated, leaving the roof in urgent need of waterproofing.

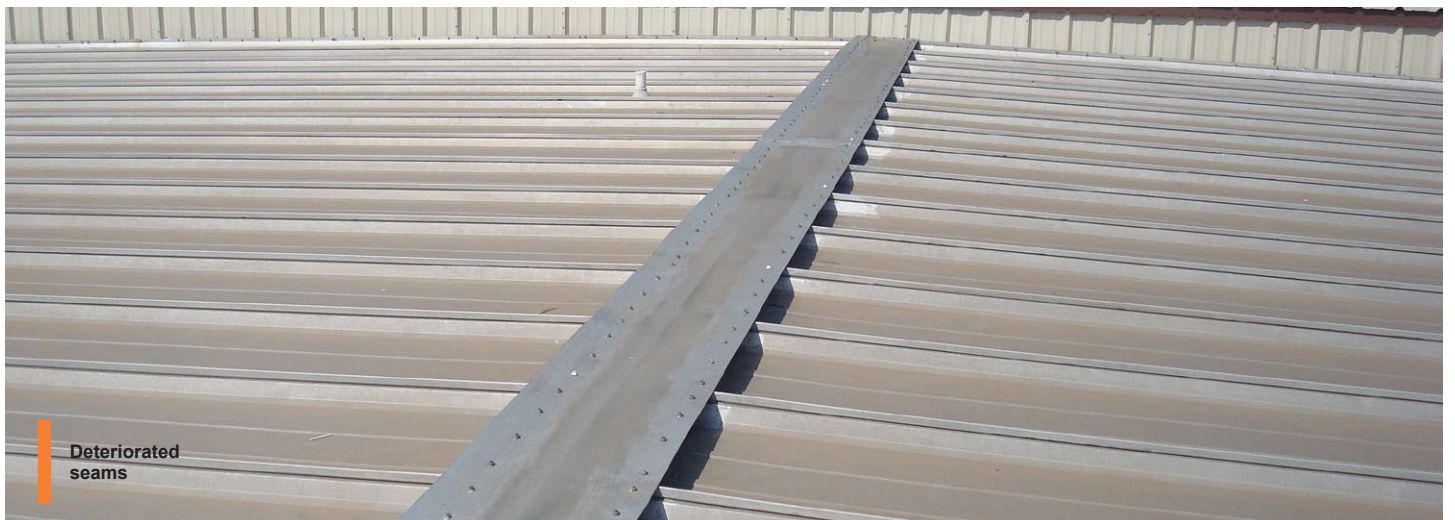
Deteriorated seams

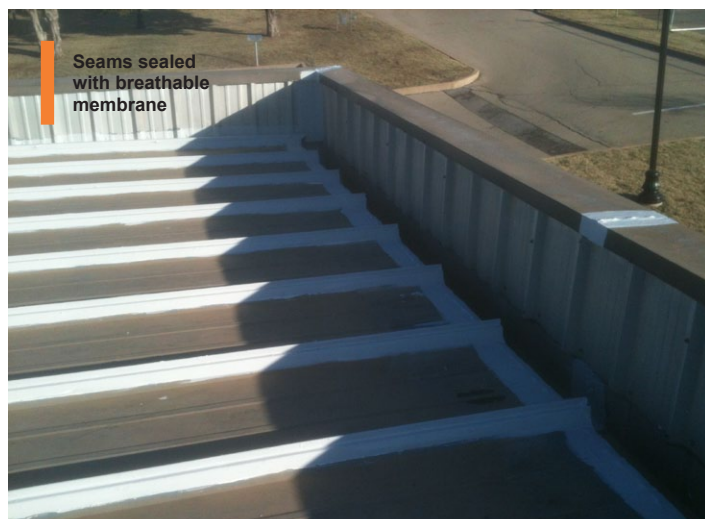
Seams sealed with breathable membrane

To ensure a neat and tidy application, masking tape was fixed inside the prepared area and the conditioner was applied up to the masking tape. Onto the conditioned substrate, a soft bristled brush was used to apply the Belzona 3111 through the Belzona reinforcing sheet laid onto the substrate. This was done without stretching or creasing the sheet, ensuring that it followed the seam contours.

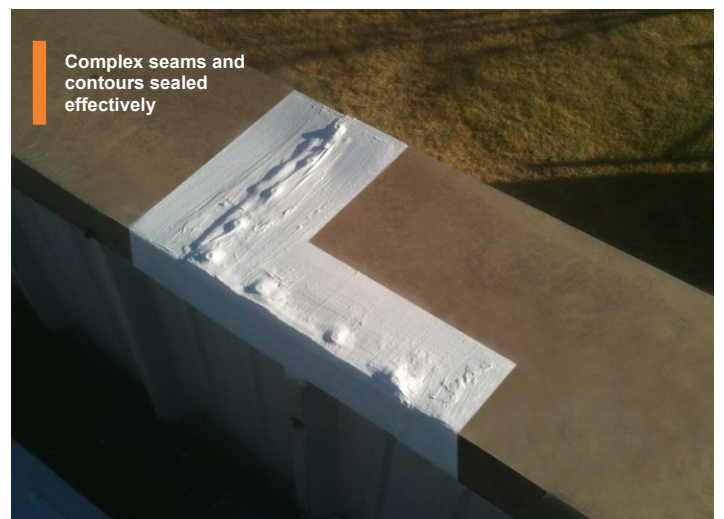
Complex seams and contours sealed effectively

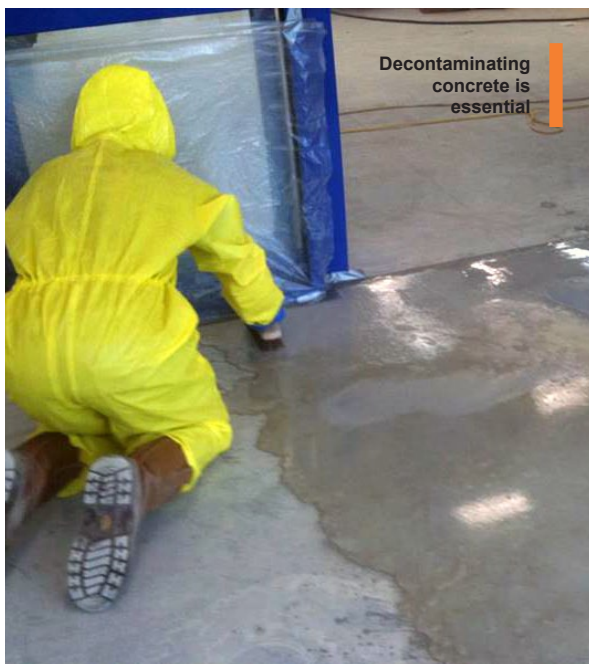
Decontaminating concrete is essential

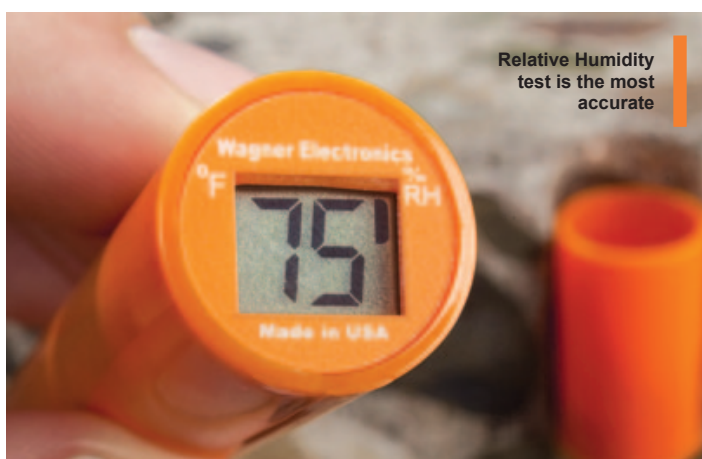
Relative Humidity test is the most accurate

Ultimately, a Relative Humidity probe is the final method Belzona specify for establishing moisture content. This method provides the most accurate assessment in terms of relative humidity, by dropping small electronic probes into drilled holes in the concrete. They are then left to equilibrate and following the recommended equilibration time, the probe can be read either directly or with a specially made reader. This should reach a target relative humidity reading of 75%. As highlighted, this method provides a very accurate measurement of the concrete's moisture content, at the recommended 40% depth of the concrete slab thickness. However, the negative of this method is that the probes are left entombed in the concrete. Once the method has been chosen and the tests have been completed, the preparation can then be moved on to the next stage, whether that involves moisture level reduction or continuing with the appropriate concrete preparation.

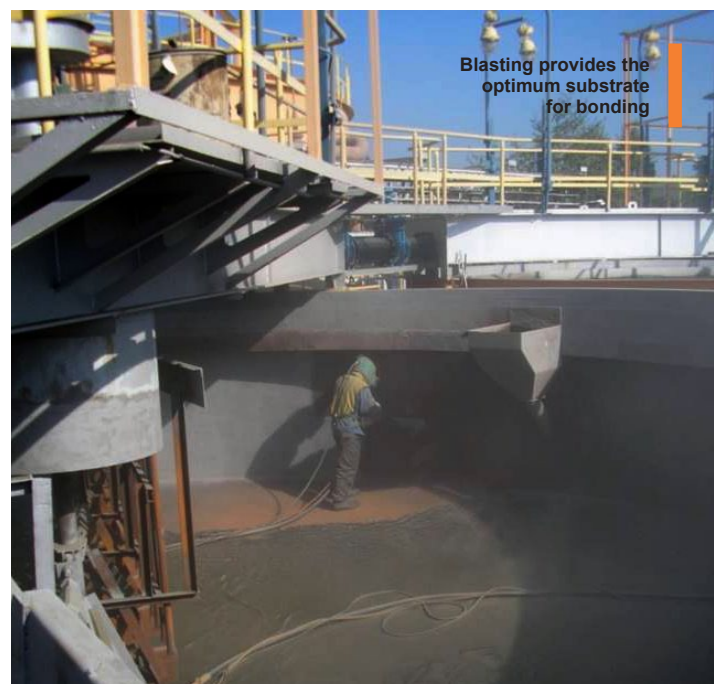
Blasting provides the optimum substrate for bonding

Loose concrete and debris jeopardises the success of any application, thus requiring a firm and stable surface. Typically, mechanical devices are used to achieve this finish and they come in two types: rotary and impact. The choice of equipment and subsequent techniques can vary depending on several factors. Age of the concrete determines whether it is necessary to remove the laitance, commonly found on newly formed surfaces. In addition, the concrete's density affects the final finish. For example, rotary equipment is usually used on low compressive strength concrete substrates, yet is not effective on hard dense concrete, which they are likely to polish rather than abrade.

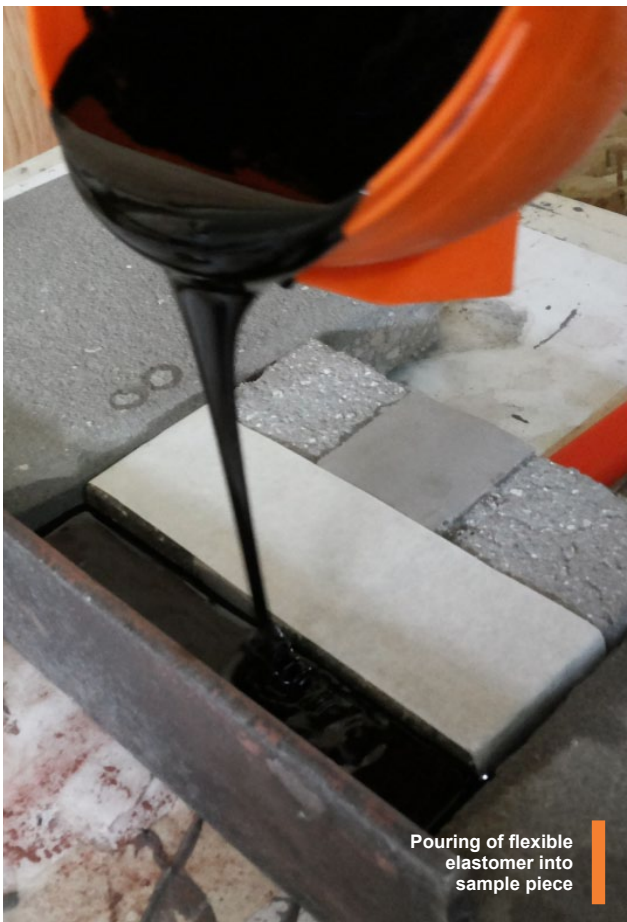
Pouring of flexible elastomer into sample piece

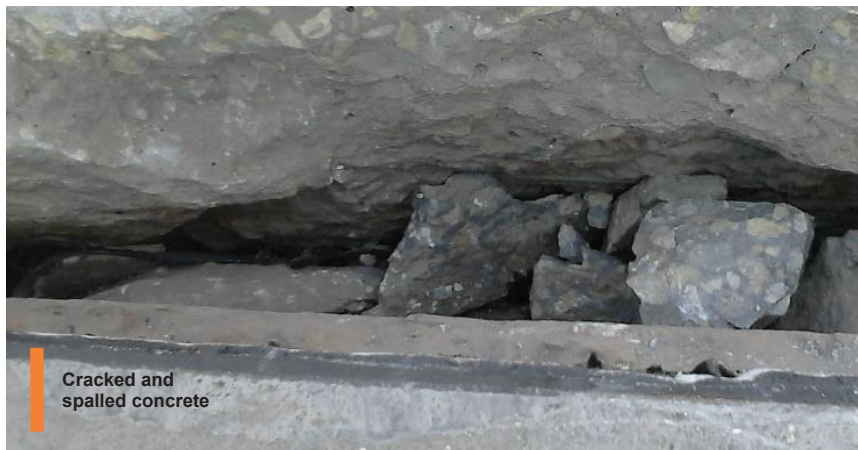
Cracked and spalled concrete

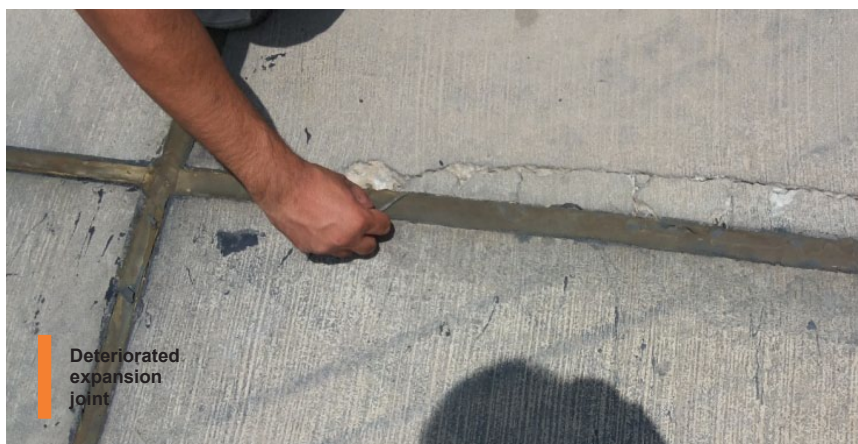
Deteriorated expansion joint

For the expansion joints, any loose contamination was brushed away and the substrate was cleaned using Belzona 9111 to remove any dirt, oil and grease. Where the elastomer was to be applied directly onto Belzona 4111, the Belzona 4111 was slightly abraded using emery paper. After conditioning of the surface, a foam backer rod with a diameter of approximately 20% greater than the width of the joint was installed. Where the depth was greater than 4cm with no support below, filler boards were placed to control the application depth. Belzona 2221 was applied using a simple pouring technique at a nominal thickness of 1cm (0.4 in), and the system was left to cure.

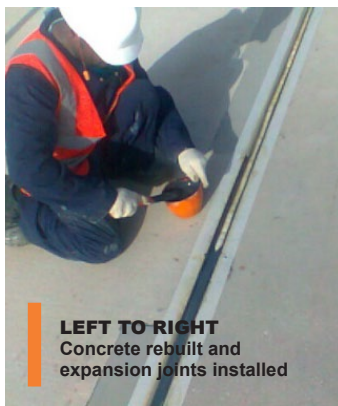
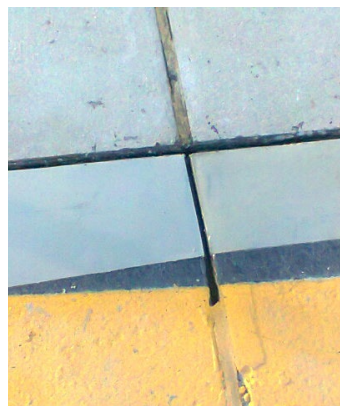
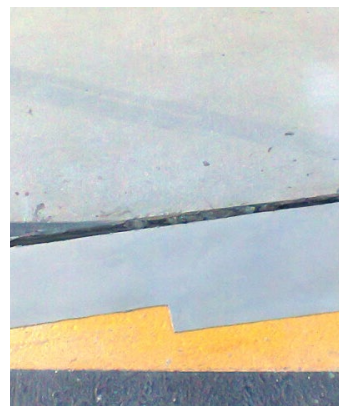
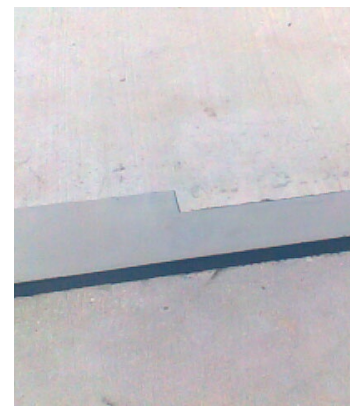
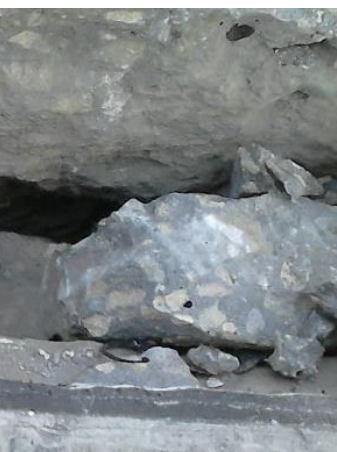
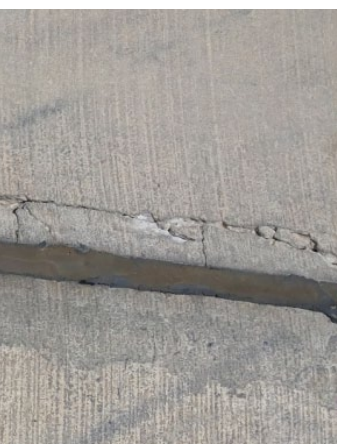
LEFT TO RIGHT
Concrete rebuilt and expansion joints installed

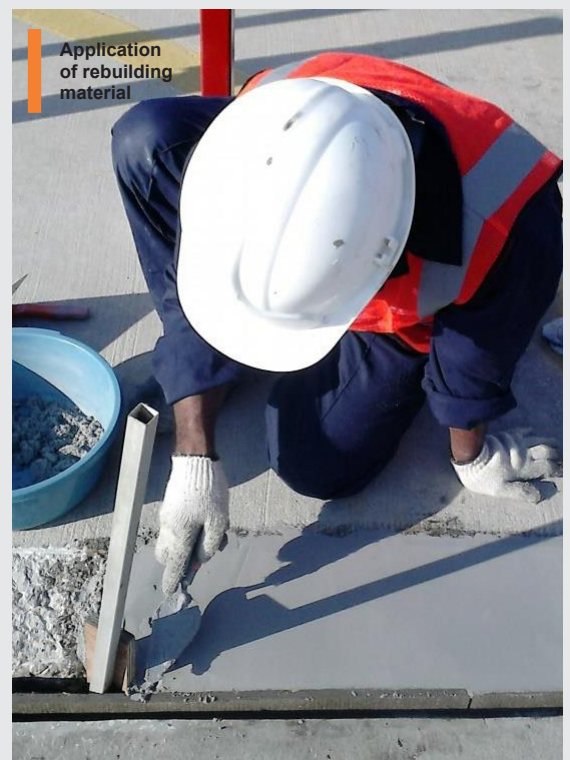
Application of rebuilding material

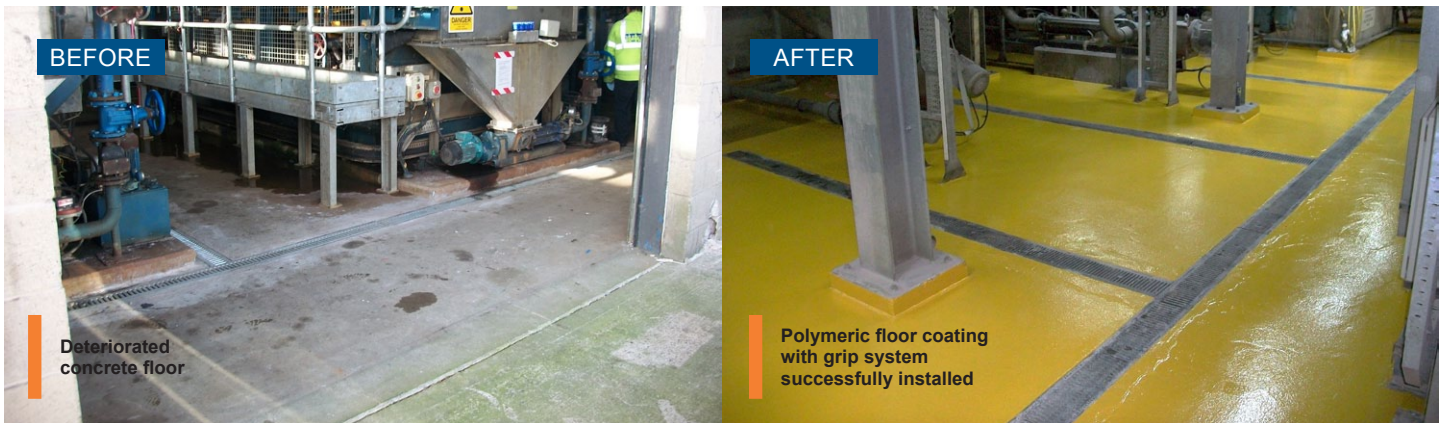
BEFORE

AFTER

Deteriorated concrete floor

Floor repaired and protected with durable polymeric systems

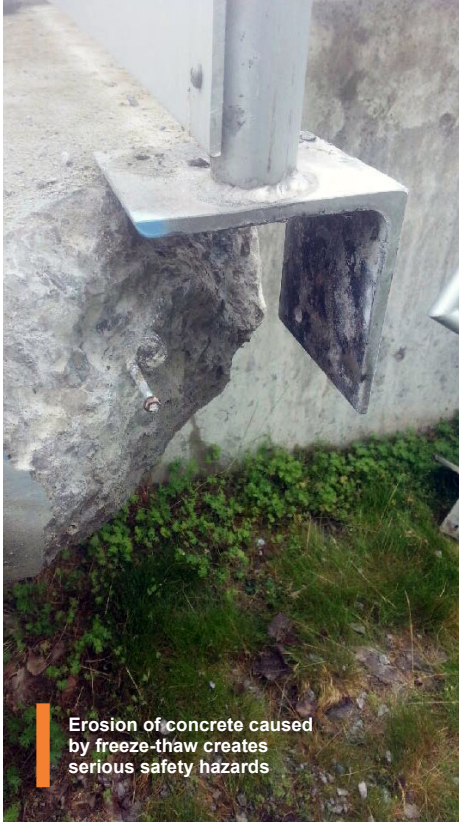
Erosion of concrete caused by freeze-thaw creates serious safety hazards

This type of regular freeze-thaw action led to severe concrete spalling at a water treatment plant in Strathroy, Ontario. As the deteriorated concrete, situated in 30 different areas next to the clarifier tanks, affected two sets of stairways and was also securing a number of handrails, this had led to a series of health and safety issues. Not only did the problem areas require urgent repair and resurfacing, but the repair solution needed to provide outstanding durability in order to withstand regular environmental attack within this vulnerable area.

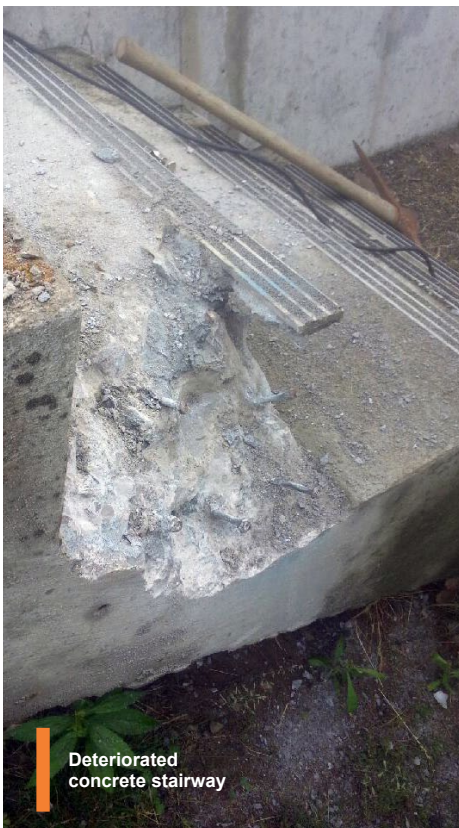
Deteriorated concrete stairway

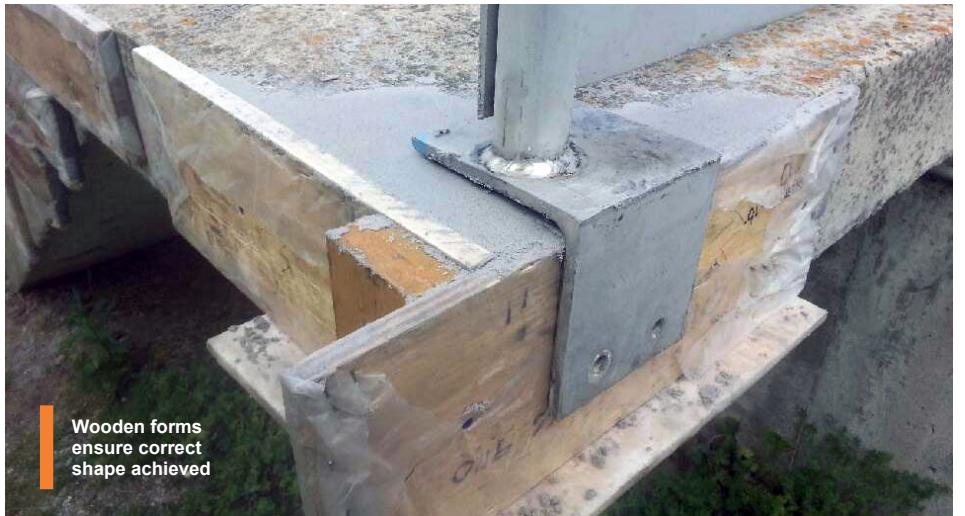
Wooden forms ensure correct shape achieved

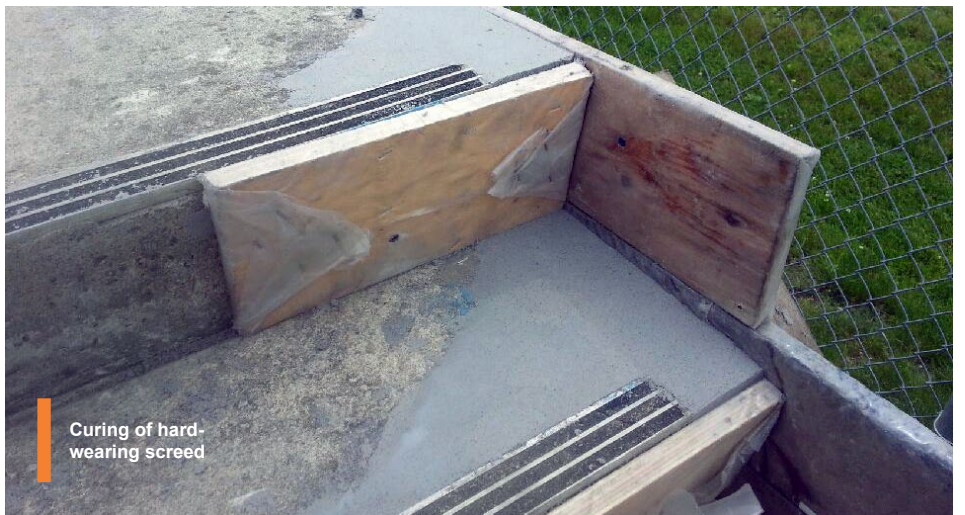
Curing of hard-wearing screed

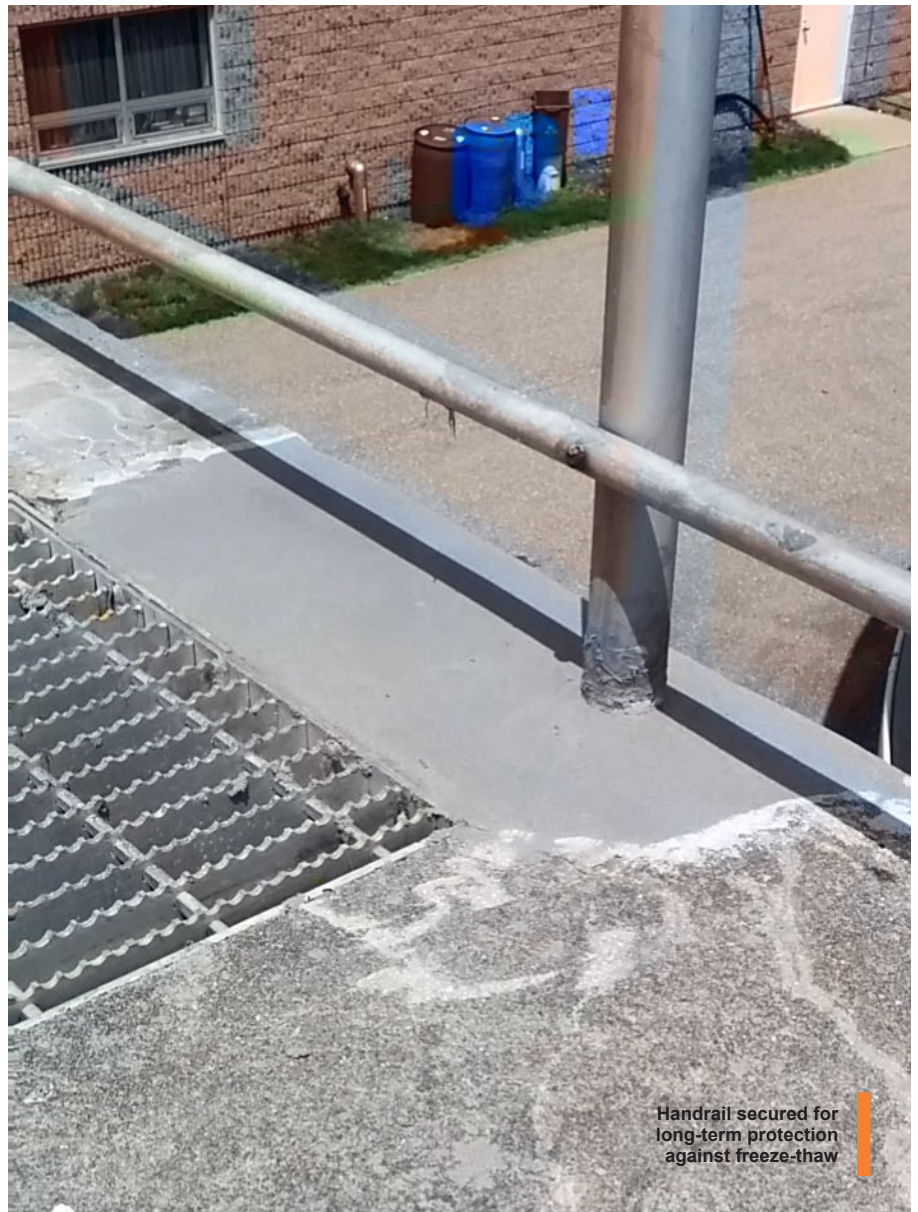
Handrail secured for long-term protection against freeze-thaw

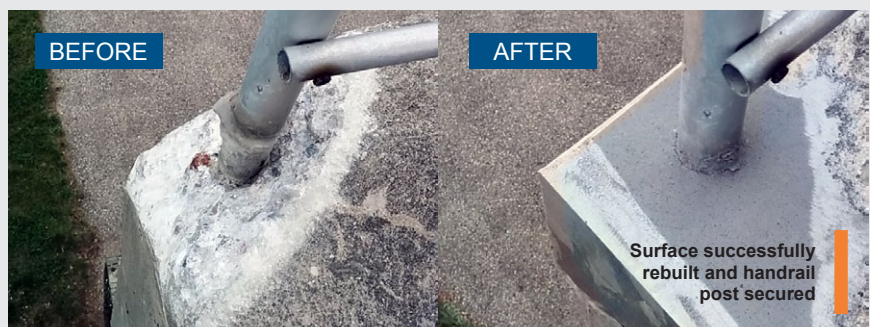
Surface successfully rebuilt and handrail post secured

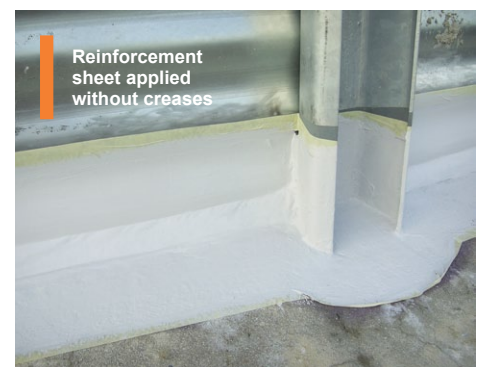
Reinforcement sheet applied without creases

The reinforcement sheet was then applied over the conditioned areas and, using a good quality soft bristled brush, the Belzona 3111 material was applied. The system was then smoothed over with the brush to ensure complete wetting and to leave a finish free from stretches or creases in the reinforcement sheet. After curing, a second layer of Belzona 3111 was applied to give a finish free from pinholes, and the breathable system was left to cure.

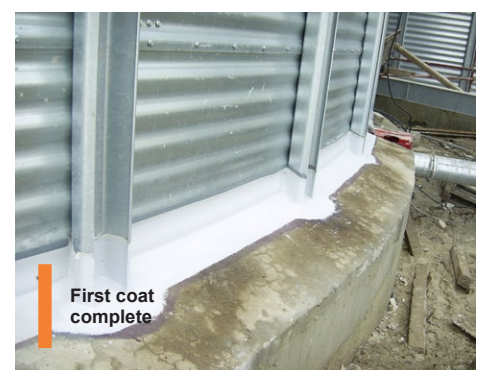
First coat complete
