FACILITATE

A COMPLETE
**COMPOSITE
SOLUTION**
FOR BUND REPAIR
AND PROTECTION

Thai Oil embraces Belzona waterproofing solution for over 3,000m² of roofs

Mosque returned to original splendour: Dome roof receives waterproof repairs

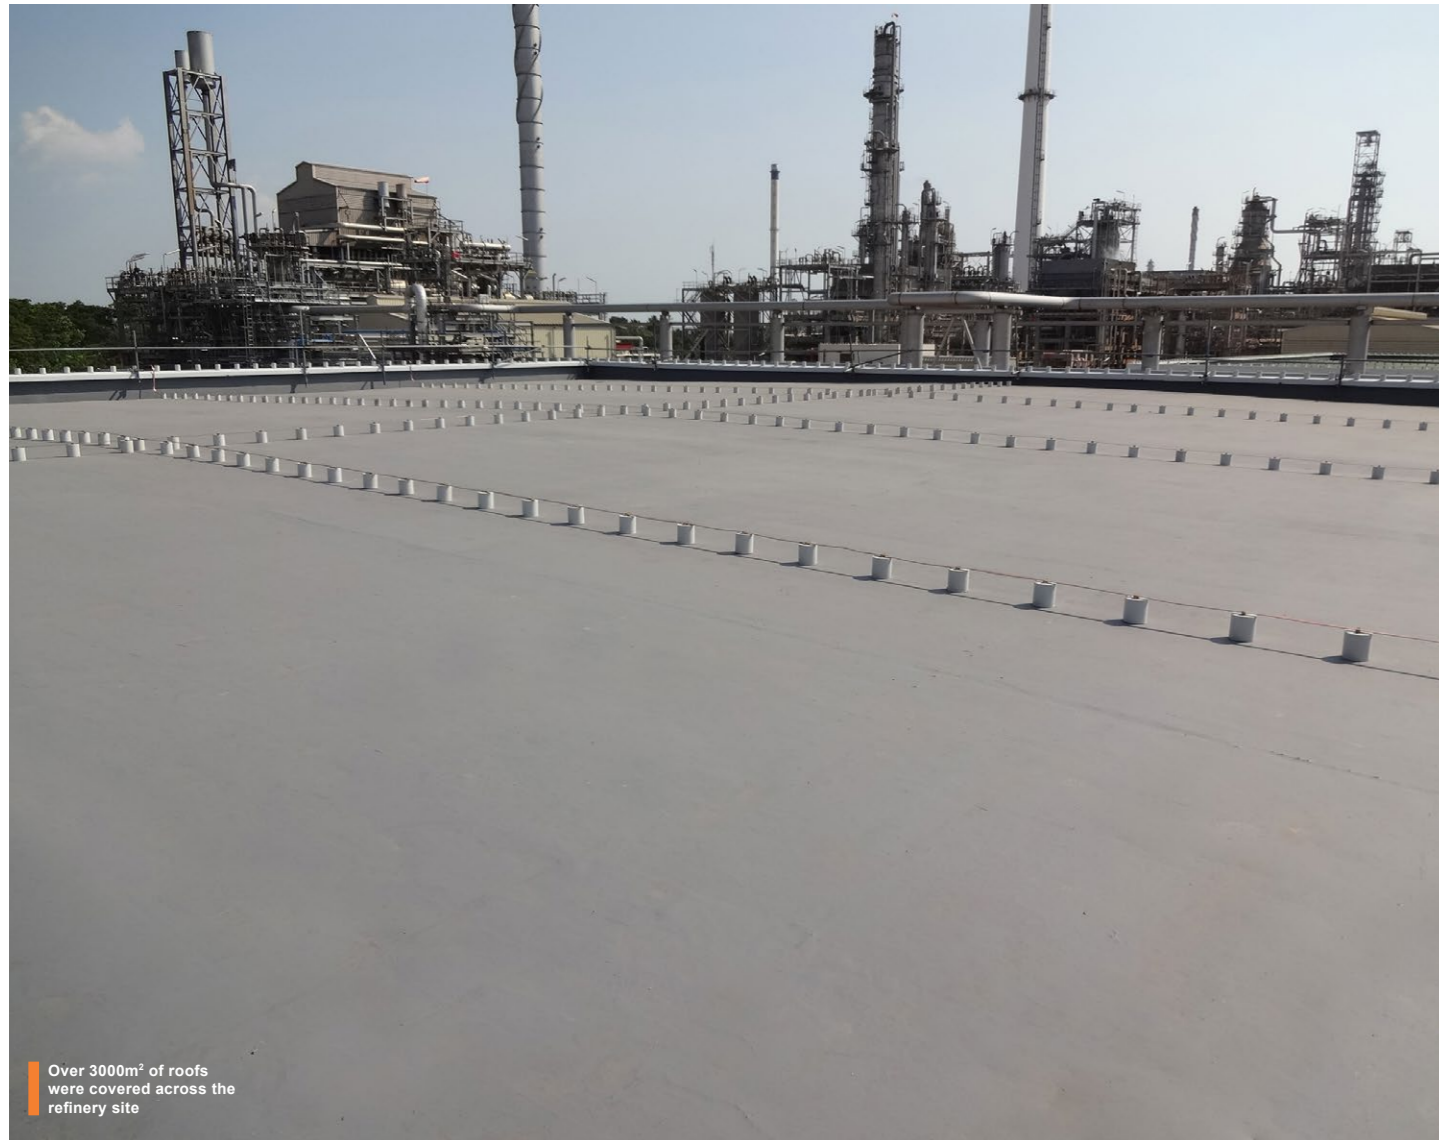
Over 3000m² of roofs were covered across the refinery site

To remove the source of the issue, the rooftop surfaces were abraded, ridding the concrete of any existing layers of laitance. Subsequently, the substrates were thoroughly cleaned of all dust and contaminants via waterjet cleaning, before final checks of the moisture and pH values. Once the concrete had been sufficiently prepared, the roofs were brushed with conditioner and the liquid-applied membrane, including reinforcement sheet, were administered. Overall, this system was implemented by 10-15 trained applicators, taking place across 60 working days.

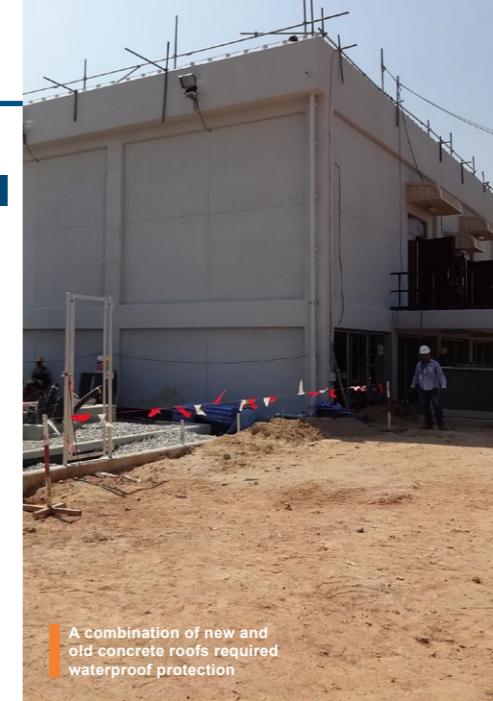
A combination of new and old concrete roofs required waterproof protection

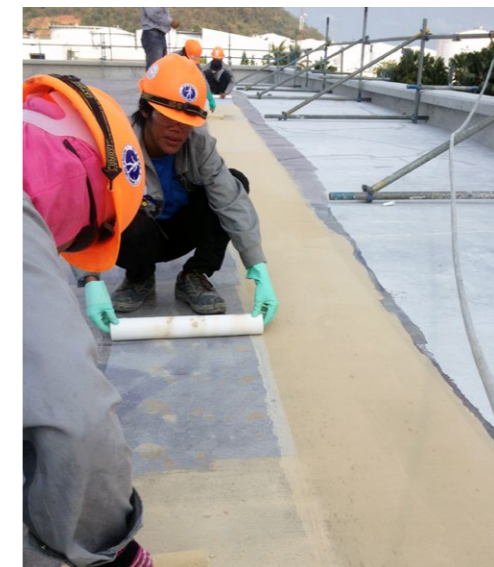
Application of reinforcement sheet

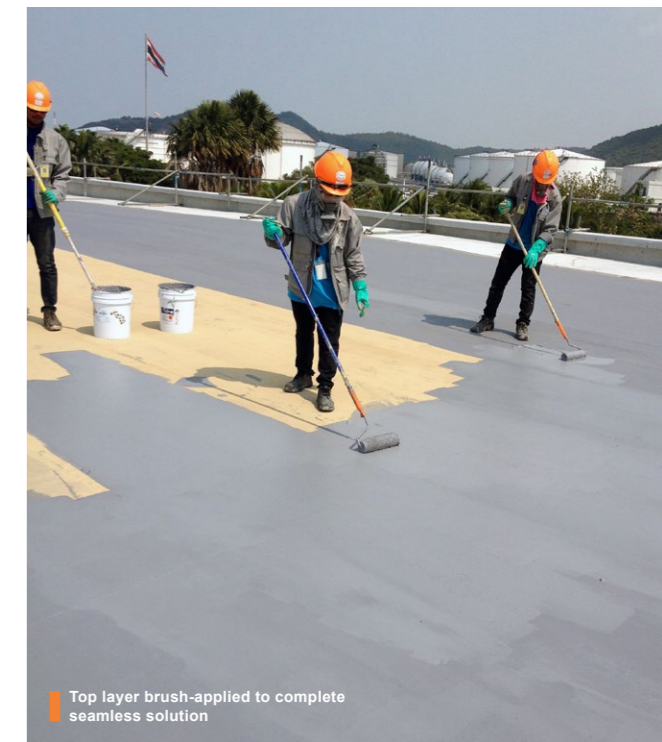
Top layer brush-applied to complete seamless solution

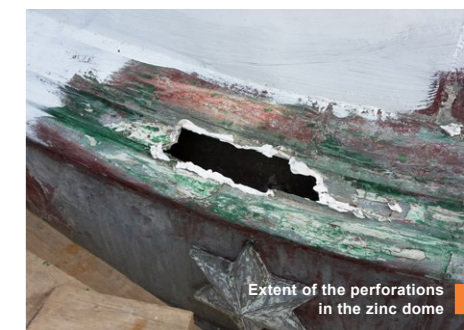
Extent of the perforations in the zinc dome

Most definitely, the jewel in the crown of this prestigious building is its green dome. Included as a homage to the green-coloured dome at the Prophet's Mosque in Medina, the striking design has become an integral part of Shah Jahan Mosque's heritage. However, over the course of its impressive lifetime, the zinc dome had become significantly damaged and was showing signs of ageing. It was suffering from a large number of perforations around its circumference, as well as several large holes, due to weathering and corrosion of the metal. In addition, the design comprised of a lateral band formed by 41 zinc stars, which had similarly succumbed to corrosion and loss of shape. All of this damage had led to

Prior to application acceptance, Belzona carried out a series of pull-off tests on the dome's current coating to assess its adhesion strength. Once the adhesion levels were determined, it was understood that the existing coating could be sufficiently removed using hand tools, creating a clean and rough surface profile, rid of deteriorated coating and corrosion. The dome, measuring a total of 6.5m in diameter, was examined thoroughly to identify and repair any thin- and through-wall defects. Starting with the most severely damaged areas, Belzona Technosol began to rebuild and resurface the dome's profile using Belzona 1121 (Super XL-Metal). Incorporated with a fine steel mesh over the large perforations in the zinc structure, the metal repair composite was cold-applied without the need for specialist tools.

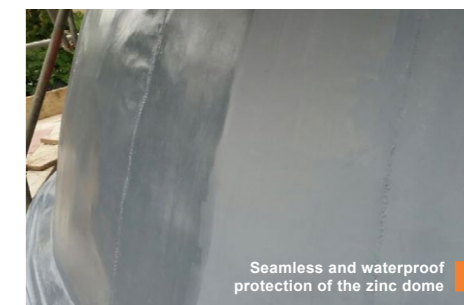
Seamless and waterproof protection of the zinc dome

Following some additional sanding, Belzona had restored a firm surface onto which the waterproof membrane could be laid. Once more, the substrate was cleaned and prepared in line with Belzona protocol, before the conditioner was applied across the entire dome and the seamless system of Belzona 3111 (Flexible Membrane) was installed. On such a complex surface, the liquid-applied, waterproof and weatherproof membrane demonstrated its ability to easily conform to the various contours of the dome, providing the mosque with long-term roof protection. In particular, this added flexibility and helped to reinforce the fragile zinc roof, offering respite from the 127 years of continuous exposure.

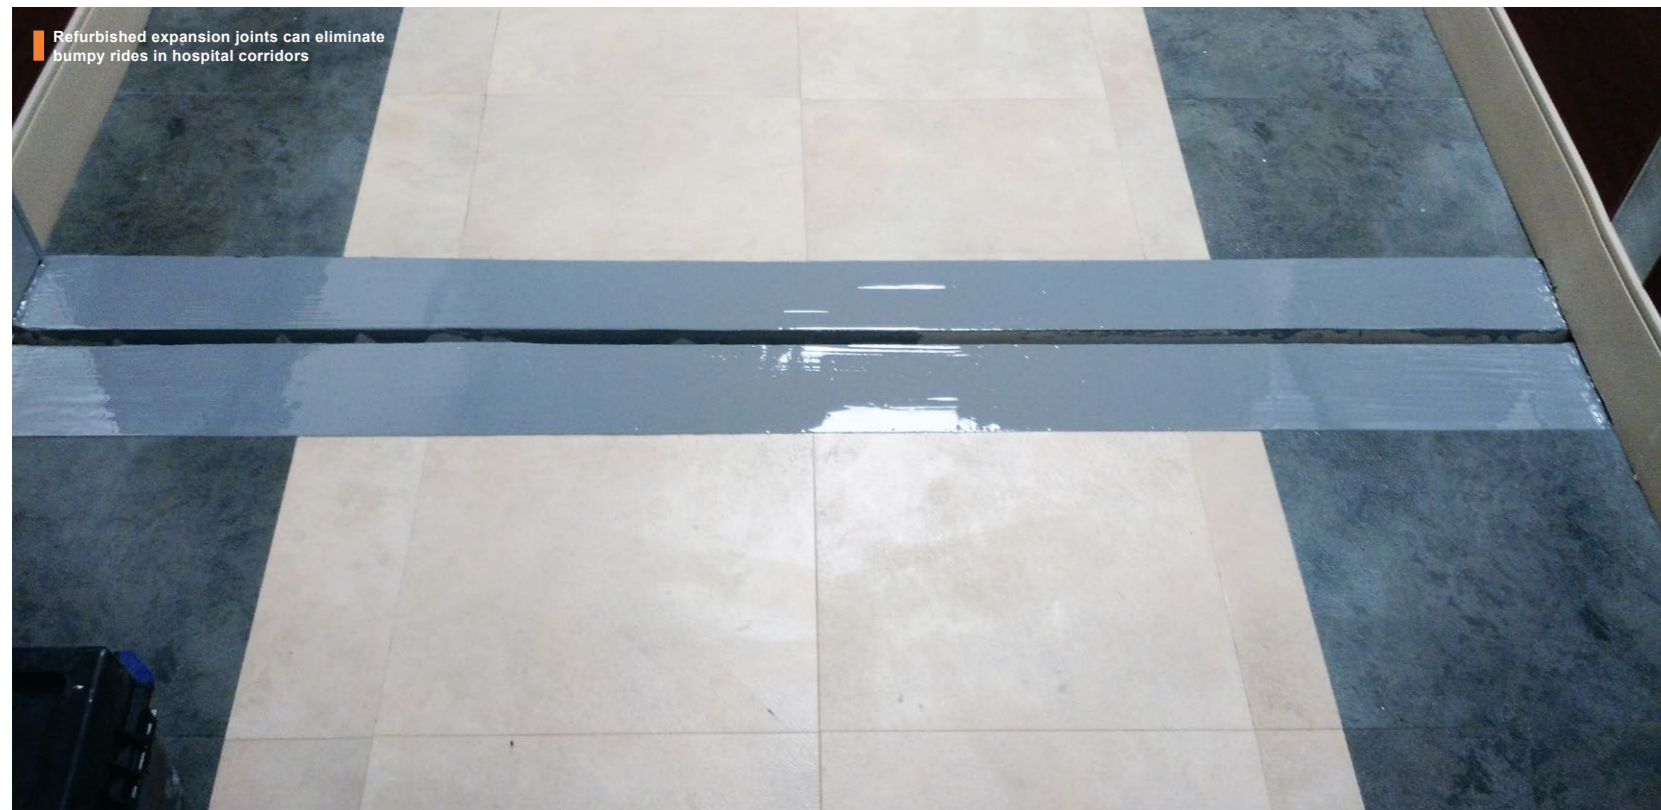
Refurbished expansion joints can eliminate bumpy rides in hospital corridors

Throughout Healthcare, floors are an essential part of Facilities Maintenance and any failure can be unsightly, noisy, harmful to mobile medical equipment and ultimately, dangerous. Amongst typical damages that can be found within Healthcare facilities is the deterioration of floor expansion joints, which can become damaged relatively quickly. Significantly, this damage results from poorly engineered expansion joints.

To effectively reinstall the expansion joint, the original is excavated, removing all the damaged concrete and failed components. Following correct surface preparation and conditioning, the repair then utilises Belzona's 4000 Series materials to rebuild the damaged concrete floor. Offering high mechanical and impact strength Belzona 4111 (Magma-Quartz) is ideally suited to replace the deteriorated concrete, which will combat the point load stresses common to that environment.

Next, a backer rod is inserted into the joint, before the application of highly flexible, Belzona 2211 (MP Hi-Build Elastomer), which accommodates for movement between materials at the joint itself. Finally, if required, Belzona 4411 (Granogrip) can be incorporated with aggregate to provide a slip reduction system either side of the expansion joint. This further eliminates the potential slip and trip hazards associated with the previous, failed system.

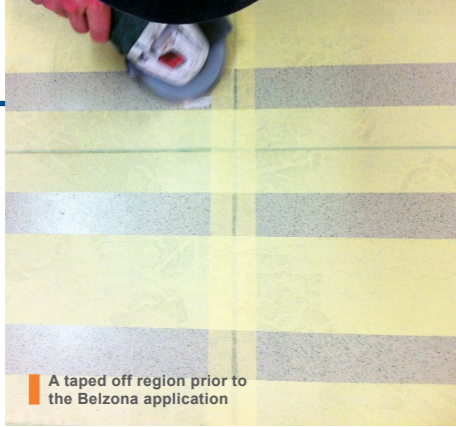
A taped off region prior to the Belzona application

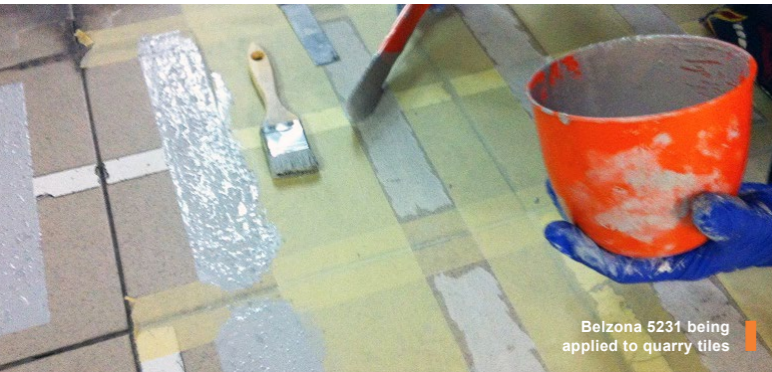
Belzona 5231 being applied to quarry tiles

Aggregate), which provides additional grip. In testing, Belzona 5231's adhesion to damp quarry tiles (using ASTM D1002) produced impressive results of 1710 psi (11.79MPa). It is also classified as having Low Slip Potential in wet conditions when tested in accordance with BS 7976 utilising RAPRA Slider 96 (and this is even without the additional grip the Belzona 9211 would create). But beyond its performance as a safety grip system, Belzona 5231 also has a quick curing period - one of the most important factors to ensure minimal downtime. After only 8 hours at 20°C, the material will be cured enough to accommodate light pedestrian traffic and after 24 hours - full traffic and loading.

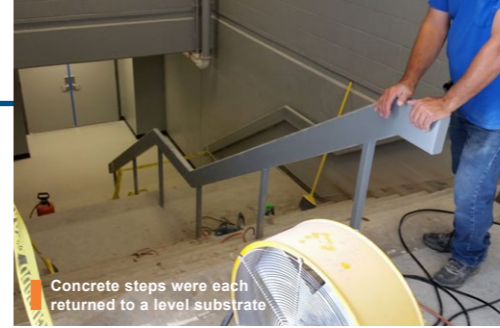
Concrete steps were each returned to a level substrate

The most prominent areas of deterioration were the steps' edges, where the concrete nosings had worn considerably. In addition, the stair treads were delaminating, causing a trip hazard as well as proving difficult to clean due to entrapped dirt and grime. To reinstate the same material would have proved costly and the customer lacked

After consultations with alternative grip system providers, Belzona's polymeric solutions were chosen to restore the concrete stairs and provide a new slip resistant coating. Initially, the glued down treads were removed and the concrete steps were prepared to ensure a clean, dry and debris-free substrate. The nosings and any additional deteriorated patches were resurfaced using Belzona 4111 (Magma-Quartz), a fast-curing concrete repair composite, providing a solid base onto which a grip system could be applied.

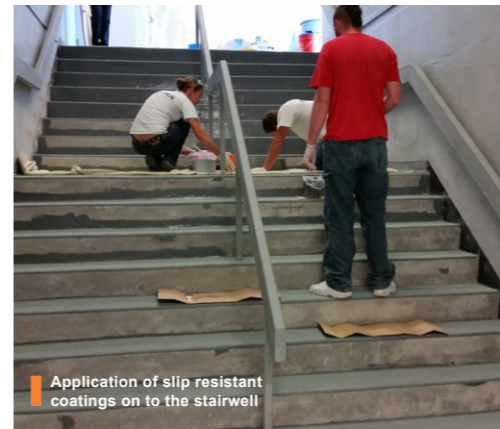
Application of slip resistant coatings on to the stairwell

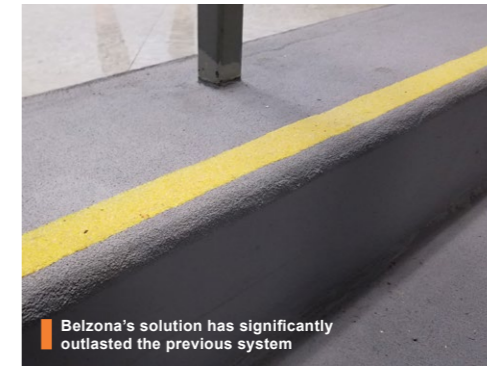
Belzona's solution has significantly outlasted the previous system

After 18 months in service, the application was inspected by the local Belzona Distributor, who stated:

"The stairs look like they are brand new as there are no scratches and no wear on the treads or edges. The school's green initiative only lets them quickly clean with water most of the time, but following a periodic deep clean, the school's Associate Principal said that the stair look really good."

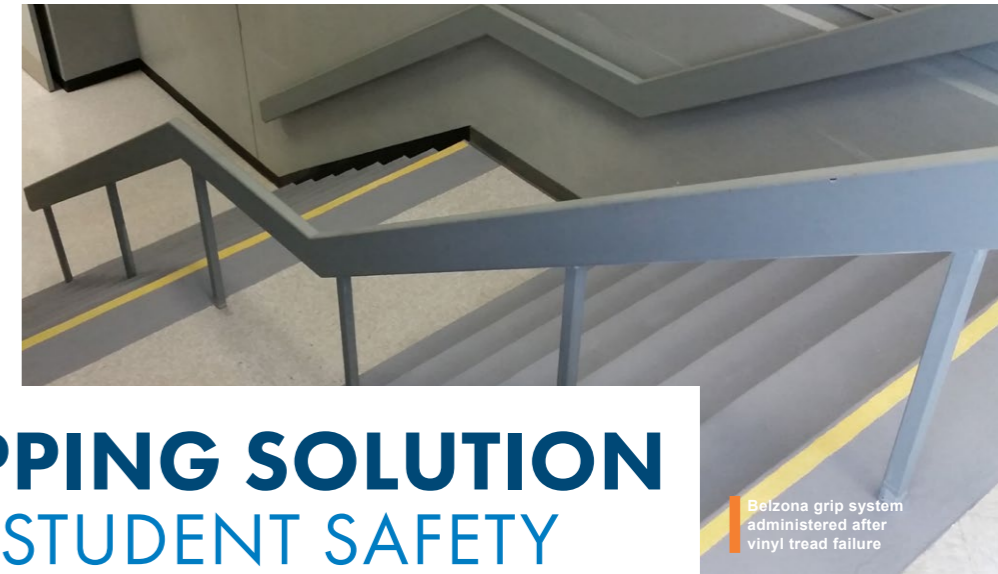
Belzona grip system administered after vinyl tread failure

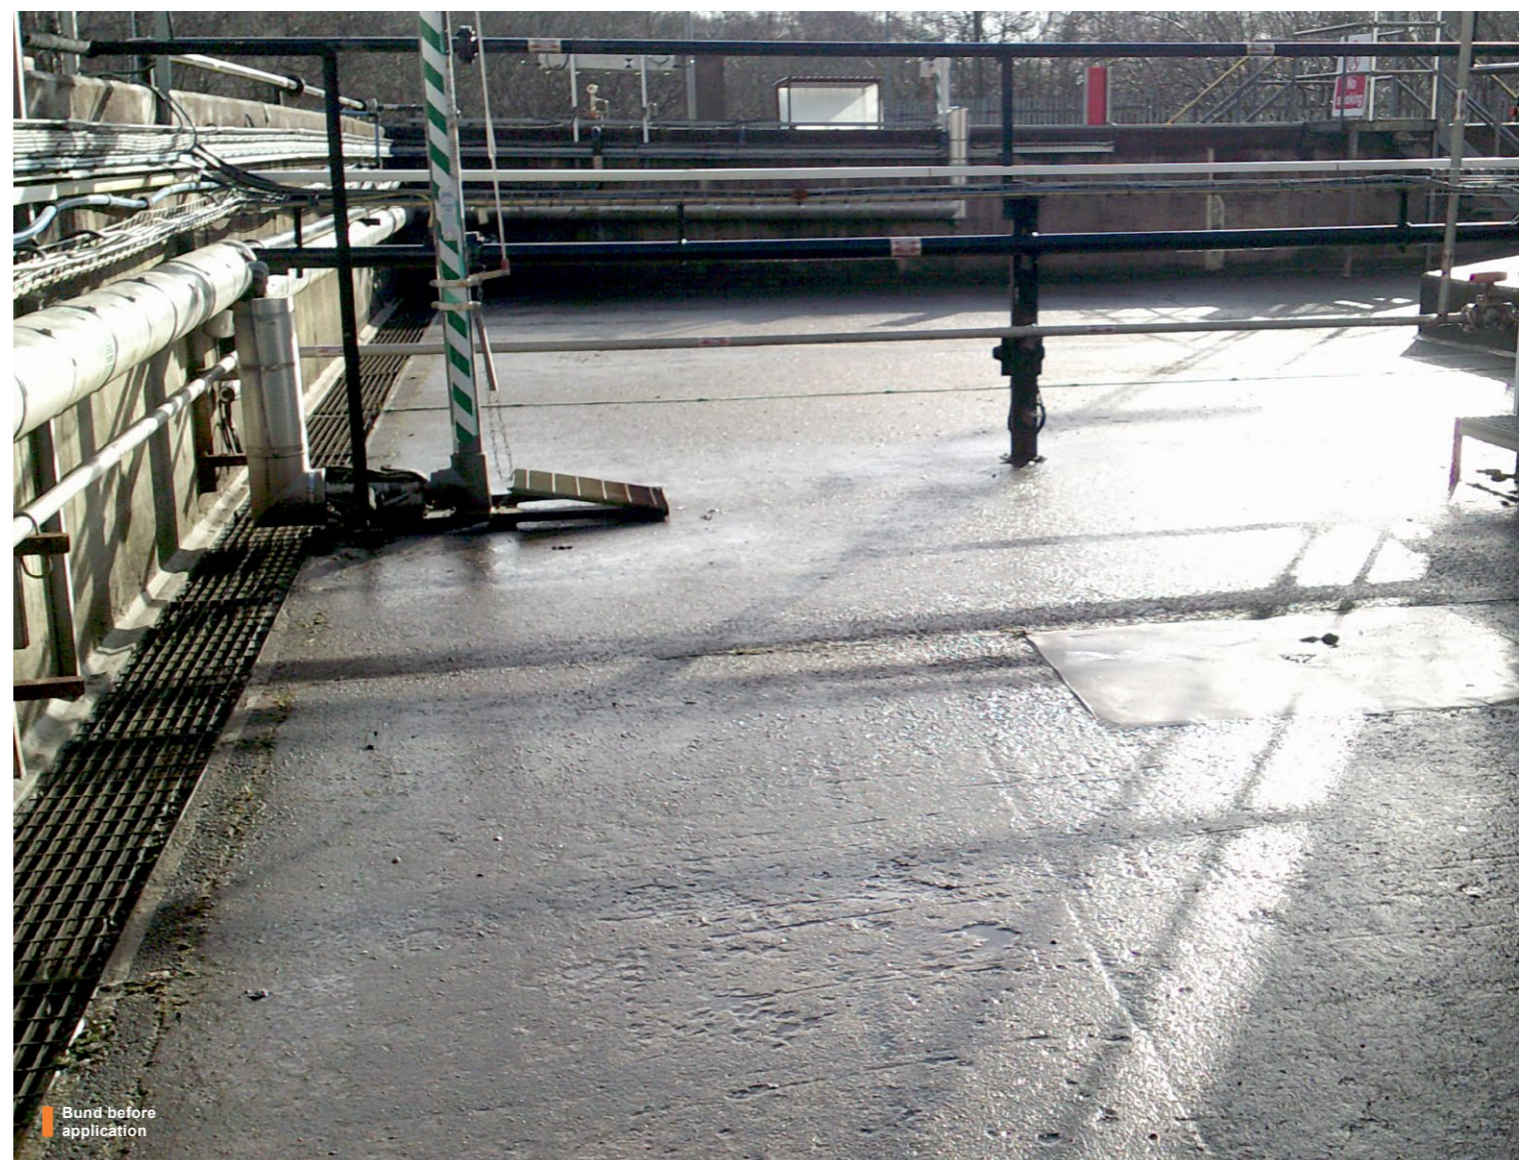
Figure 1: Containment area design

The total bund surface area to be coated was around 460m², which included a 0.5m vertical band around the concrete plinth B, walls A, B, C, D and E, and a 1m band up onto the concrete plinth A (Figure 1). Previous attempts to repair cracks and fillets around the base of the plinth and surrounding walls had resulted in failures, leaving several areas of the bund vulnerable. As well as needing to restore these, a 25m, linear, mastic, expansion joint also needed to be replaced. To cope with the level of concrete movement, the asset owner required a protective coating which could move in sympathy with the large concrete pad and cope with stresses if any

Before the application, the area was cleaned using a combination of detergent and antifungal washing, alongside high-pressure water to remove any contamination. Blasting wasn't permitted due to the tank containing methanol, so any loose concrete was removed to ensure a firm platform. The surface was then abraded to expose the aggregate by mechanical scarification.

the surfaces had dried, any cracks in the substrate were filled with Belzona 4131 (Magma screed). This was also used to create fillets to reinforce the joints between the walls, floors and tank base where required. Belzona 4361 was then chosen to coat the entire bund area, including walls, concrete plinths and drainage channel due to its excellent chemical resistance against methanol, flexibility and good adhesion, facilitating long-term sealing between the wall and the floor.

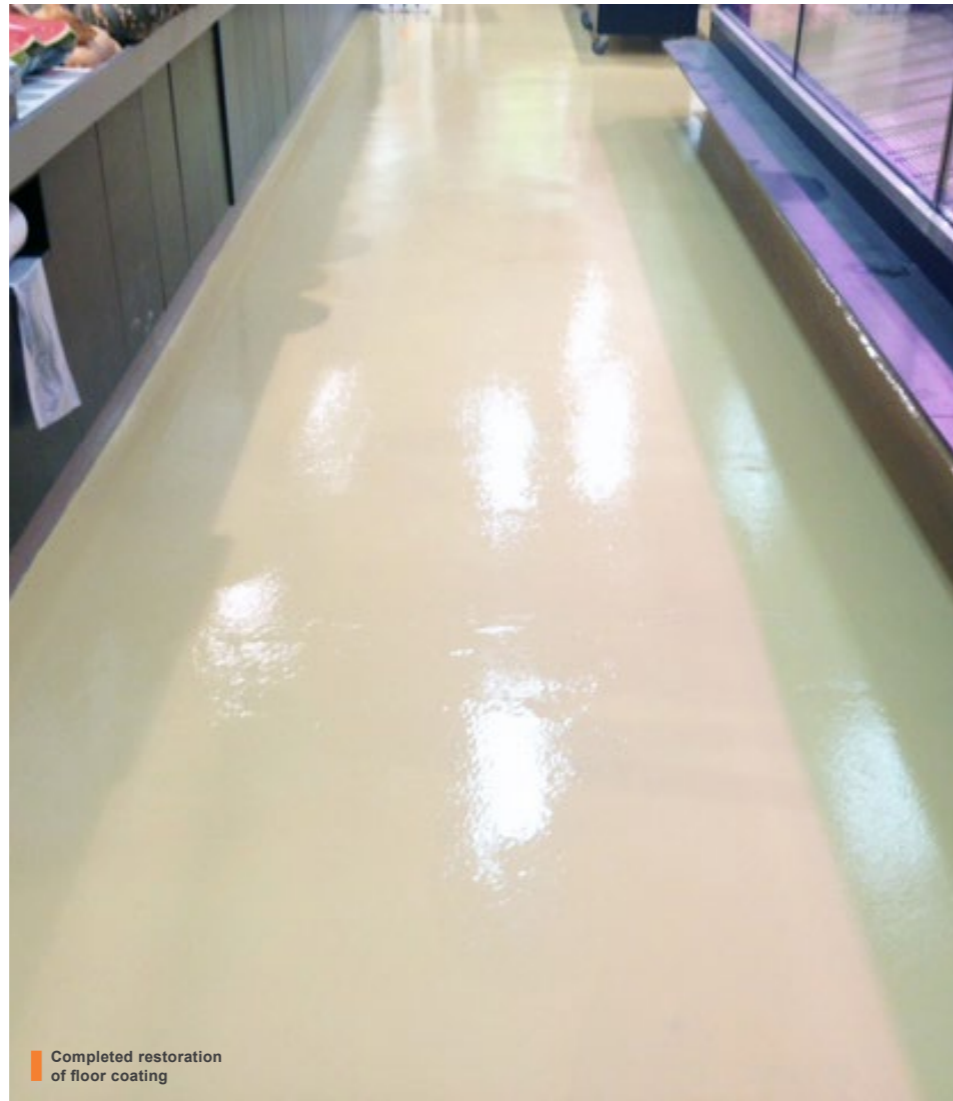
Completed restoration of floor coating

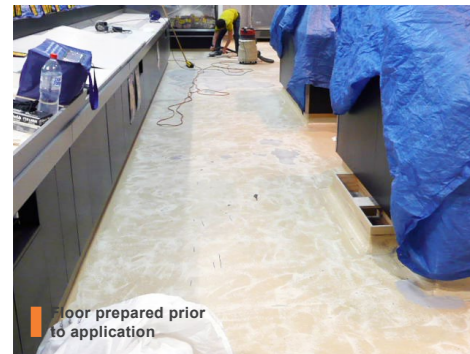
Floor prepared prior to application

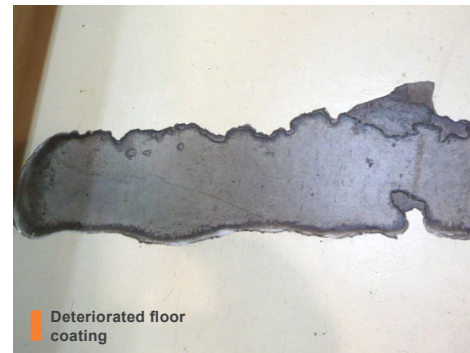
Deteriorated floor coating

In this instance, there was a need to recoat the floor as several concrete areas were damaged and the old coating had delaminated in many places. Highlighted as an issue during a Health Inspection audit, Rezitech tackled the damaged concrete floor using Belzona 4111 (Magma-Quartz), a fast-curing concrete repair material. Accompanied by a two-part floor coating, to improve abrasion and slip resistance, the shop floor was reinstated quickly with minimal disruption.

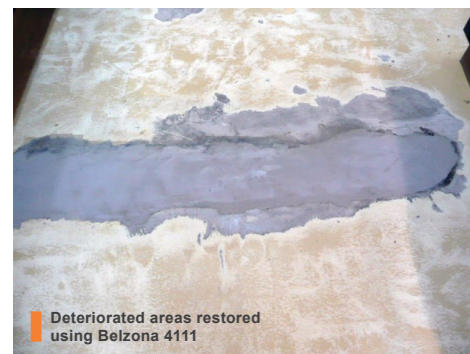
Deteriorated areas restored using Belzona 4111

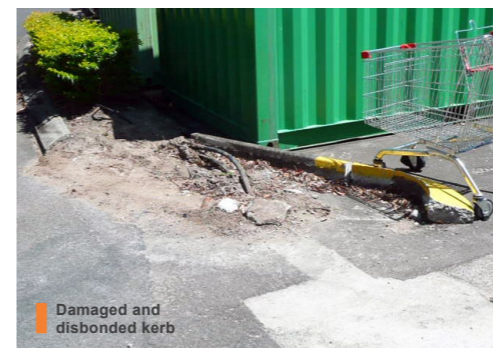
Damaged and disbonded kerb

Sometimes this required refitting or even the creation of a new kerb. In Winter 2013, this specific application was required after damage to the kerb warranted its removal and replacement. Using a wooden former, Belzona 4111 (Magma-Quartz) was applied into the design, re-creating the original kerb profile. Once the concrete repair material had sufficiently cured, the former was removed leaving the perfectly-formed kerb, ready to be painted.

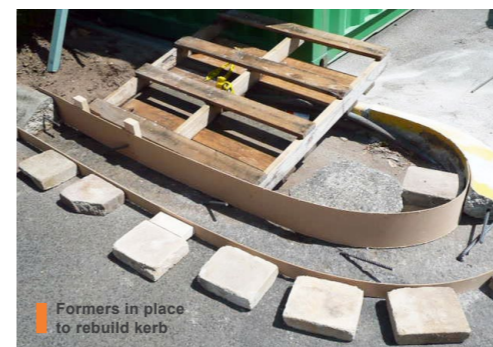
Formers in place to rebuild kerb

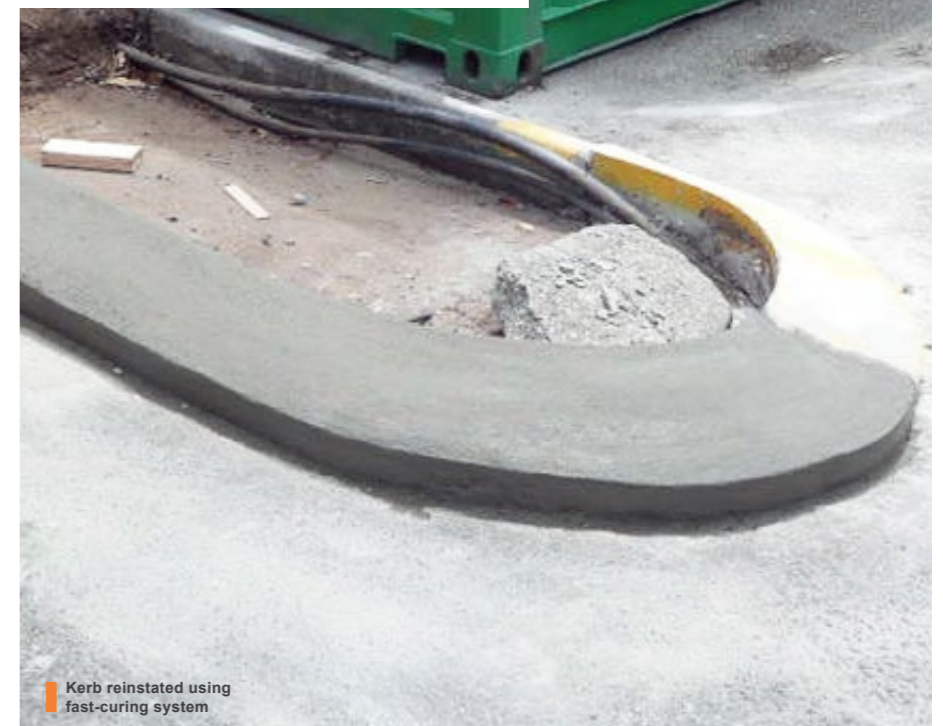
Kerb reinstated using fast-curing system

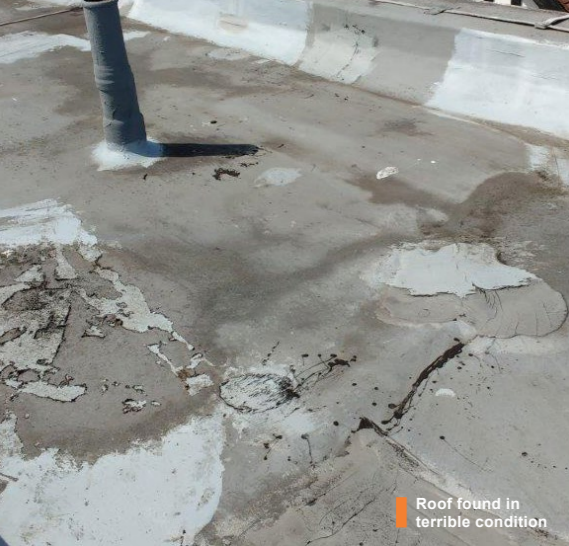
Roof found in terrible condition

Previously, the steel panel clad roof and metal box gutters had been suffering from cut edge corrosion which, if left untreated, can result in roof failure. However, Belzona 3111 provides the protection to counter this. The coating can last for 25+ years as

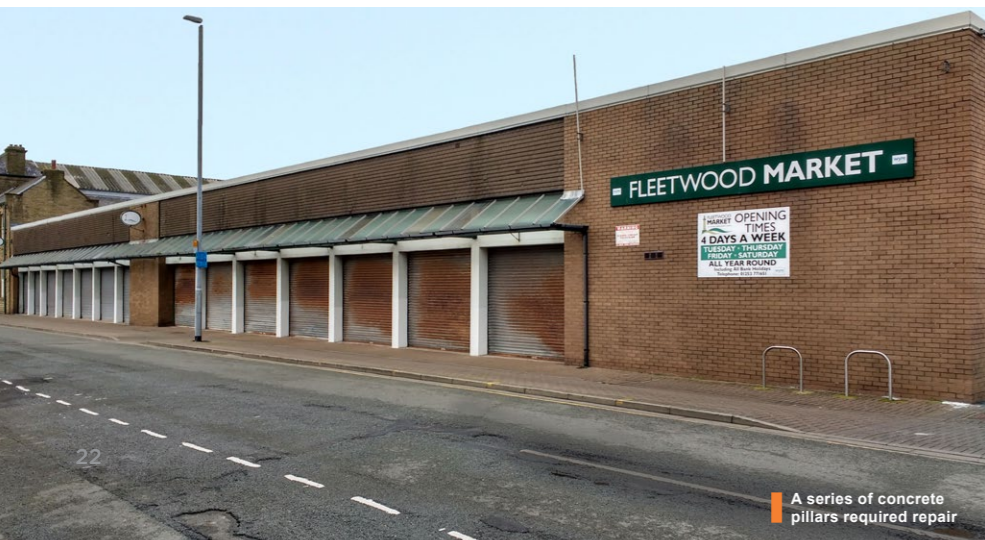
A series of concrete pillars required repair

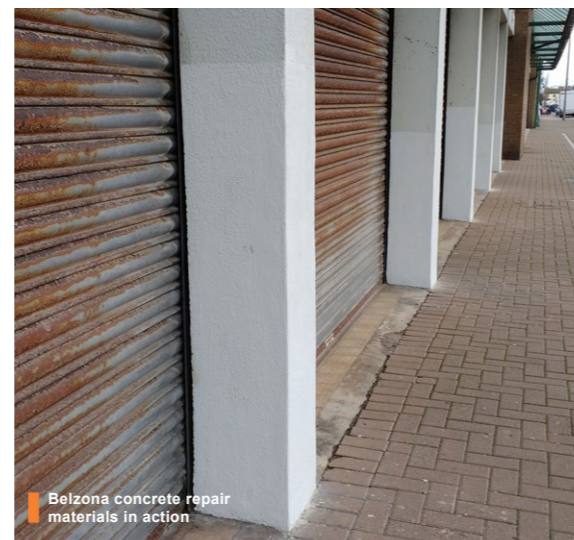
Belzona concrete repair materials in action
