# IN FOCUS: Abrasion

Issue 108

## LONG-LASTING POLYMER TECHNOLOGY

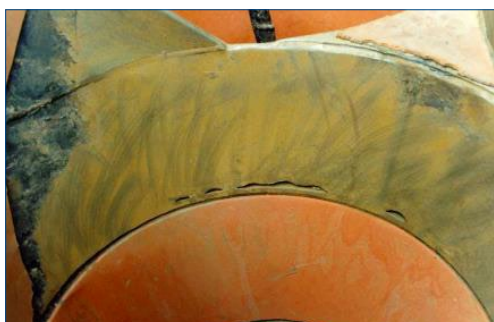
Failed rubber lining

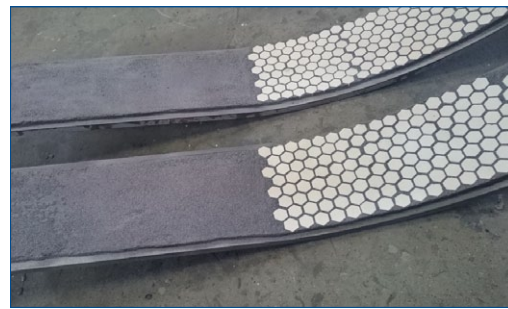
### Belzona 1800 Series systems

For areas of extreme wear, the [Belzona 1800](#) Series of products are recommended. Containing hard solid fillers, these systems are designed to be applied as thick wear layers ensuring continued operation of critical equipment. Belzona 9811 alumina tiles can be incorporated with the [Belzona 1800](#) Series for situations with severe impact abrasion.

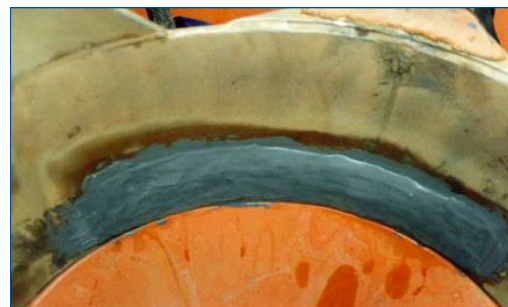
### Belzona 2100 Series systems

Belzona's durable and abrasion (D&A) resistant elastomers are designed to withstand impact attack such as in brittle erosion. Used frequently to repair damage of existing linings, they are also regularly specified for protection of areas where heavy erosion mechanisms are present such as cavitation in fluid flow equipment.

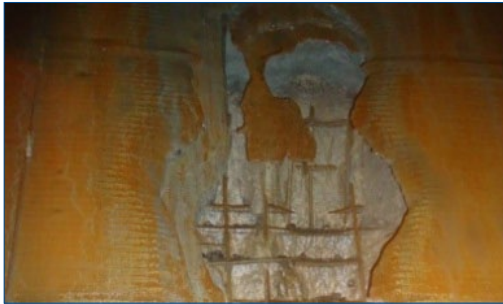
Damaged areas of the concrete sump

Belzona's abrasion resistant system was successfully applied to the concrete channels and sumps at a copper mine in Brazil. These areas presented widespread wear due to erosion caused by the flow of copper ore pulp leading to loss of thickness and profile. Due to the severity of the damage, the surfaces of the channels and sumps required major reconstruction.

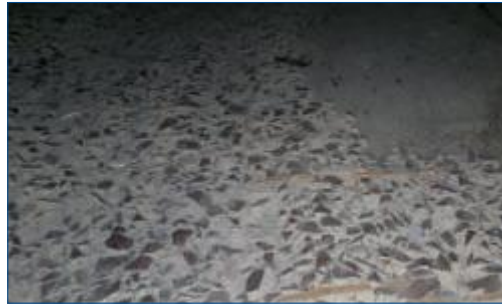
Worn reinforced concrete channel

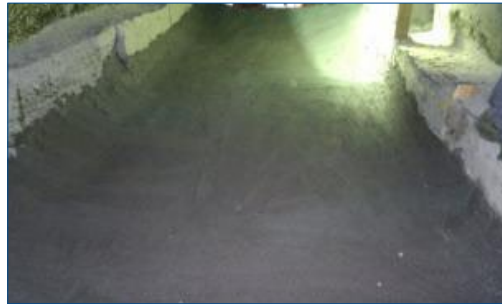
Completed application on a channel

A previously used system required 96 hours to apply and failed every 3-4 months. The client was very satisfied with the results provided by the Belzona solution which is inspected every 2 years during planned turnarounds. ■

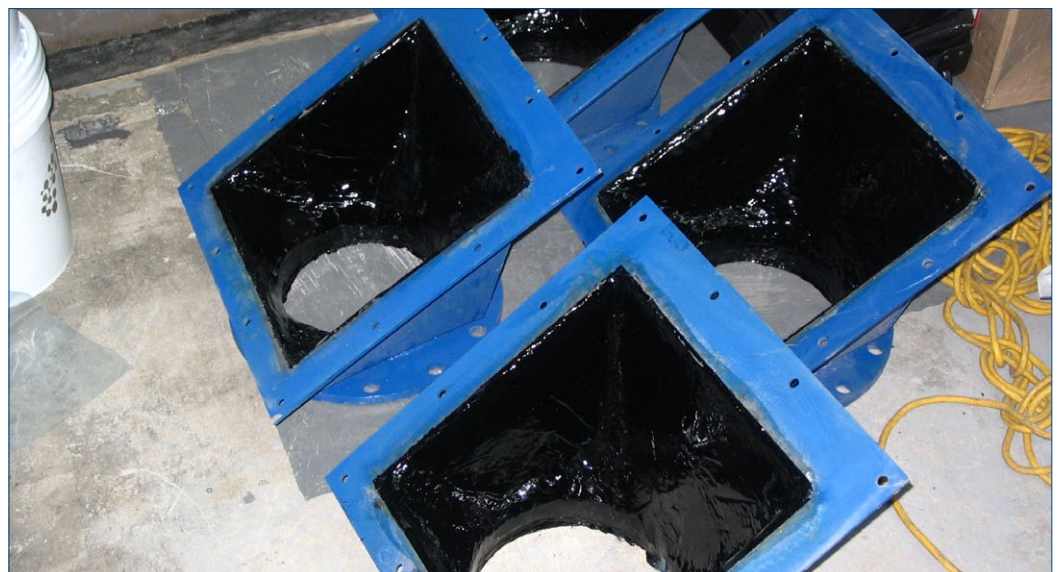
Hoppers lined with Belzona 2111

Upon carefully reviewing the operating conditions of the hoppers, a durable and lasting Belzona system was specified, which consisted of [Belzona 1812 \(Ceramic Carbide FP\)](#) and [Belzona 2111 \(D&A Hi-Build Elastomer\)](#). Belzona 1812 was applied to profile the hopper before overcoating with [Belzona 2111](#). Both the mild steel hopper substrate and [Belzona 1812](#) were grit blasted before coating.

With the Belzona solution equipment now operates for a period of 18 to 24 months maintenance free. The client also approved [Belzona 1812](#) as an inventory product, which is used in other applications. ■
