IN FOCUS: Chemical Attack

SECONDARY CONTAINMENT REPAIR AND PROTECTION

Issue 107

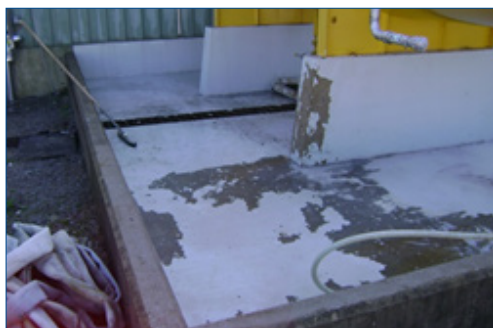
98% sulphuric bund in need of repair

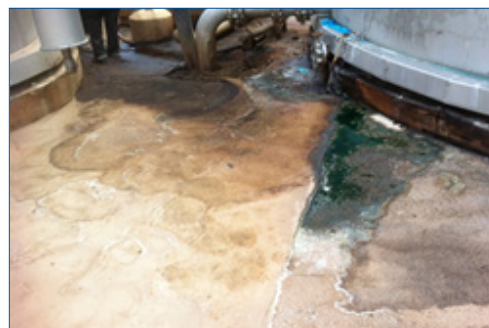
Acid attack at 49°C/120°F

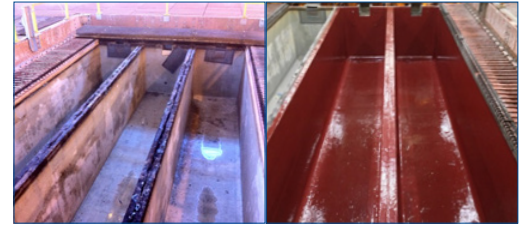
Furniture rails at copper mine protected from CuSO₄ electrolyte

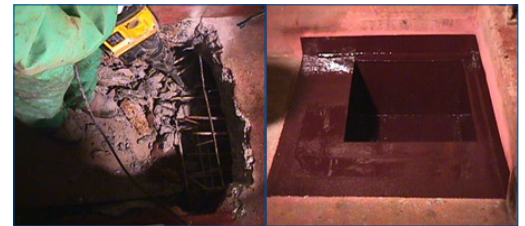
Badly deteriorated acid sump repaired

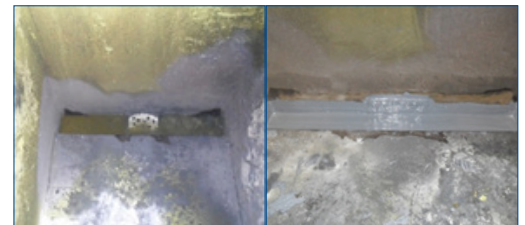
Through-wall damage repaired on pickle tank containing 36% hydrochloric acid

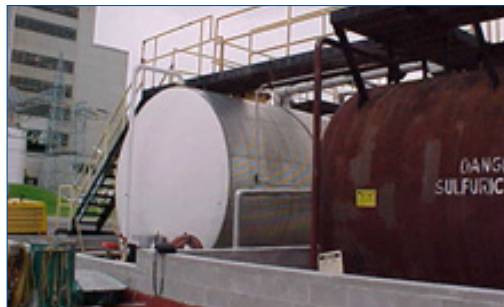
Sulphuric acid (right) and caustic (left) containment areas

The protective coating system at an Alabama power plant failed, allowing sulphuric acid to deteriorate the secondary containment area. Chemical leakage in turn contaminated the surrounding environment.

The acid side of the containment area was then coated with [Belzona 4311](#) and the caustic side with [Belzona 5811](#), a material best suited for chemical resistance to lighter compounds. The application was revisited after eight years in service, and minor touch-up repairs were all that was needed. ■

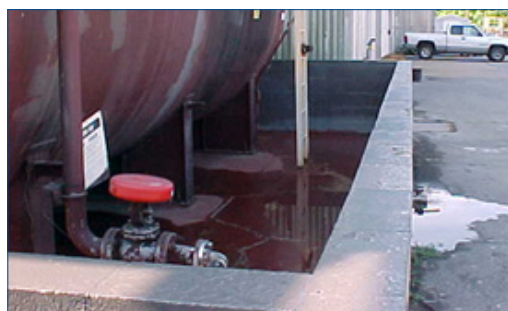
Concrete damage due to system failure

As a solution to this problem, a competitor system was applied, but failed within the first two years in service. This premature failure prompted the asset owner to seek a proven lasting solution. Since the acid tank itself had already been coated with [Belzona 4311](#) and remained in service with no incidents for 12 years, the customer decided to coat the surrounding concrete with Belzona.

The damaged concrete areas were repaired with [Belzona 4111](#), a fast curing polymer mortar. First of all, the existing failed coating was completely removed. All loose concrete was chiselled away and the whole area was thoroughly cleaned. To achieve maximum adhesion to the substrate, Belzona 4911 conditioner was used. Belzona 4111 was then applied at a minimum thickness of 6mm. A

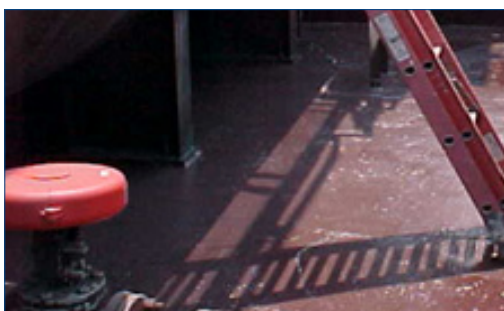
Coated area after eight years in service

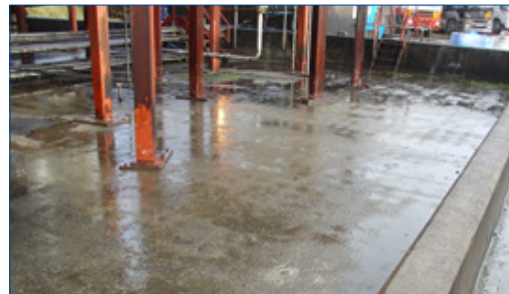
Containment area prior to application

A premium spirits distiller in the UK required a repair and protective system for a caustic chemical containment area after the existing fibre glass system had failed.

A Belzona Authorised Contractor was approached to provide a long-term solution. On preparing the surface and removing the fiber glass lining it became evident that the concrete substrate had badly degraded and required extensive repair. [Belzona 4131 \(Magma Screed\)](#) and [Belzona 4141 \(Magma Build\)](#) were used to repair the degraded sections of the walls to bring the banded area back to its original state.

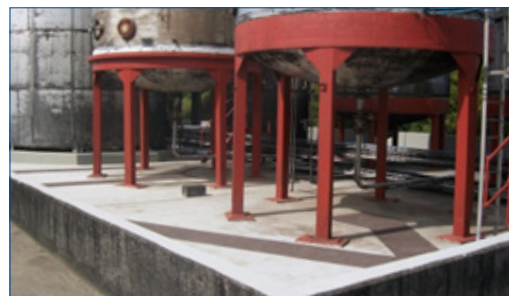
Concrete substrate repairs

The concrete floor surface was skimmed to a depth of 6mm and 50mm x 50mm fillets were installed to all horizontal and vertical corners of the bund with Belzona 4131 and Belzona 4141. A two coat system of [Belzona 5811 \(Immersion Grade\)](#), a high performance barrier coating, ideally suited to this application providing protection from the effects of the disclosed chemicals, was then applied to the internal and external walls of the bund along with the floor. ■

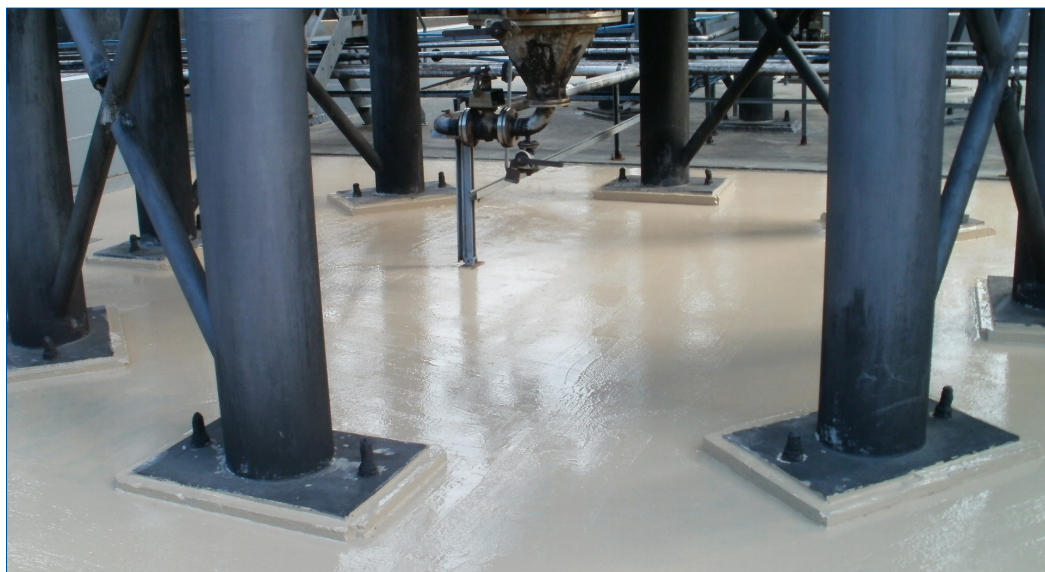
Completed application
