IN FOCUS: Concrete and Masonry Repairs

FAST-CURING AND DURABLE REPAIR SOLUTIONS

Issue 114

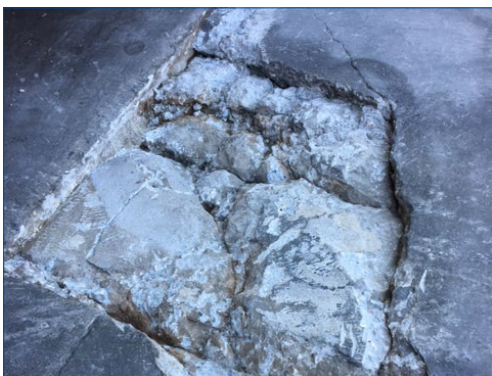
Impact from heavy traffic can damage concrete

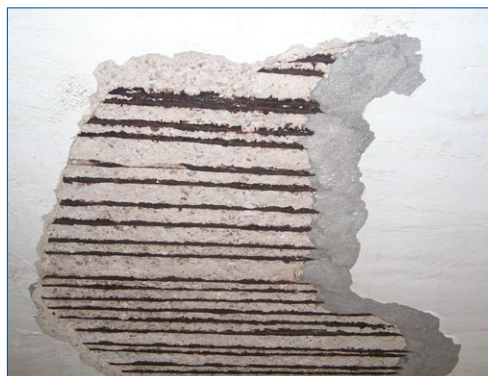
Corroding metal leads to spalled concrete

In fact, one of the leading causes of deterioration in concrete results from fluid penetration of the porous substrate corroding the embedded metalwork. Oxidization of the reinforcing bar causes tensile stresses, leading to increased weakness and spalling. Reapplication of the porous material onto the same area does not negate the issue. Overall, like-for-like repairs can prove costly and time-consuming upon reoccurrence of the same issues. ■

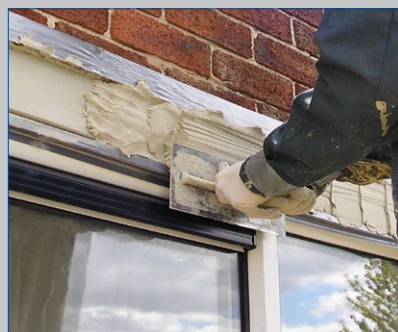
BELZONA REPAIRS FOR CONCRETE AND MASONRY

Floor, wall and overhead repairs with non-porous polymeric repair systems

Belzona's 4100 Series polymeric materials provide a range of concrete and masonry repair solutions for floors, walls and even overhead.

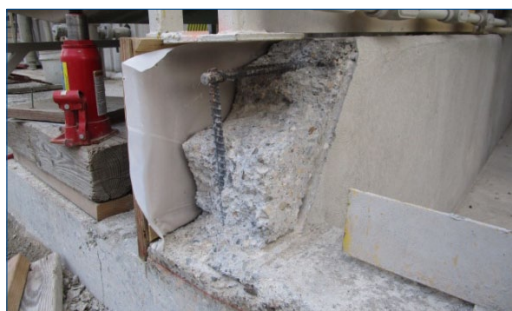
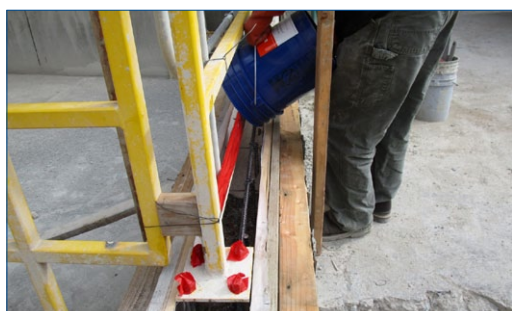
Removal of all deteriorated concrete

The repair application started with removing all loose and damaged concrete, including a large section of the wall corner area. To fully prepare the steel rebar, a grinder was used to remove traces of oxidation.

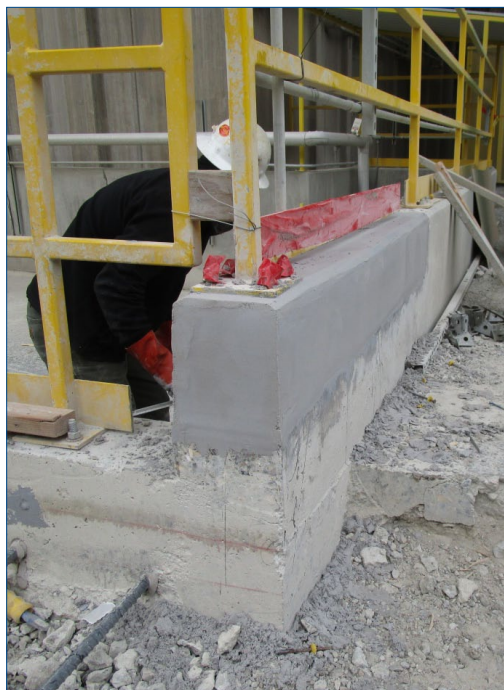
Secondary containment wall rebuilt and finished with a layer of Belzona 4111

A frame was then created by attaching form boards to the remaining concrete and Belzona 4154 was poured in to fill the space. This polymeric resin has been specially designed to be a cost-effective repair system which, when mixed with local aggregates such as sand, quartz or crushed stone, effectively fills large holes and cracks. It is fast-curing and it can be over-coated after 6 hours at 20°C/68°F, achieving full mechanical hardness after 24 hours. This is in comparison to the 28 days it takes for concrete to fully cure.

After using Belzona 4154 it is always necessary to complete a repair with a top coat. In this instance, Belzona 4111 was chosen as an over-layer due to its outstanding chemical, abrasion and impact resistance, as well as excellent adhesion even to vertical substrates.

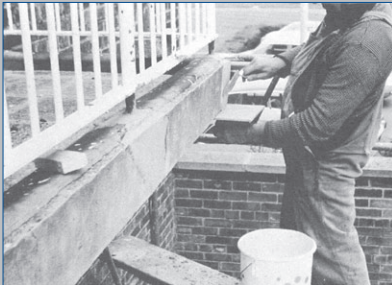
This repair has been periodically inspected, with a visit in 2016 confirming the Belzona repair to still be in perfect condition over 35 years after the original application. This aptly demonstrates the longevity and durability of Belzona's mortar repair systems.

Back in 1981, Belzona was contacted by the Department of Education in Newcastle, UK, to assess the failing masonry at one of their colleges. The edges of a balcony were spalling and the rail supports were suffering from erosion-corrosion. Initially, Belzona removed the corroded tubular rail supports, before using [Belzona 1111 \(Super Metal\)](#) to cold bond steel bars, restoring the support's structure. The spalled concrete was then rebuilt using [Belzona 4111 \(Magma Quartz\)](#), encapsulating the new steel supports.

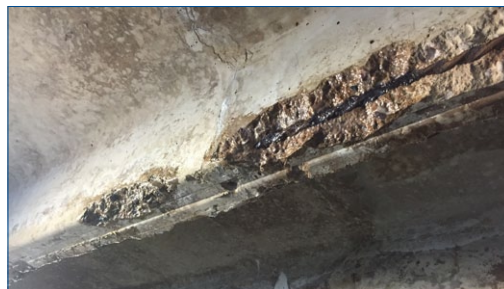
Deteriorated overhead concrete on car park

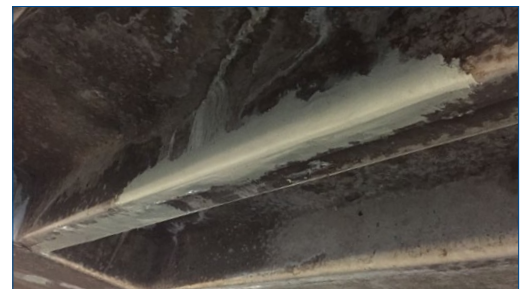
Rebuilding of overhead concrete
