IN FOCUS: Flexible Repairs

LONG-TERM FLEXIBLE AND DURABLE SOLUTIONS

Issue 112

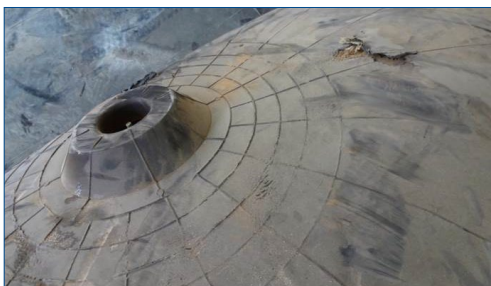
Torn rubber fender

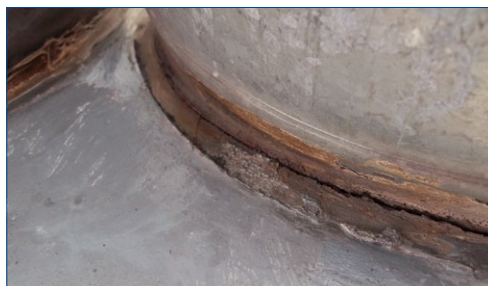
Deteriorated joint on HVAC unit

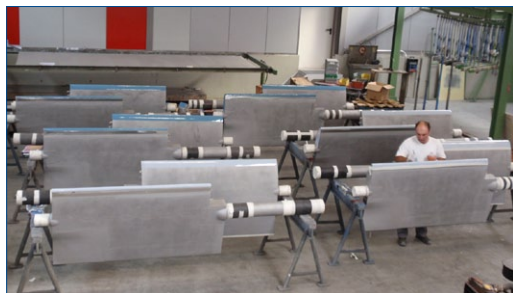
Wicket gates after blasting and initial application

A turbine manufacturer in France required a long-term solution to protect 12 wicket gates which were suffering from severe corrosion and abrasion. The damage, located on the leading edge of the wicket gates, was caused by entrained solid particles carried in the water.

For the application, the entire surface was firstly grit blasted using an angular abrasive to give ISO 8501 Swedish Standard Sa2 ½ cleanliness ensuring a minimum 75 µ (3 mil) profile. Once the grit blasting was completed, the substrate was then washed using Belzona 9111 (Cleaner Degreaser) in order to remove any residual blasting debris. Next, the application of Belzona 1341 was carried out using a stiff, short bristled brush. Once cured, the two coats of Belzona 2121 were then applied using the same technique, ensuring the first layer had cured before application of the second layer.

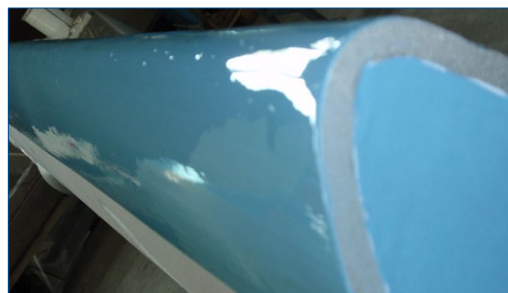
Belzona 1341 applied

To repair the damaged areas, a combination of [Belzona 1341 \(Supermetalglide\)](#) and [Belzona 2121 \(D&A Hi-Coat Elastomer\)](#) was chosen. Belzona 1341 was selected as not only does this epoxy coating improve the efficiency of fluid handling equipment, but it also provides outstanding erosion and corrosion protection. As the leading edges were known to suffer from impact damage due to solids in the water, Belzona 2121 was specified to be applied in two coats (black and red) over Belzona 1341 to offer long-term impact protection in these specific areas. Belzona 2121 is specially designed for applications where durability, elasticity, high abrasion and tear resistance are required, making it the ideal solution to protect this harsh application area.

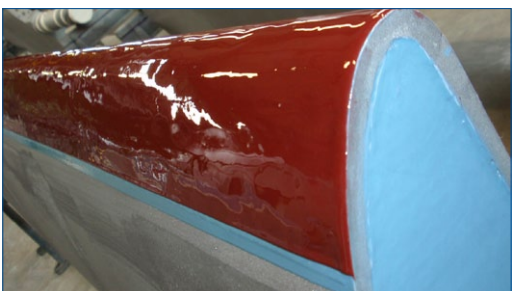
Belzona 2121 applied

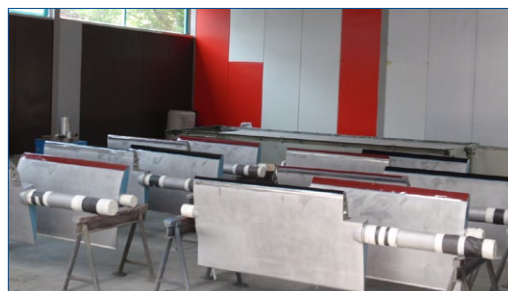
Long-term erosion-corrosion protection of the leading edge

This combination of Belzona systems ensured a robust protection mechanism was successfully achieved. As these materials offer long-term protection, even when the substrate is subjected to abrasive media, there has been a growing rise in the application of this system and is now in general use across France. ■

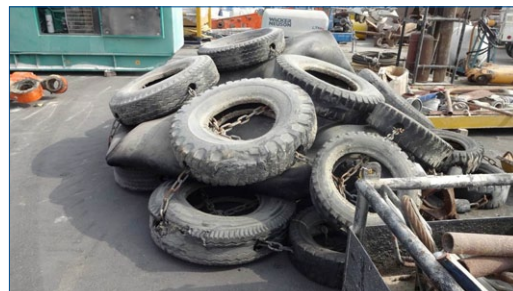
Initial inspection of deflated fender

A national dredging company in Abu Dhabi, U.A.E required a flexible and robust repair solution to treat a number of fenders which had become worn and punctured over time. Although wrapped with the tyre net for protection, due to the extent of the damage, the fenders were in urgent need of a full service and, in more severe cases, complete replacement.

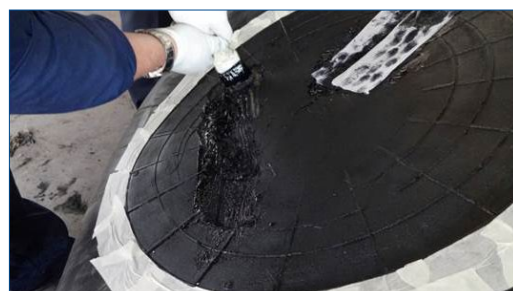
Application of Belzona 2111

A flexible, abrasion resistant polyurethane elastomer, [Belzona 2111 \(D&A Hi-Build Elastomer\)](#), was chosen to repair and rebuild the damaged fenders. As this material exhibits high elasticity, it will successfully absorb any impact damage and dissipate the energy, fortifying the substrate with robust, long-term protection. Furthermore, the cold curing properties of Belzona 2111 will enable the company to bypass the need for vulcanisation, which can incur a number of hazards due to the hot work involved.

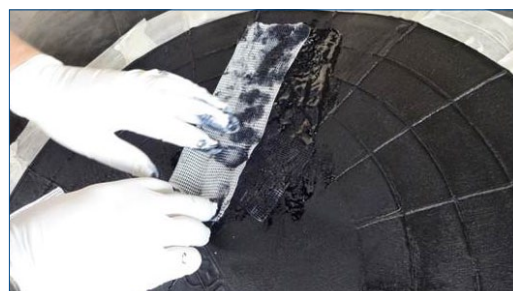
Application of Belzona 9341 into Belzona 2111

For the application, the surfaces were prepared by firstly removing any material loosely adhered to the substrate. This was done using a knife to leave a sound edge terminated square or undercut. For the next step, the complete area of damage plus an area of 75mm (3") around the damage was then abraded using a power wire brush to produce a woolly finish. Following this, the surface was then washed with Belzona 9111 in order to remove all dirt, grease and other surface contamination. After conditioning the areas, Belzona 2111 was applied in a thin film using a stiff bristle brush to the entire prepared area, pushing the product well into the prepared profile. To rebuild the damaged substrate, lengths of Belzona 9341 reinforcement tape were wetted out with the Belzona material and applied to the damaged areas. A final layer of Belzona 2111 was then applied to encapsulate the Belzona 9341 reinforcement tape, and the application was left to cure.

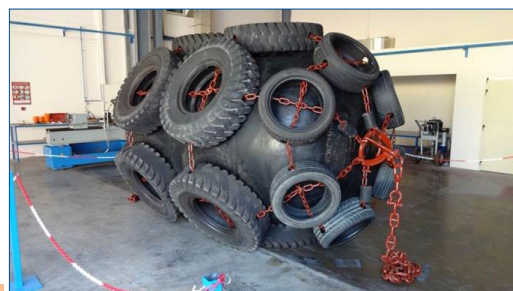
Flexible and durable repair

The complete Belzona package, including the polymeric system and its application, facilitated a quick and cost effective solution for the dredging company. This repair method enabled the company to simply restore and strengthen the existing fenders, rather than replacing them, saving valuable downtime and capital expenditure.
