# IN FOCUS: HVAC Maintenance

## REPAIR AND PROTECTION SOLUTIONS FOR HVAC

Issue 113

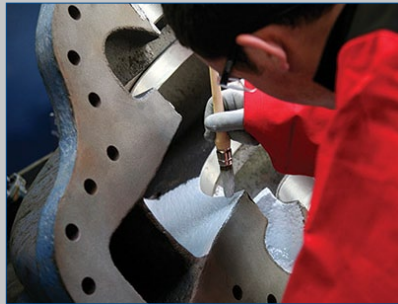
**Belzona 1300 Series**  
Erosion-corrosion resistant coatings and repair composites for repair and protection of chiller tube sheets, pump casings and impellers, fan blades and other components

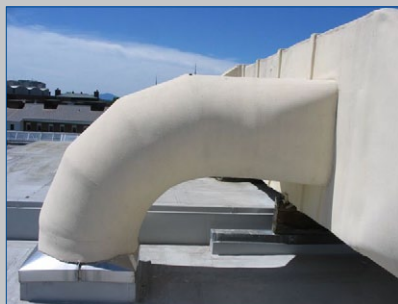
**Belzona 3100 and 3200 Series**  
Liquid-applied membranes for internal and external sealing of joints, seals and roof penetrations, as well as encapsulation of insulated pipework and ductwork

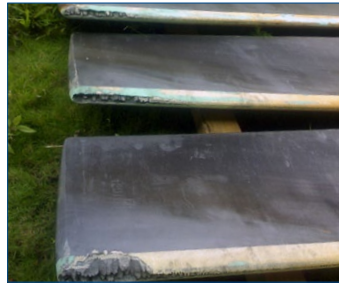
Damaged blades

In addition, cooling tower fan blades usually suffer from erosion of the leading edge, as well as cracks and flaking on trailing edges, reducing the overall efficiency of the cooling system. Poor maintenance such as lack of bearing lubrication, loose pulleys or fan hubs results in scored and worn shafts.

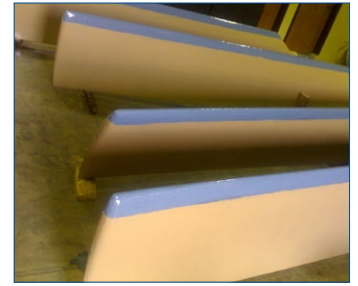
Completed application

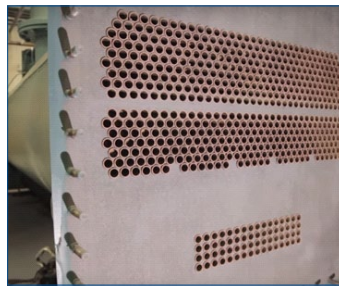
Grit blasted tube sheet

Belzona 1100 Series rebuilding materials can be used to rapidly repair and rebuild damaged tube sheets, water boxes and end covers in situ and without the need for hot work prior to the application of a long-lasting protective coating.

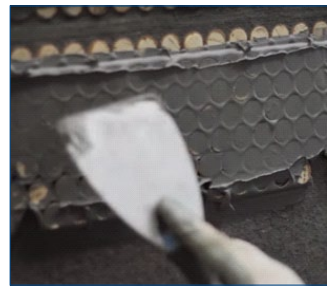
Corks inserted and rebuilding in progress

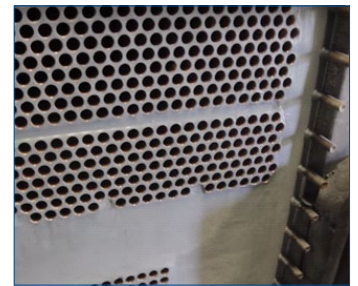
Completed repair and protection

coating, which will isolate the dissimilar metals and eliminate corrosion. The Belzona solution not only restores the original tube profile but also creates a smooth tube sheet face flush with the tube ends, reducing turbulence and increasing efficiency.

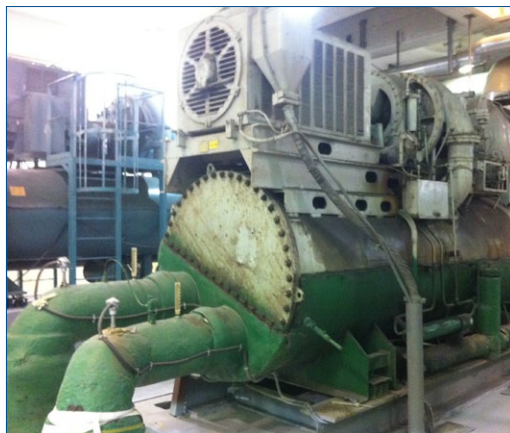
A university facility in Israel had a chiller unit that was in its 35th year of service. The tube sheet was badly corroded and gas leaks were occurring, significantly decreasing the efficiency of the system. The university required a long-term solution to rebuild and protect the tube sheet with minimal downtime and disruption.

The York chiller unit

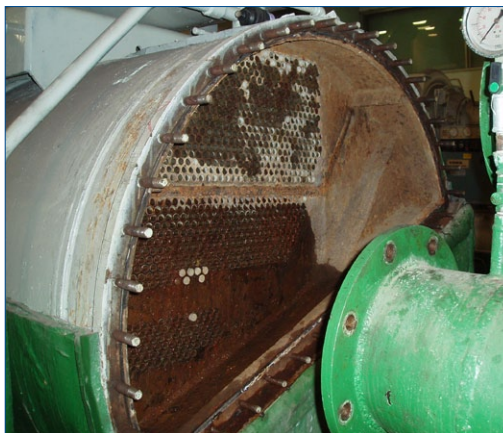
Tube sheet before application

Prior to the application, all dezincified tube sheet material was removed so a solid metallic surface could be exposed, followed by grit

blasting. After completion of blasting, the area was washed with Belzona 9111 (Cleaner Degreaser) to remove all residual blasting debris.

All tubes were blocked off with corks to avoid contamination before Belzona 1311 was applied to recover the metal loss, commencing at the centre of the tube sheet and progressing to the extremities. A thin film of Belzona 1311 was applied in the seal area around a former to restore the original seal groove dimensions. Once the repair material had cured, the tube sheet was coated with Belzona 1341 to provide additional corrosion protection.

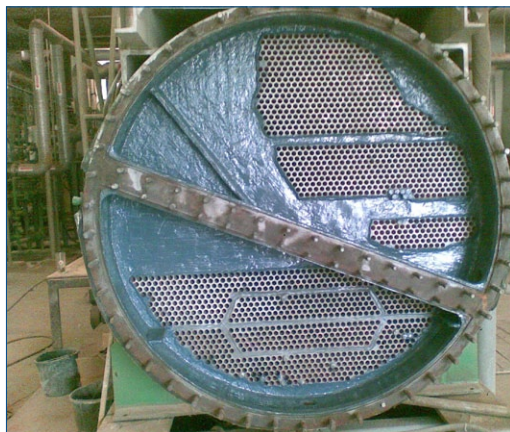
Completed coating of the tube sheet

The end covers were also protected. After application of the coating, the corks were removed to reveal the completed repair and protection solution. The standard Belzona repair techniques sealed the gas leaks on the tube sheet and provided corrosion protection to allow the unit to continue in service for many more years. ■

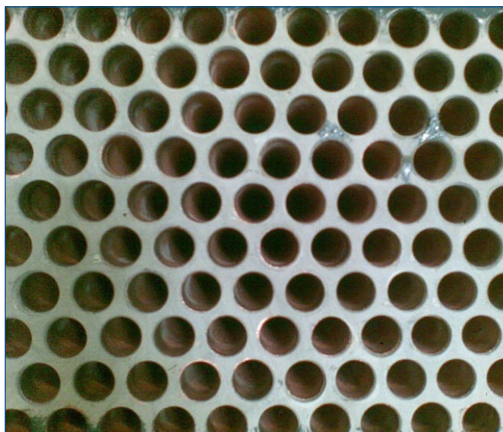
Close-up of the coated tube sheet

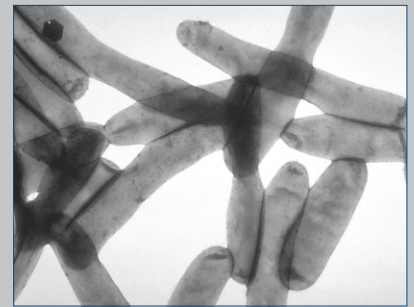
These bacteria can thrive in the warm and wet conditions found in cooling towers. Leaks at the construction joints not only affect the efficiency of the cooling process but could lead to the distribution of the dangerous legionella bacteria. Poorly maintained cooling towers are the main cause of outbreaks of Legionnaires' disease.

Belzona 5811DW2, a corrosion and chemical resistant coating designed to operate in the wet and warm environments present in cooling towers, can be used to prevent corrosion and the creation of through-wall defects. This coating provides a smooth and easy to clean surface for routine maintenance and cleaning of the tower.

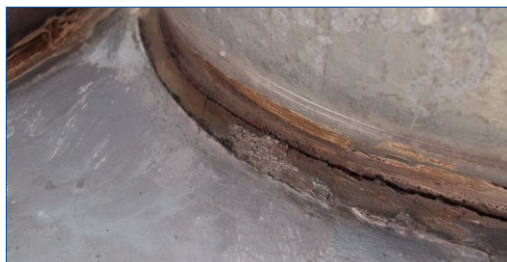
A manufacturer in the United Kingdom had an issue with their extraction outlets on its roof over the production area. The effects of weather and UV had caused the rubber seals around the ductwork penetrations to degrade, allowing rainwater to leak directly into the production area and creating disruption in production and safety issues. The company required a durable, waterproof and weatherproof repair solution that would not only seal the leaking areas, but also continue to protect the substrate against any future damage.

Deteriorated joint

The application was carried out in accordance with the Belzona procedure. Firstly, the surface was grit blasted in order to remove all loose debris before the substrate was prepared with a conditioner to maximise adhesion of the Belzona materials. The joints were first resealed with a Belzona Elastomer, [Belzona 2211 \(MP High-Build Elastomer\)](#), a polyurethane resin system designed for the repair, coating and sealing of rubber and metal components. A fully reinforced Belzona 3111 system was applied incorporating Belzona 9311 (Reinforcement Sheet) using soft bristled brushes, encapsulating the sealing areas.

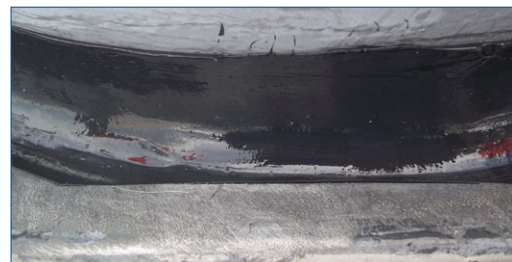
Belzona 2211 applied to seal gap

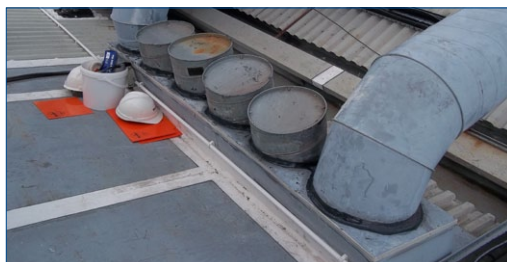
All joints sealed with Belzona 2211

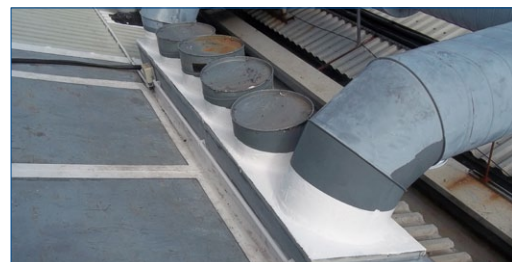
Completed sealing and protection

The Belzona system was applied in two days without disruption to the manufacturer's operations, sealing and protecting the ductwork penetration area against weather and further environmental effects. ■
