IN FOCUS: Hydropower

PIONEERING POLYMER TECHNOLOGY

Issue 103

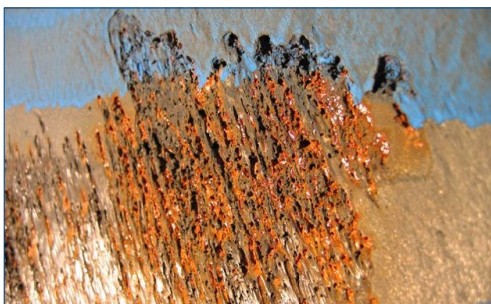
Fig 1: Cavitation damage on a stay vane

Areas deteriorated from erosion-corrosion and cavitation (see Fig 1 and 2) can be rebuilt using Belzona’s two component repair composites. This method bypasses the need to replace the damaged material with the same material, a like for like repair, which would otherwise leave ▶▶

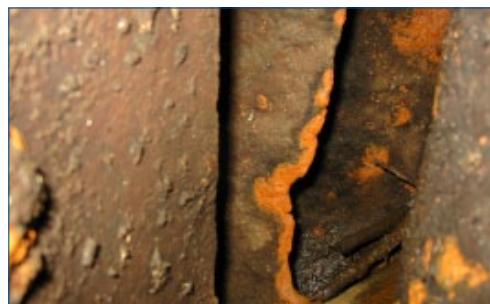
Fig 2: Deteriorated turbine runner

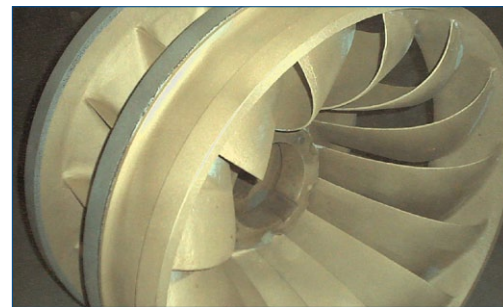
Francis turbine following preparation by grit blasting

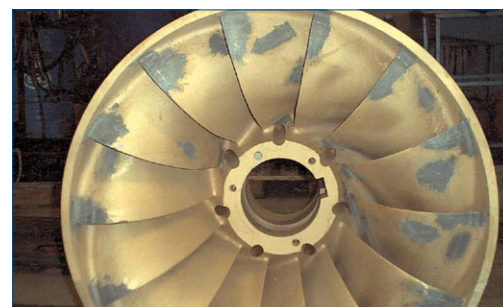
Application of [Belzona 1341 \(Supermetalglide\)](#) in progress to runner

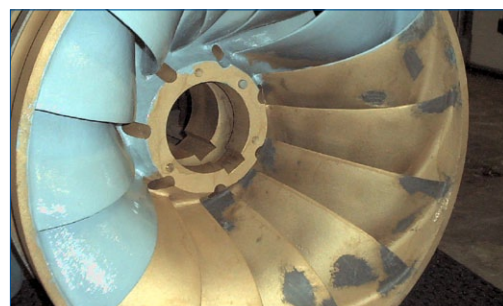
Turbine following rebuild using a paste grade material to in-fill areas of erosion damage

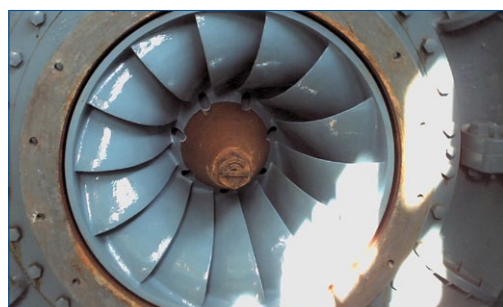
Completed runner installed and ready to return to service

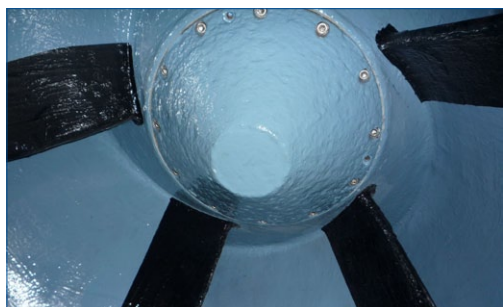
[Belzona 2141 \(ACR-Fluid Elastomer\)](#) can be used in conjunction with Belzona erosion-corrosion coatings to allow localised protection where cavitation resistance is required

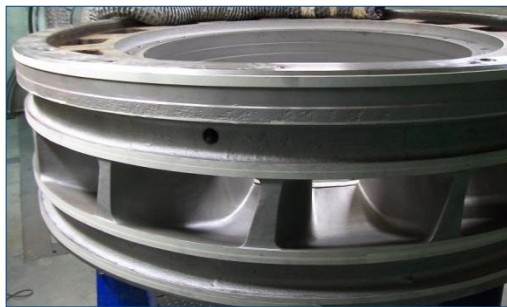
Blasted runner prior to the application

A Belzona application was carried out on a Francis turbine runner which had been previously coated 15 years ago. The original coating was found to be in good condition with the exception of the areas subjected to extensive cavitation damage. When the original application took place [Belzona 2141 \(ACR-Fluid Elastomer\)](#) was not yet formulated. The client was satisfied with the performance of the Belzona coating and wished to renew it to maintain erosion-corrosion protection.

[Belzona 5811 \(Immersion Grade\)](#), a high performance barrier coating was applied to the bottom and top parts of the turbine, as these areas required only corrosion protection. [Belzona 2141 \(ACR-Fluid Elastomer\)](#) and [Belzona 1341 \(Supermetalglide\)](#) were used on the middle

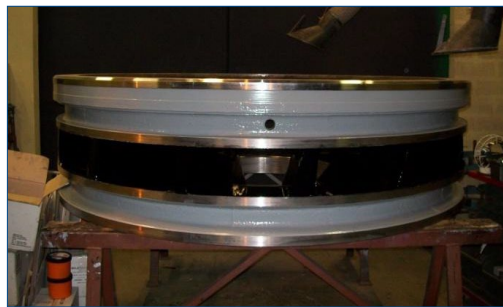
Completed application

part of the turbine where cavitation damage had previously occurred. With the elastomer addressing the cavitation problems and the smooth hydrophobic coating protecting the metal from erosion and corrosion, the system provided the ideal solution for the long-term protection of the turbine.

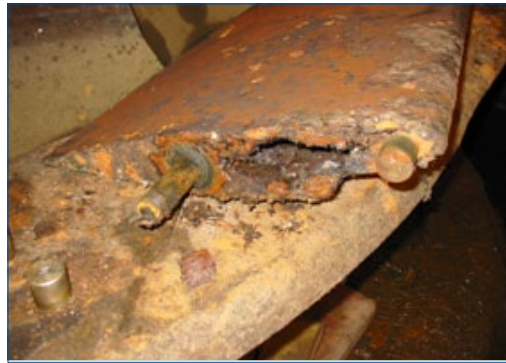
Damaged wicket gate blade

A Francis turbine in a hydroelectric power plant was left in a terrible state of repair following impact from debris in the water in conjunction with erosion and corrosion. As Francis turbines are subject to high pressure flows, the client required a solution that would provide long-term, durable protection against erosion corrosion and impact damage from objects in the water.

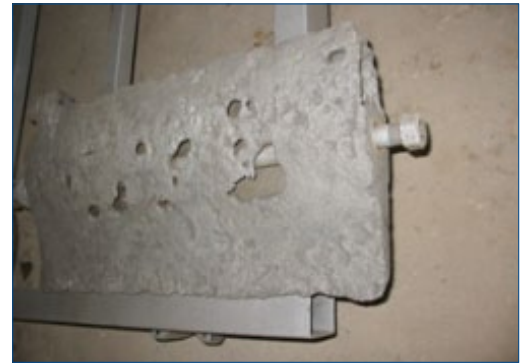
Blade after grit blasting

The wicket gates and stay vanes were grit blasted and rebuilt using a durable, corrosion resistant composite, [Belzona 1111 \(Super Metal\)](#). A hydrophobic smooth epoxy coating [Belzona 1341 \(Supermetalglide\)](#) was used to protect the runner from erosion-corrosion and create a smooth surface improving flow. After the overhaul and coating of both the wicket gates and the runner the client saw an increase in output of 10-15%. After three years in service minor damage was repaired due to impact with objects in the water. Some remedial work was also carried out following a flood in 2006. The client expressed himself happy with the application. ■

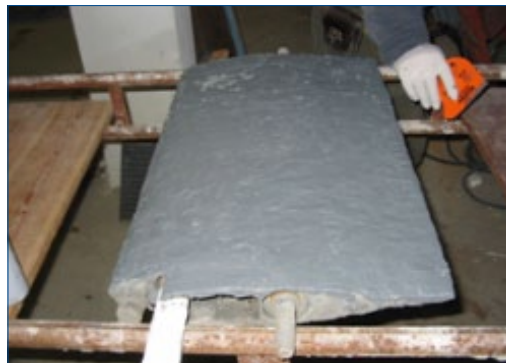
Blade after rebuilding with [Belzona 1111 \(Super Metal\)](#)

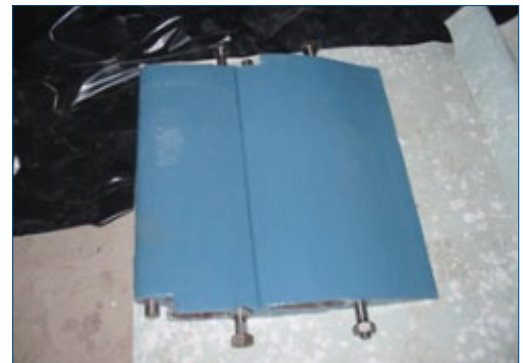
Blade after coating with [Belzona 1341 \(Supermetalglide\)](#)
