IN FOCUS: Offshore Repairs

IN-SITU SOLUTIONS ENSURE FAST TURNAROUND

Issue 111

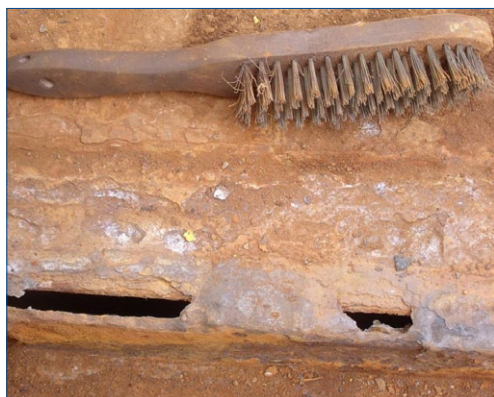
Holed deck

If not addressed promptly, the damage can lead to high repair and replacement costs, costly shutdown periods and environmental complications. A whole deck may require repair or replacement due to years of corrosion.

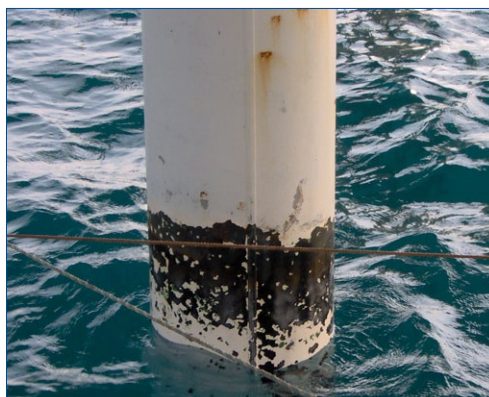
Corroded platform leg

Constant salt spray and wave impact create perfect conditions for erosion and corrosion in the splash zone areas of offshore assets. Risers and platform legs, for instance, can become severely damaged due to continuous exposure to the erosive nature of the marine environment. Salt spray also has a potential to reach equipment and machinery aboard platforms and FPSOs, leading to corrosion, which can be exacerbated by the process conditions, such as in case of hot pipework.

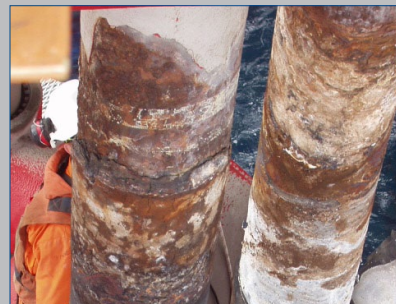
- » Surface deterioration due to constant contact with sea water
- » Loss of pipe integrity
- » Thinning of the walls in splash zone areas
- » Damaged riser cladding and disbondment

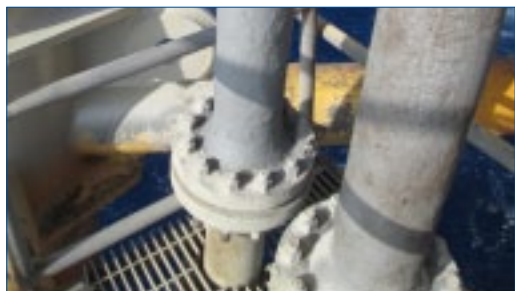
Pitting filled with Belzona 1121

with minimal interruption to the operation. The original thickness of the riser wall had to be rebuilt prior to being reinforced with Belzona SuperWrap II. Due to severe pitting Belzona 1121 (Super XL-Metal) was chosen to fill the pitted areas and to restore the original profile of the pipe. Belzona SuperWrap II was applied onto the pipe in 4 wraps (8 layers) in compliance with the engineered design. Belzona 9382 was applied to consolidate repair during cure. After 24-hour cure, the surface of the cured wrap was washed, sanded and the pipe received an overcoat of Belzona 1121, prior to application of an urethane top coat.

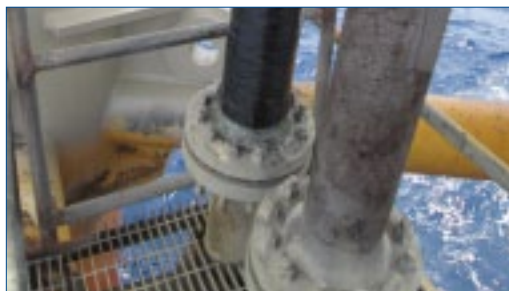
Four wraps of Belzona 1982 applied

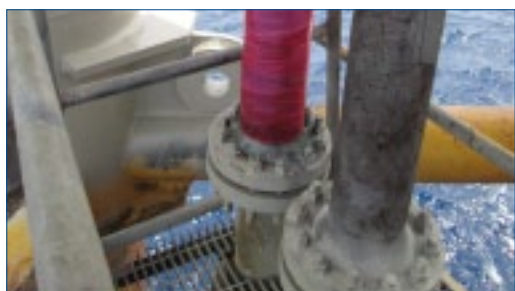
Belzona 9382 applied to consolidate repair

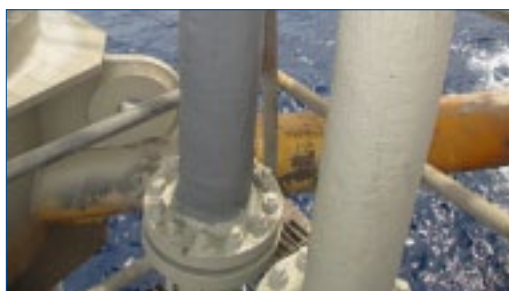
Complete application

The installation of the system took 7 hours, with an additional 24 hours to allow it to cure, not disrupting the operation of the platform. ■

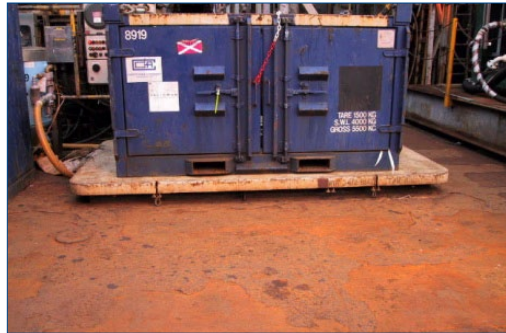
Corroded platform deck

Belzona's cold bonding technology was applied to a badly deteriorated deck on a North Sea platform in 2004. The deck had become weakened through daily operation and weather. The original 8mm steel deck was corroded through in many locations and welding was not an option due to the installed under-deck passive fire protection.

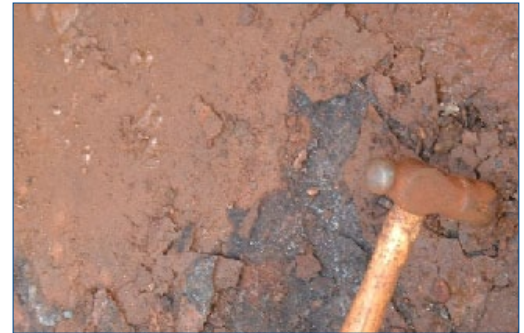
Close up: corroded platform deck

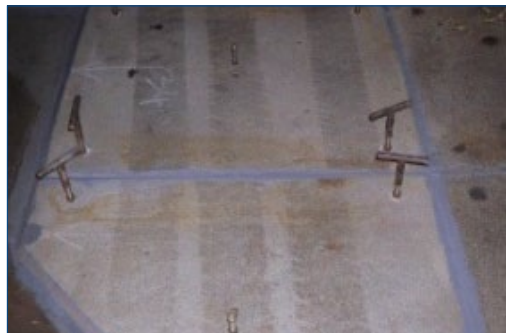
Plates bonded onto the deck

The following application procedure was developed, specified and applied by a competent team, who received comprehensive Belzona training. Steel plates, drilled to accept jacking bolts and injection ports, were prepared and positioned onto the grit blasted deck. The jacking bolts were used to obtain accurate levels. The sides of the plates were dammed using an epoxy

paste. A fluid grade epoxy was then injected into the void using an airless pump to seal and bond the reinforcement plate to the deck achieving full contact.

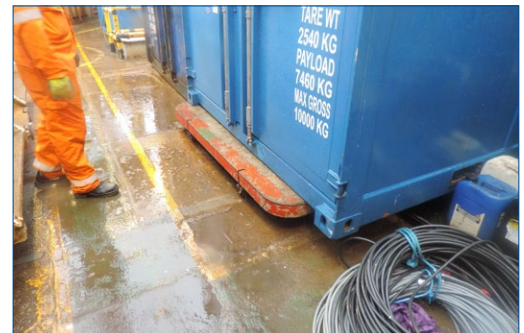
Deck inspected in 2015, 11 years later after application: Belzona plate bonding solution in excellent condition

Independent testing showed that the Belzona bonding method in this case was equivalent in strength to a welded plate. Very good resistance to impact loading was achieved and considered by the independent engineering designers to be "robust enough to withstand the rigours of the laydown area operations". Daily operations were not interrupted and the passive fire protection in the machinery space below was not affected. This work has been inspected annually and now, almost 12 years on, is still in perfect condition. ■
