IN FOCUS: Pipe Wraps

WRAP IT UP WITH BELZONA

RISING TO THE OCCASION

SOME LIKE IT COLD
No hot work – no problem

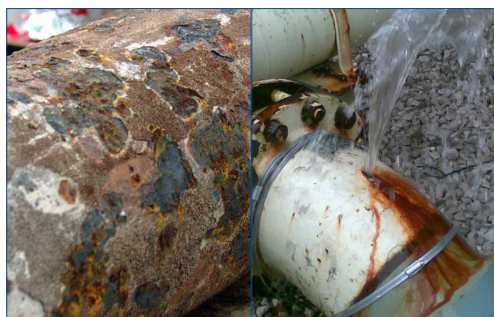
Fig 1: Erosion, corrosion and pitting damage
Through wall damage resulting in leaks

A major battle faced by asset owners and operators is to maintain the integrity of pipework. As main conduits of processed fluids, pipework is susceptible to suffer corrosion, erosion or mechanical damage (see Fig 1). If these problems are not addressed in time, there is a high probability that environmental and safety hazards, incidents and high costs can occur. The question of how to reduce the likelihood of these events in the long term represents a major challenge for the industry.

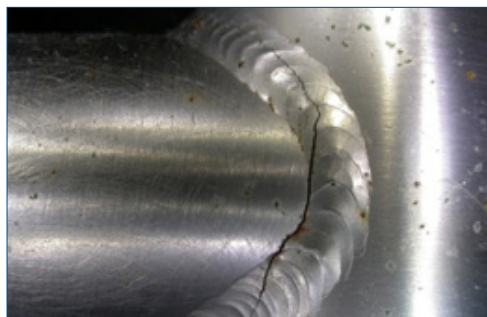
Fig 2: Stress cracking on a weld

Historically, damaged pipework was repaired by cutting out the affected section and replacing it with a new welded section. This requires production to be stopped and involves hot work which can lead to metallurgical problems, hazards to the safety of applicators and serious environmental issues if risks are not carefully managed (see Fig 2).

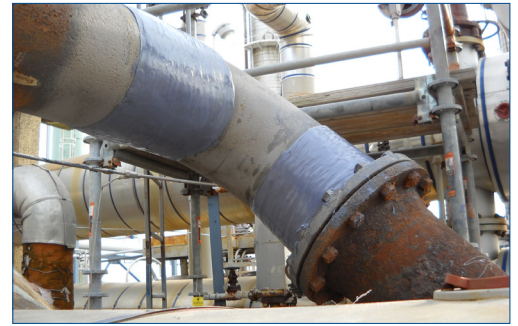
Thin-wall defect repaired

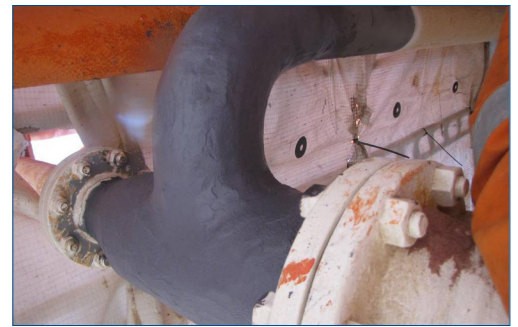
T-piece wrap

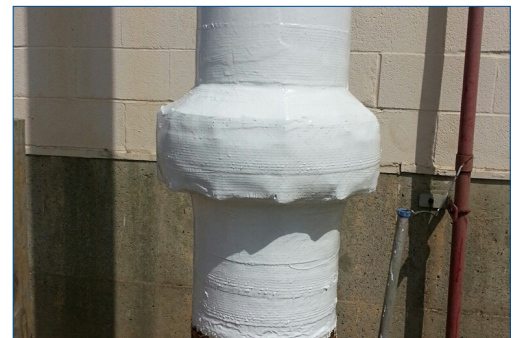
Encapsulated flange

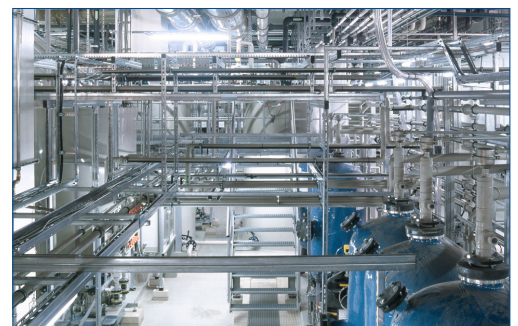
Belzona 1221 can be used for the permanent bonding, repairing or rebuilding of PE and PP substrates

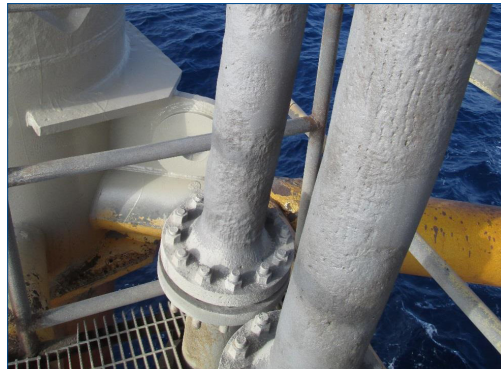
Riser blasted

The application was completed in one day. Following grit blasting, cleaning and degreasing, Belzona 1121 was applied onto the entire corroded surface. This material was chosen due to its extended working life and the ability to effectively restore wall thickness. Then, 4 layers of Belzona SuperWrap II were applied reaching a total thickness of 8 mm and extending over 3 feet (990.6 mm). The whole repair was completed in the afternoon of that day. Upon curing, the Belzona SuperWrap II system was lightly blasted to receive a urethane ultraviolet resistant topcoat.

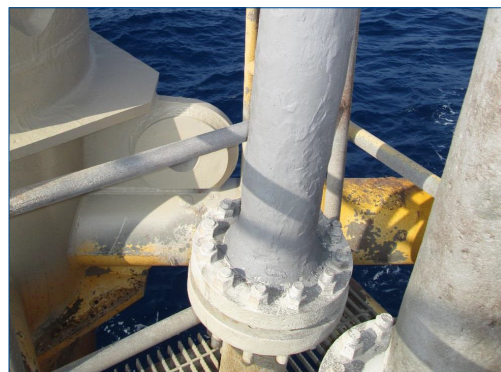
Pits filled and wall thickness restored

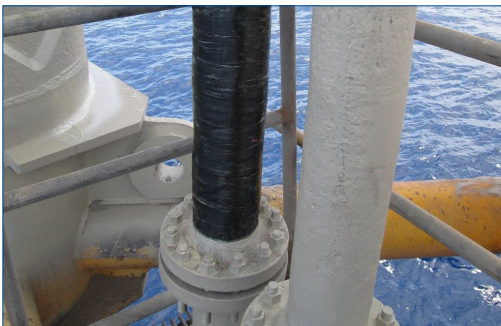
Belzona SuperWrap II applied

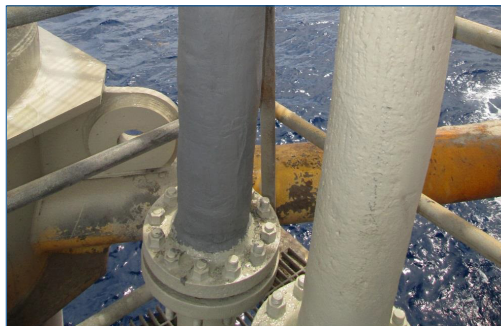
UV-resistant top coat applied

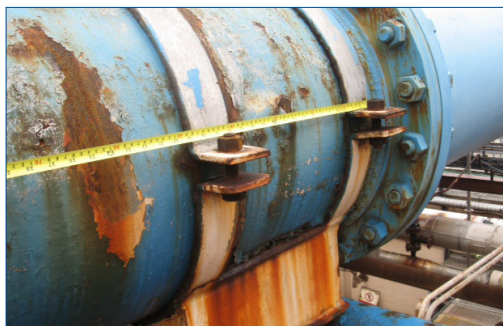
Damaged pipework

Pipework in a refinery was suffering from thin and through-wall defects, caused by severe external corrosion and pitting. Due to Health & Safety hazards blasting to prepare the surface was not an option, and the client required a fast solution to this problem with minimal service disruption. After all, every day of shutdown was costing them £1.5 million.

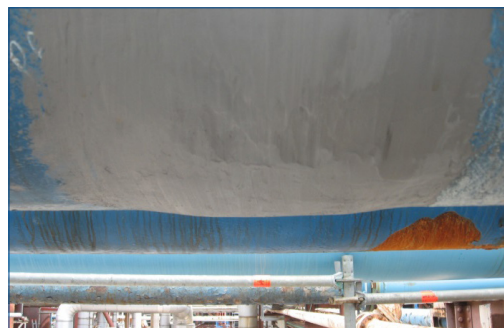
Temporary wrap to holed area

An application team worked without the necessity for shutdown, hence production could continue. Where leaks were present, a plate was bonded using Belzona 1221 (Super E-Metal) over a holed area. Temporary wrap was created around that area using the same material. Then the whole pipe was wrapped using Belzona 4301 (CR1), a material known for its excellent chemical resistance properties.

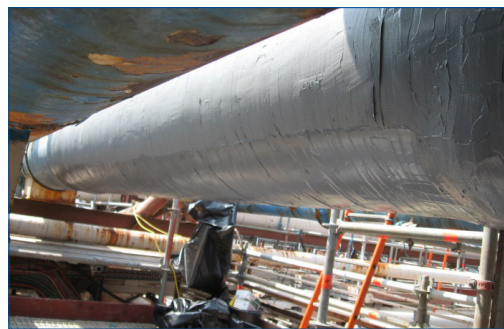
Belzona 4301 (CR1) for chemical resistance

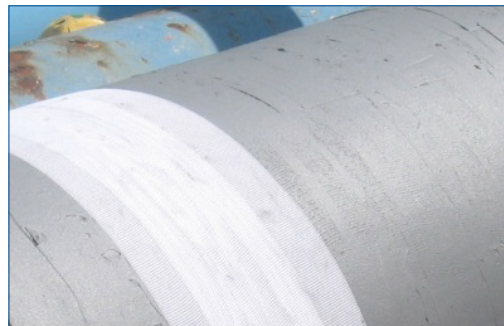
Belzona 1161 (Super UW-Metal) final infill and wrap

Belzona 1161 (Super UW-Metal) wrap was applied on top and also used to encapsulate the adjacent flange. This clever system was chosen for a reason. In case the metal underneath the Belzona wrap continued to deteriorate and a through-wall defect occurred, Belzona 4301 (CR1) would resist the contents of the pipe. Belzona 1161 (Super UW-Metal) in turn adds mechanical strength, while at the same time protecting the pipework from external damage.

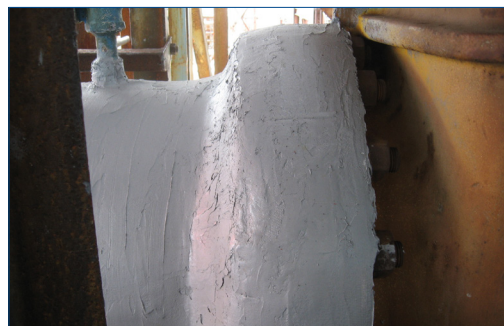
Belzona 1161 (Super UW-Metal) flange sealing
