IN FOCUS: Pulp & Paper

DURABLE, ABRASION AND WEAR RESISTANT SOLUTIONS

Issue 115

COMPOSITES AND COATINGS FOR THE PULP AND PAPER INDUSTRY

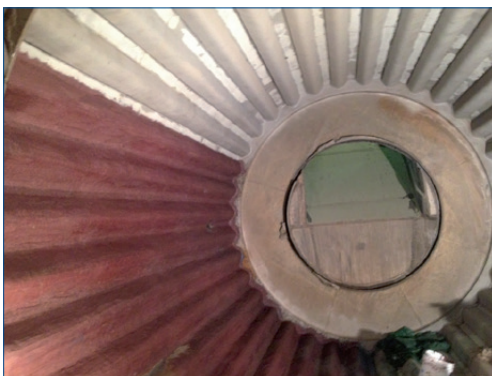
Abrasion resistant lining on de-barker

Durable repair composites, such as Belzona 1811 (Ceramic Carbide), are designed to withstand these harsh environments. They are often used to rebuild damaged equipment and provide long-term abrasion resistance.

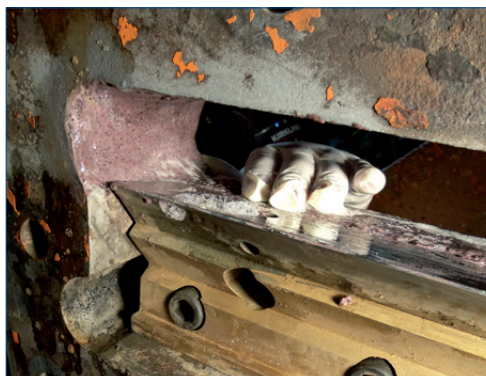
The process of wood chipping causes continuous wear and abrasion from wood chips entering at high velocity, damaging the knives but, more importantly, the knife pockets as well.

Worn knife pocket profiles can further deteriorate the rotor assembly, as well as lead to the generation of off-size chips. Unsatisfactory chips will adversely affect the pulping process and the quality of the resultant paper, therefore this issue can be rather costly.

Chipper disk pocket rebuilt with Belzona

Pockets can be reformed using a 100% solids Belzona 1000 Series material, to create a perfectly mated profile. Future corrosion issues will be eliminated making the recurrence of worn knife pocket profiles unlikely.

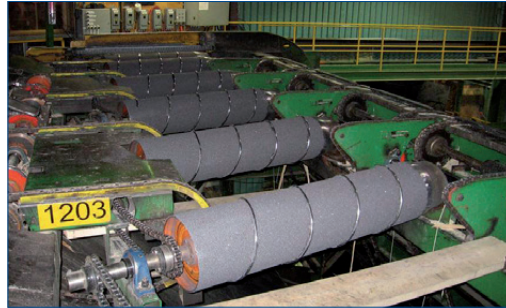
The equipment involved in the processing of raw wood can suffer from a variety of problems. Chipper discs, for example may suffer from wear, whilst mill rolls and lumber transfer rollers may lose positive traction over time. Other equipment such as belt and screw conveyors, silos and storage tanks also suffer from abrasion and wear.

Grip system applied to transfer rolls at lumber mill

Belzona provide solutions to many of the problems related to storage and moving of the chips. With a versatile product range specifically designed to repair and prevent various abrasive wear conditions, Belzona has become the solution of choice for many pulp and paper plants where abrasion is an issue.

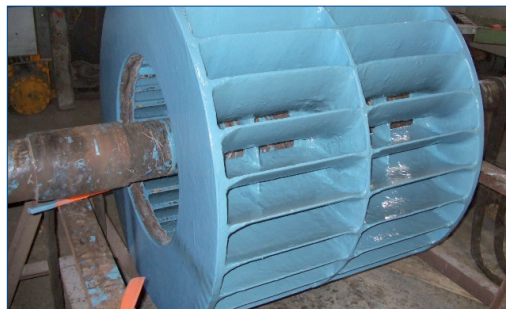
Regardless of the pulping methods, paper mill pumps are put under immense strain due to the transfer of viscous material throughout the pulping process. Together, the sludge and slurries combine a high solids content, copious amounts of entrained air and often processing chemicals, resulting in issues associated with erosion, corrosion and chemical attack.

Vacuum pump protected against corrosion

Severely damaged equipment, such as diffusers, rotary vacuum washers or liquid ring vacuum pumps, can be restored to their original profile and protected from deterioration using our range of epoxy repair materials and coatings. Belzona's cold-applied, paste-grade, metal repair composites, such as Belzona 1111 (Super Metal), can be used to repair cracked and holed pumps, providing outstanding chemical resistance.

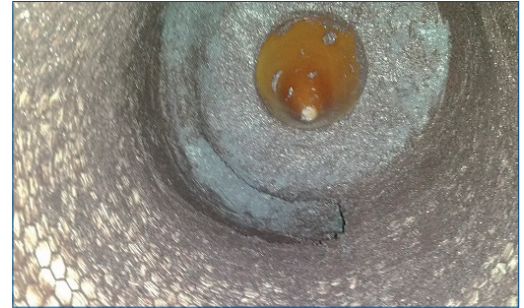
After successful screening, the pulp goes through mechanical processes known as beating and refining. Equipment commonly used in this process, such as cone refiners, hydrafiners and disc refiners, operate under extreme compression and tension which often leads to severe erosion and abrasion of the internal surfaces.

Abrasion resistant system incorporating tiles

Incorporating ceramic aggregates prevents deformation and wear, providing long-term protection. To increase equipment life, wear resistant alumina tiles can be bonded and grouted in place to create a hard wearing, extremely abrasion resistant lining.

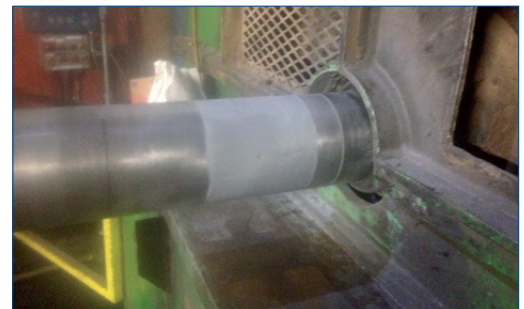
As pulp contains 99% water, paper mills are very wet and warm environments, meaning various components used in this process are subjected to heat and high humidity. This, coupled with vibration, can cause wear and mechanical damage to shafts, bearings and casings.

Shaft repair on chipper disk

Worn and damaged shafts can be repaired in situ, limiting the downtime and lost production costs which can be incurred. Bearing housings can be repaired utilising our erosion and corrosion resistant metal repair materials, which provide solutions that can extend the lifetime of equipment and return machinery to service in a fraction of the time. Dryer cans prone to leaks and steam loss can be also refurbished with Belzona metal repair composites and epoxy coatings.

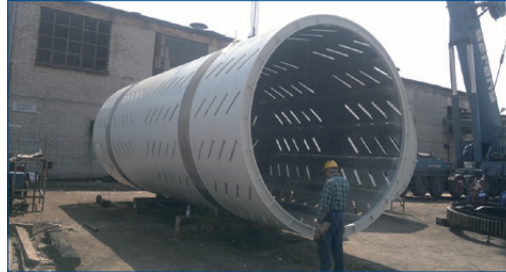
At a Polish paper mill, operated by Stora Enso, the hardened steel protection plates of its de-barker were wearing away at a rate of 2-3mm per year. The significant static and dynamic stresses associated with the process were severely abrading the equipment; therefore, Stora Enso required a solution to prolong the life of the equipment. However, if the problem was not resolved during the planned maintenance period, the customer could risk a stoppage to the plant and costly downtime.

Each drum measured 10m in diameter

Due to the scale of the de-barker, which measured 10m (33ft) in length and 3.9m (13ft) in diameter, the paper mill was impressed that the application was completed within the designated timeframe so quickly and effectively. Pleased with the result, Stora Enso commented "The application on the dry and wet sections of the de-barker was good quality and completed on time. We recommend Belzona technology as a high quality and durable solution"

Upon selection, the work was performed over the course of six days, including full surface preparation of both the wet and dry drum by grit blasting. Initially, the steel drums were coated using Belzona 1321 (Ceramic S-Metal), a ceramic filled epoxy coating, designed to combat highly corrosive environments. Additionally, a protective barrier of Belzona 1811 (Ceramic Carbide) was applied. Incorporating abrasion resistant ceramic aggregates, this system was chosen to provide the de-barker with long-term wear and abrasion

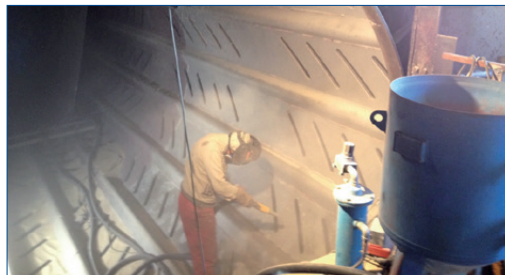
Grit blasting the de-barker drum

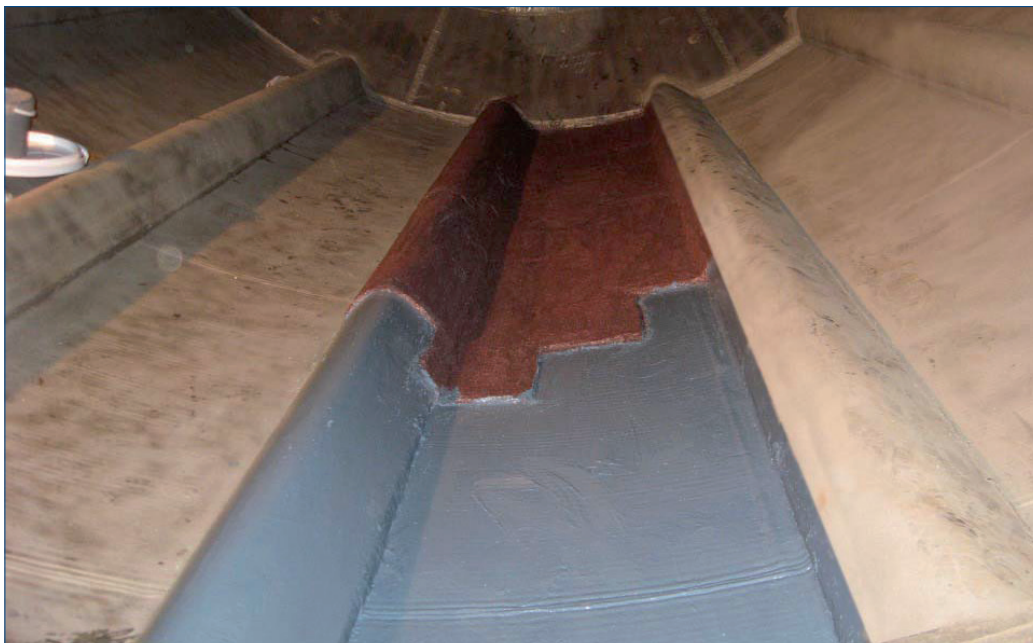
Application of Belzona 1321 (in grey) and Belzona 1811 (in red)

resistant characteristics, alleviating the issues it had been facing.

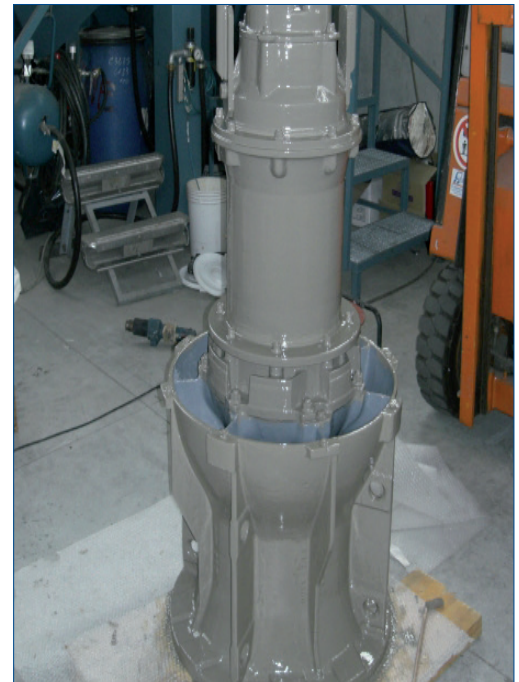
In 2010, at an Italian paper mill, the casing and internal components of a cast iron, submersible sludge pump were suffering from particular problems relating to transfer of viscous slurries. In fact, the pump was barely lasting a maximum of two years in service before requiring major overhaul and replacement.

Pump originally coated in 2010

After initially rebuilding the metal loss in the pump using Belzona 1311 (Ceramic R-Metal), it was internally coated with Belzona 1321 (Ceramic S-Metal). This coating offered significant erosion-corrosion protection, whilst simultaneously providing a barrier against chemicals used in the pulping processes. Finally, the pump was coated externally using Belzona 5811 (Immersion Grade), designed to preserve equipment operating under immersed conditions.

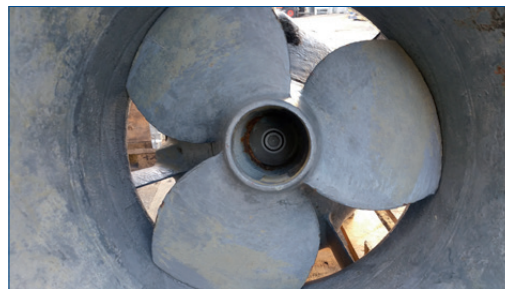
Originally coated in 2010 with Belzona, six years later the customer opened the pump for mechanical maintenance. Throughout its six-year service life, the pump faced zero downtime due to Belzona erosion-corrosion protection and, impressively, the coating was found to be in excellent condition. However, it was decided to refresh the coatings in order to prepare the pump for more years of service in sludge; therefore, the original coating was roughened before applying a new layer on top.

Components still excellent six years on

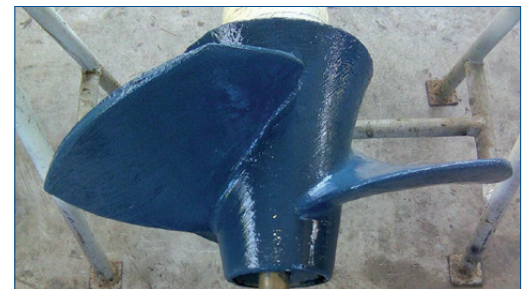
Recoated for future service in sludge
