# Facilitate

BELZONA'S FACILITIES MAINTENANCE MAGAZINE

ISSUE 5

SUMMER 2014

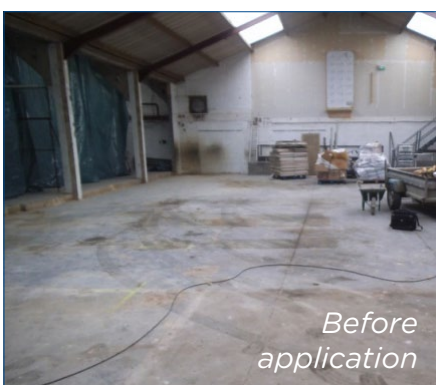
*Before application*

After a site-survey, Belzona outlined several repair and maintenance solutions that were required to completely transform the warehouse. These included localised repairs to the concrete floors, refurbishment of the vertical columns, kerbstone

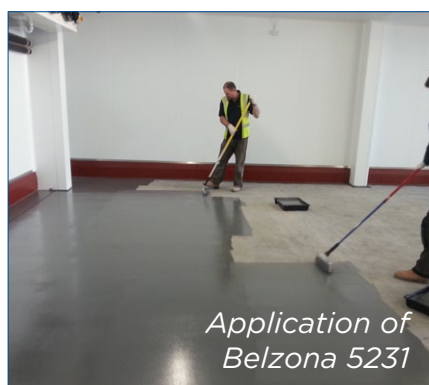
*Application of Belzona 5231*

The floor and kerbstones were then coated with Belzona 5231 (SG Laminate). This is a high-build, solvent-free coating ideal for providing protection against the pressure jet washing, sanitising agents and chemicals used on the site. As it can be difficult to attain a seamless finish when coating large floor areas, a team of several people lined up and applied the coating simultaneously. This ensured a consistent layer of coating across the substrate was achieved. Extra aggregate was added to the coating before it cured in order to create a safety grip surface and prevent slippages in the cold store.

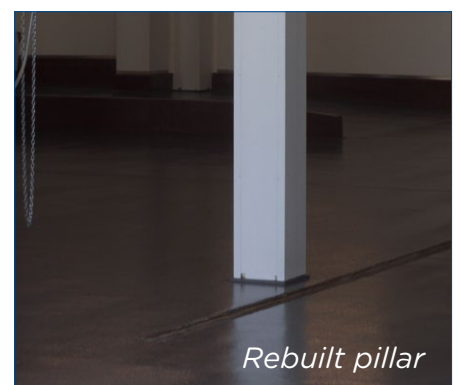
*Rebuilt pillar*

A lightweight material, Belzona 4141 (Magma-Build), was used to repair damage to the vertical concrete columns. This material ensures the columns will remain thoroughly protected within the busy working environment as it is designed to combat numerous types of deterioration including chemical attack and carbonation of concrete.

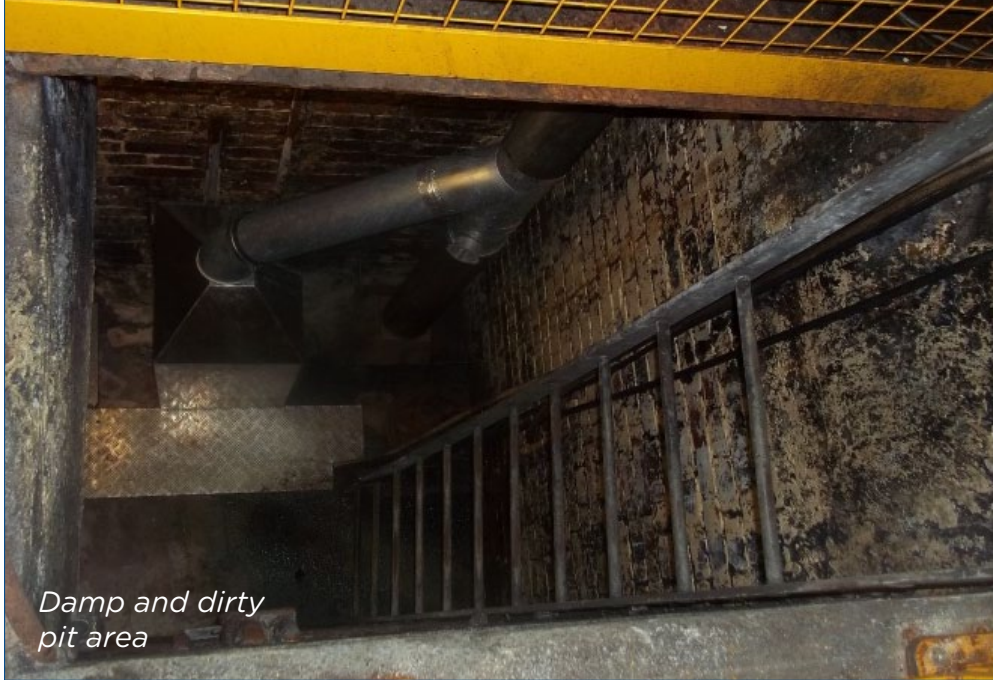
*Damp and dirty pit area*

Belzona ensures that this is not the case, as demonstrated in a recent application carried out at the facilities of a leading cider producer. The client required a safety grip system to be applied to a deteriorated floor located in a damp and dirty pit area. The

floor had accumulated a lot of dirt, making the area highly unhygienic and therefore susceptible to a number of health and safety issues. The Belzona solution was chosen for this project due to its many years of proven success on the site.

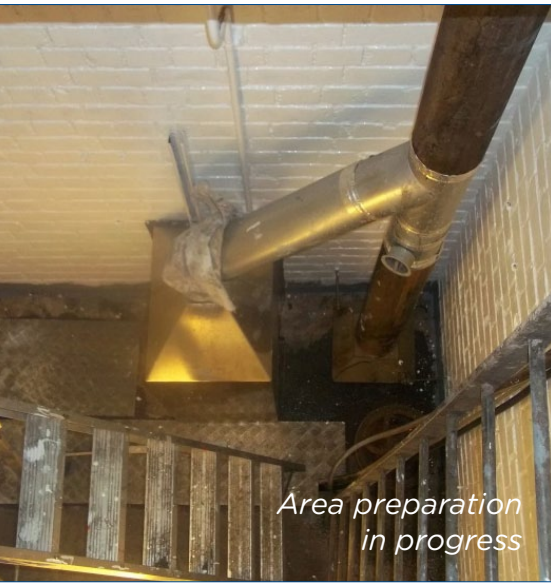
*Area preparation in progress*

For the application, all loose material was firstly removed from the substrate before it was cleaned and then rebuilt with Belzona 4131 (Magma-Screed). This is a high performance, non-porous resurfacing material designed to protect concrete against the effects of abrasion, impact, vibration and chemical attack. This material cures quickly, is resistant to a broad range of chemicals and is impermeable to water. These qualities ensure the substrate will remain protected even

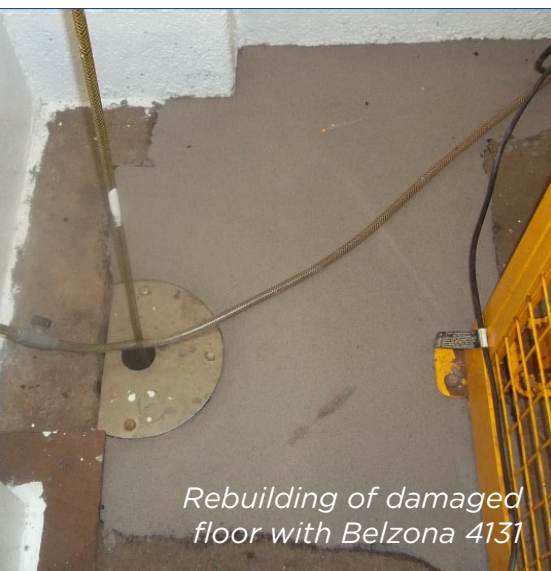
*Rebuilding of damaged floor with Belzona 4131*

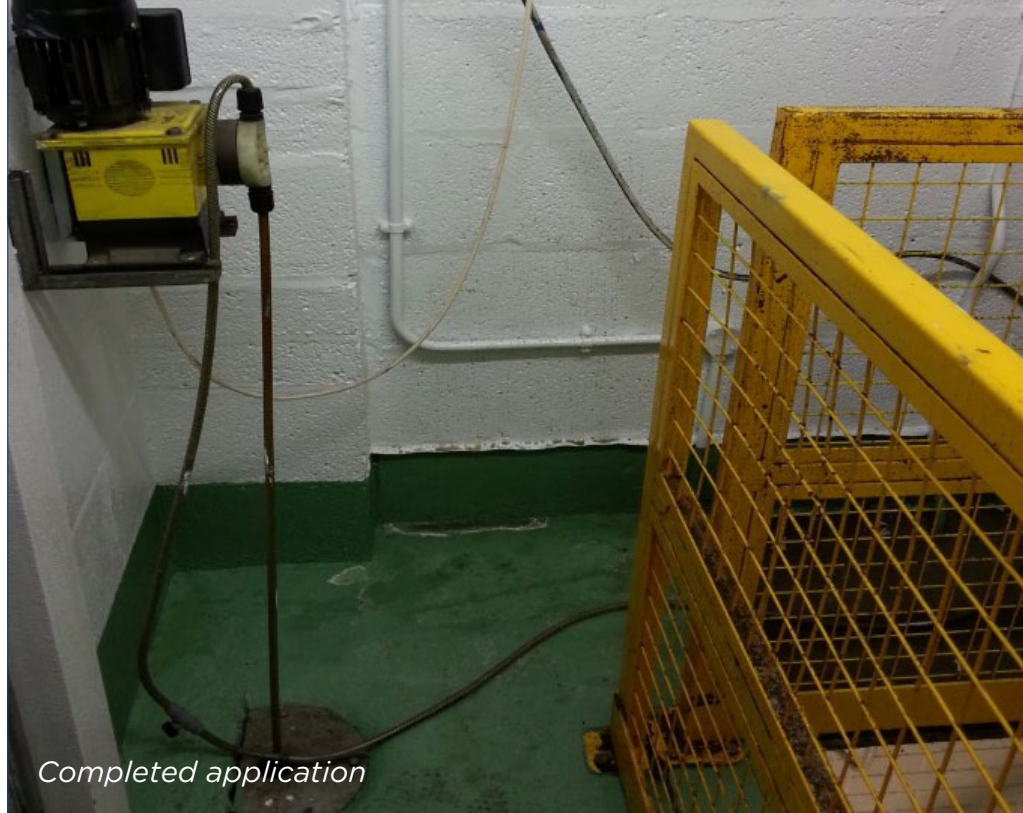
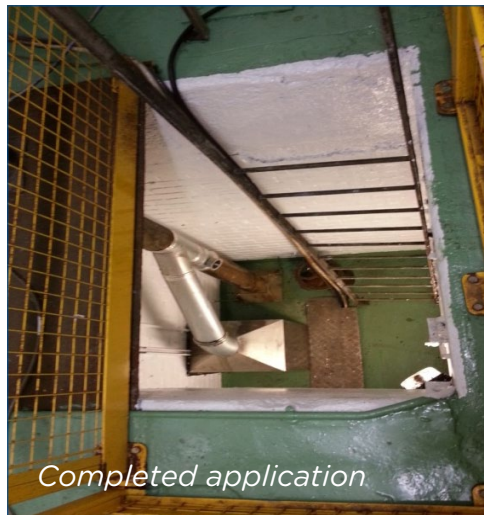
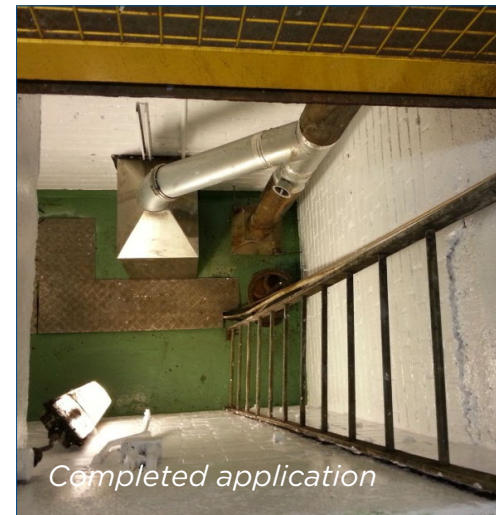
*Completed application*

Following this, the floor was coated with Belzona 5231 (SG Laminate), a two component coating system incorporating an aggregate that is designed for floor areas where chemical, abrasion and slip resistance is required. This material will protect the floor from chemical attack, extend its life and reduce the potential for accidents. This coating also provides a seamless finish, leaving the floor protected as well as ensuring the appearance is aesthetically pleasing.

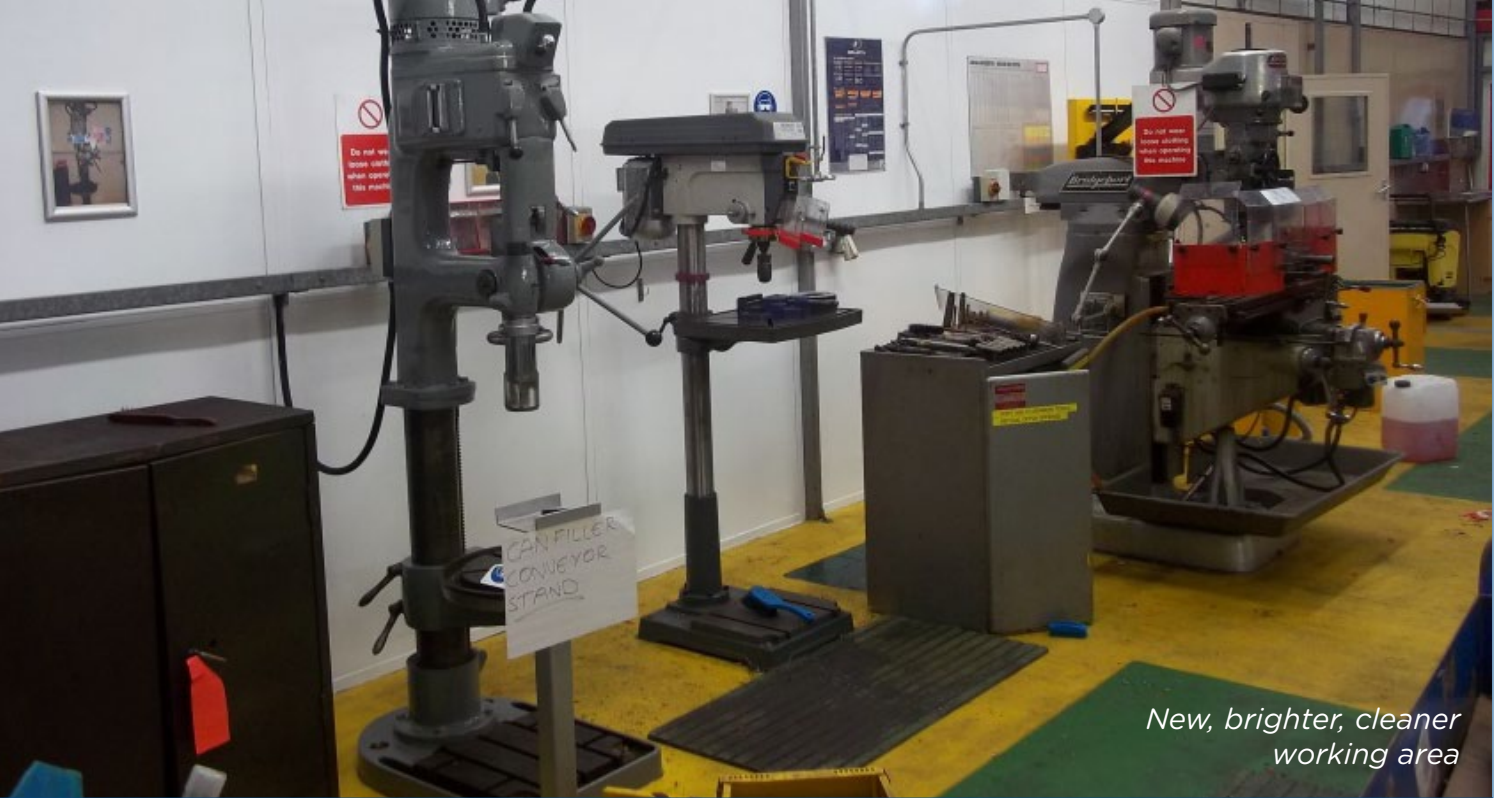
*New, brighter, cleaner working area*

For the application, all contamination and loose substrate matter was removed before Belzona 5911 (Ceramic Conditioner) was applied. The conditioner, designed specifically for porous surfaces, was allowed to dry before Belzona 5111 was applied on the entire workshop surface.

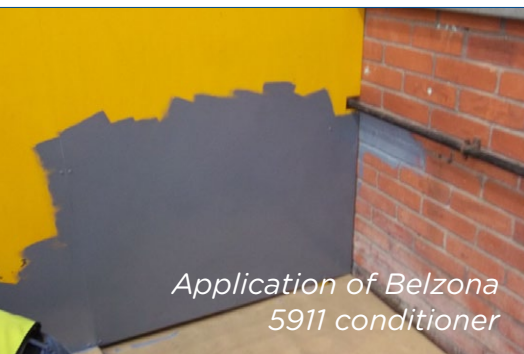
*Application of Belzona 5911 conditioner*

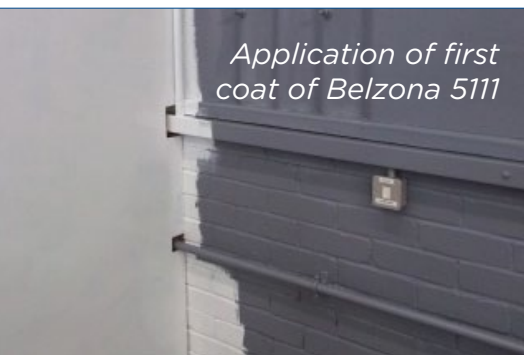
*Application of first coat of Belzona 5111*

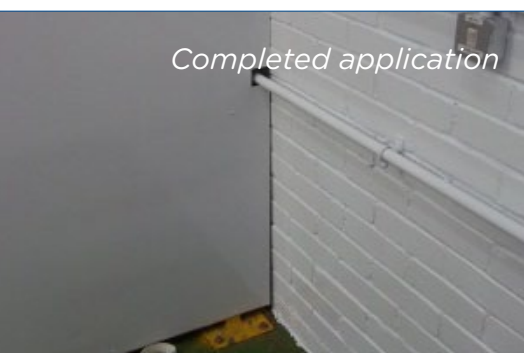
*Completed application*

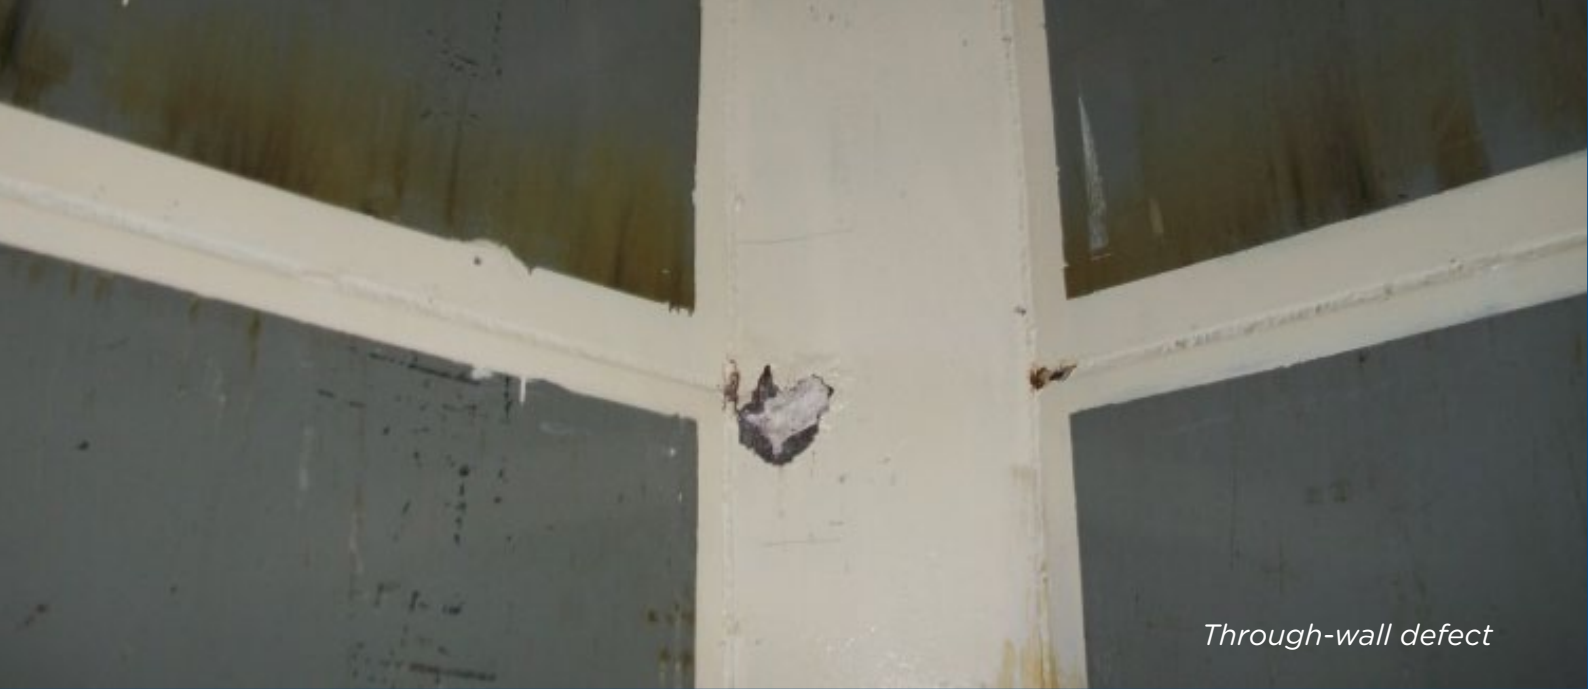
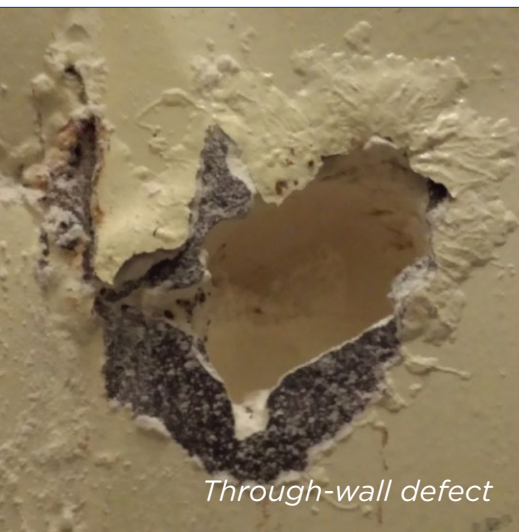
*Through-wall defect*

A flour silo in a mill was experiencing corrosion issues due to water being held on the outside of the wall. A through-wall defect consisting of a hole and a crack had developed a few meters from the base of the silo. The hole was 60mm in diameter, and the crack was 550mm linear along the weld seam and had a 120mm propagation upwards.

A Belzona cold plate bonding solution was chosen. The crack was first terminated by drilling and tapping each end before the whole area was prepared using a pneumatic MBX® Bristle Blaster®.

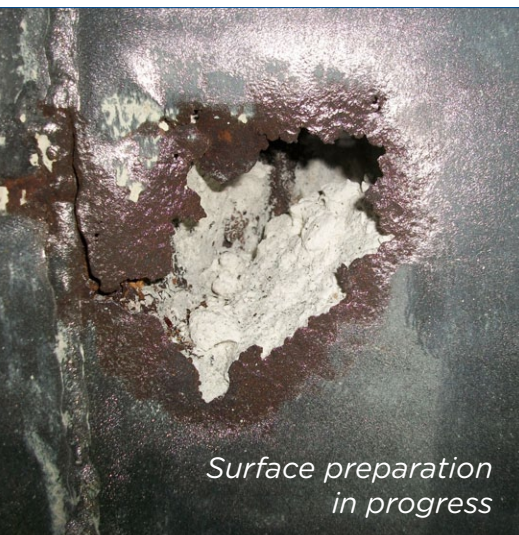
*Surface preparation in progress*

This removed the existing coating and created a surface profile in the metal (mild steel). Pre-fabricated plates were then bonded in place with Belzona 1111 (Super Metal). This is a versatile, two component repair composite perfect for repairing damaged metal substrates as well as bonding metal plates without the use of hot work. The plates were then filleted around the edges creating a smooth and tapered finish.

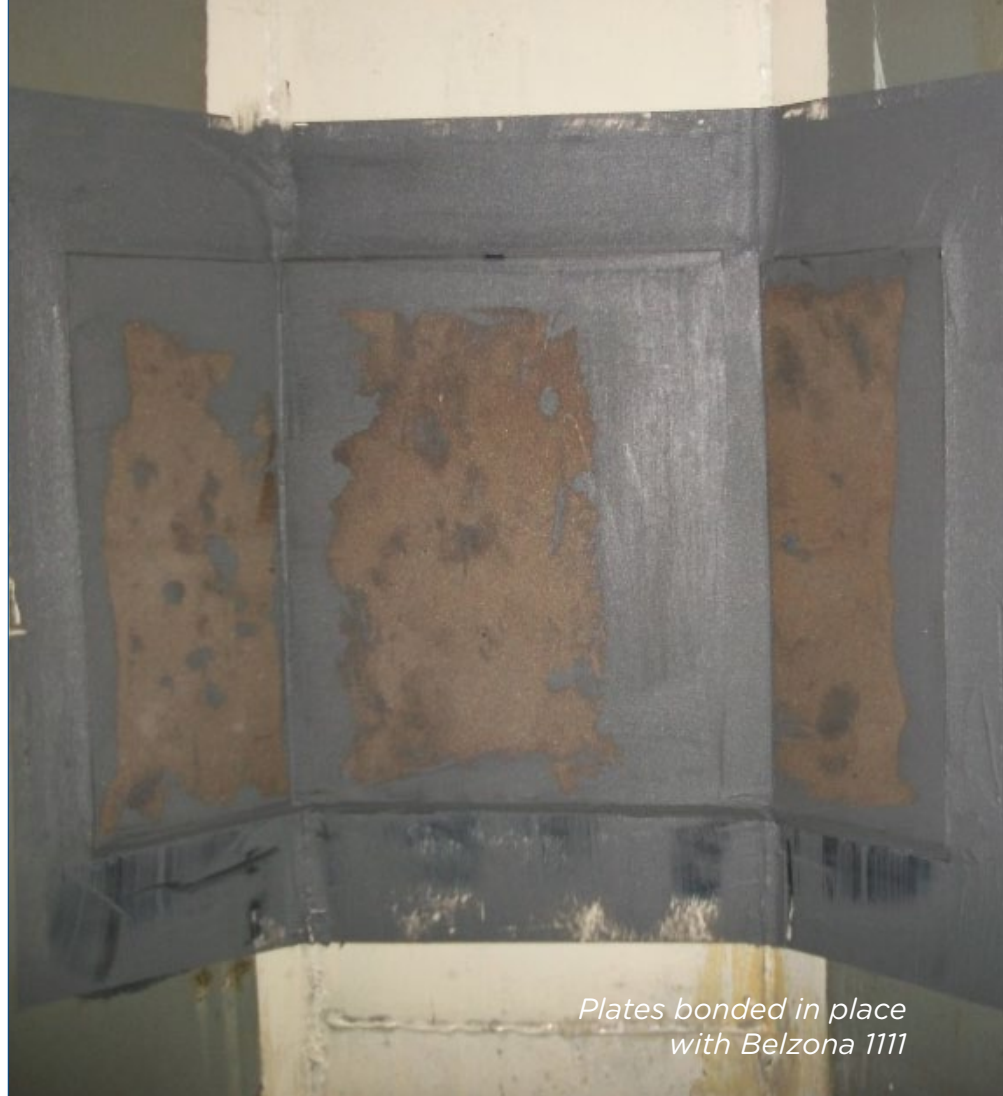
*Plates bonded in place with Belzona 1111*

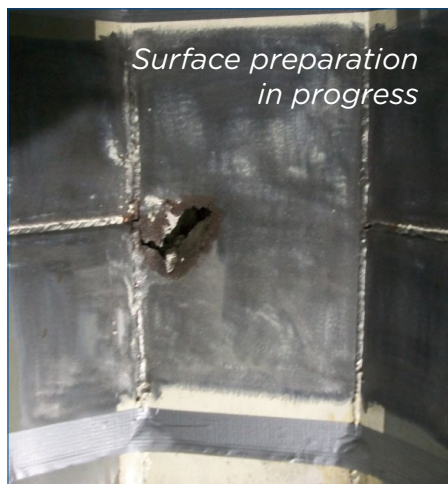
*Surface preparation in progress*

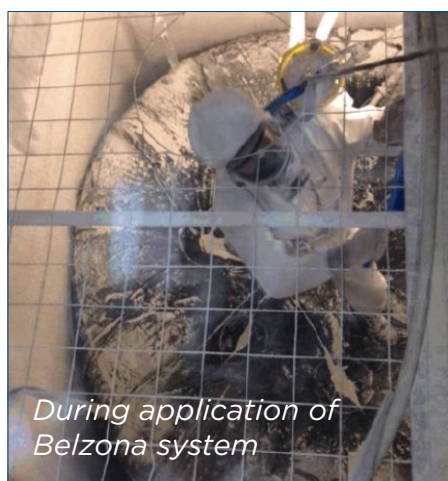
*During application of Belzona system*

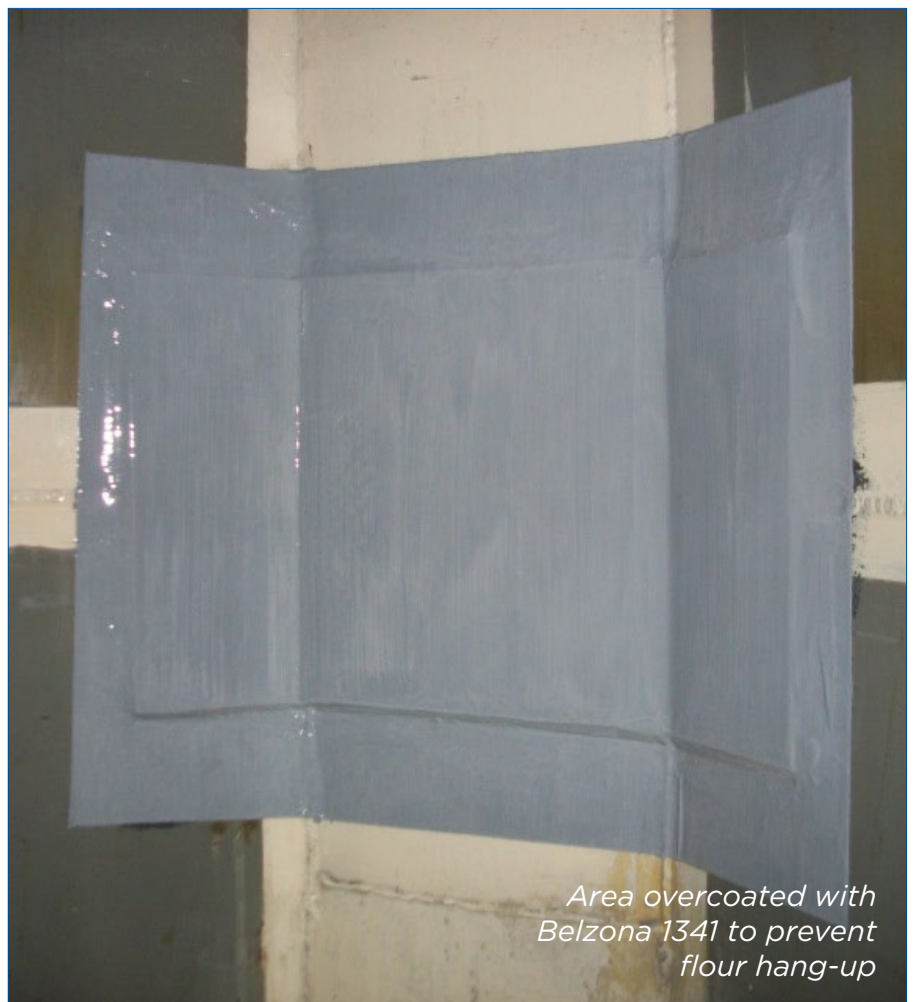
*Area overcoated with Belzona 1341 to prevent flour hang-up*

The entire area was then coated with two layers of Belzona 1341 (Supermetalgilde), a coating designed for the protection of metals from the effects of erosion-corrosion. This further provided a super smooth finish, and the low friction qualities of Belzona 1341 prevented any hang-up of flour over the repair area thus successfully eliminating any potential hygiene issues.

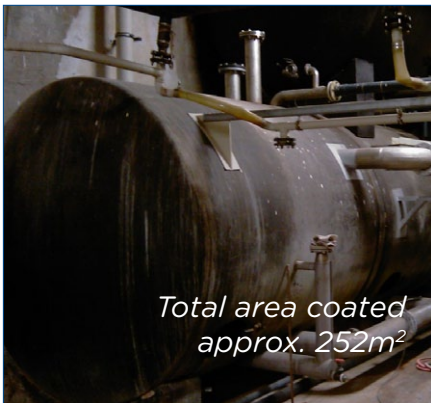
After 60 years in service, two neutralisation tanks at a leading German brewery had suffered extensive internal corrosion damage. The internal lining of the tanks had deteriorated greatly and the problem needed to be promptly addressed in order to prevent acceleration of the deterioration.

By using the Belzona solution, the brewery was able to bypass a lengthy replacement process and thus avoid any potential loss to business. The entire internal area was coated with Belzona 5811 (Immersion Grade), a corrosion resistant protective coating designed specifically for surfaces operating under immersion conditions in contact with aqueous solutions.

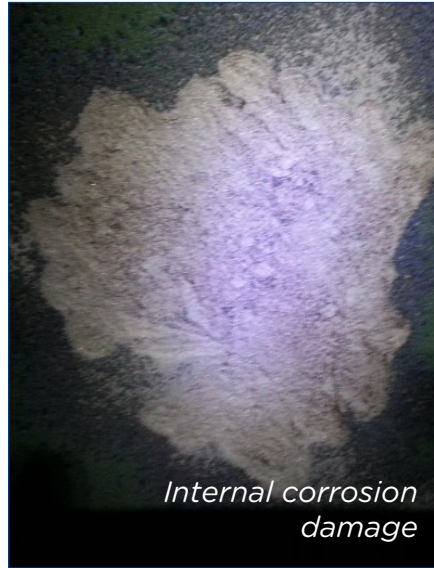
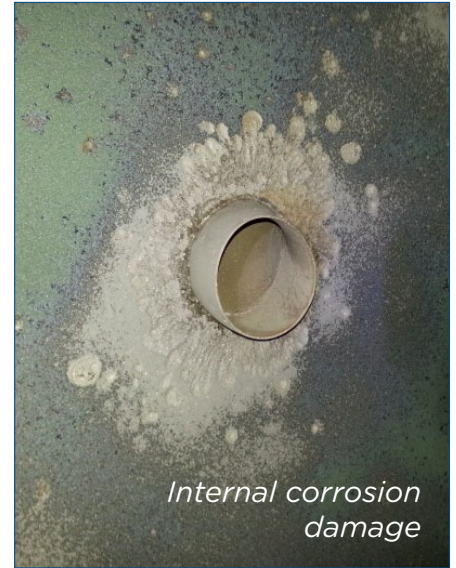
*Internal corrosion damage*

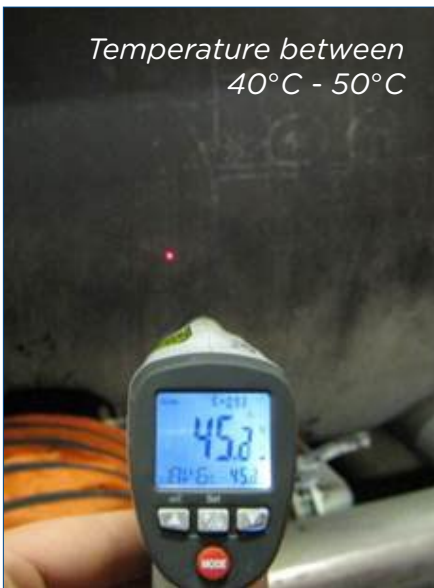
*Temperature between 40°C - 50°C*

The coating was post cured at 40°C - 50°C in order to accelerate the cure time.

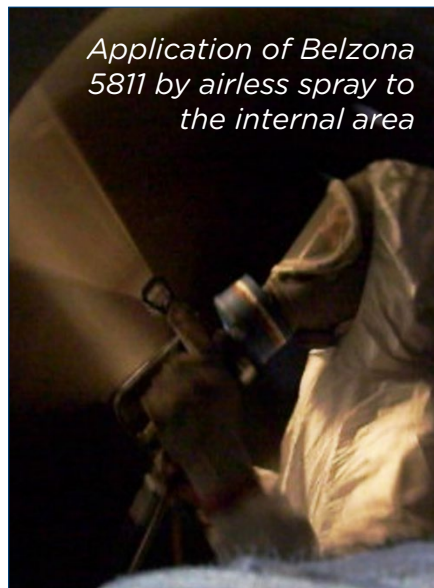
*Application of Belzona 5811 by airless spray to the internal area*

For the application, the edges and detail areas (approximately 252m<sup>2</sup>) were stripe coated before two coats of Belzona 5811, consisting of 176 litres, were applied by airless spray to the internal area of the tanks.

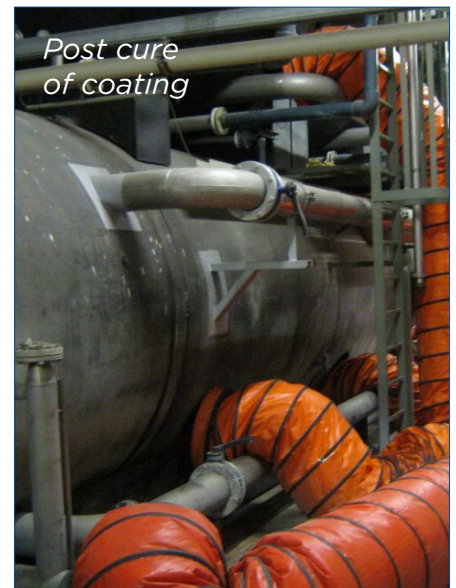
*Post cure of coating*

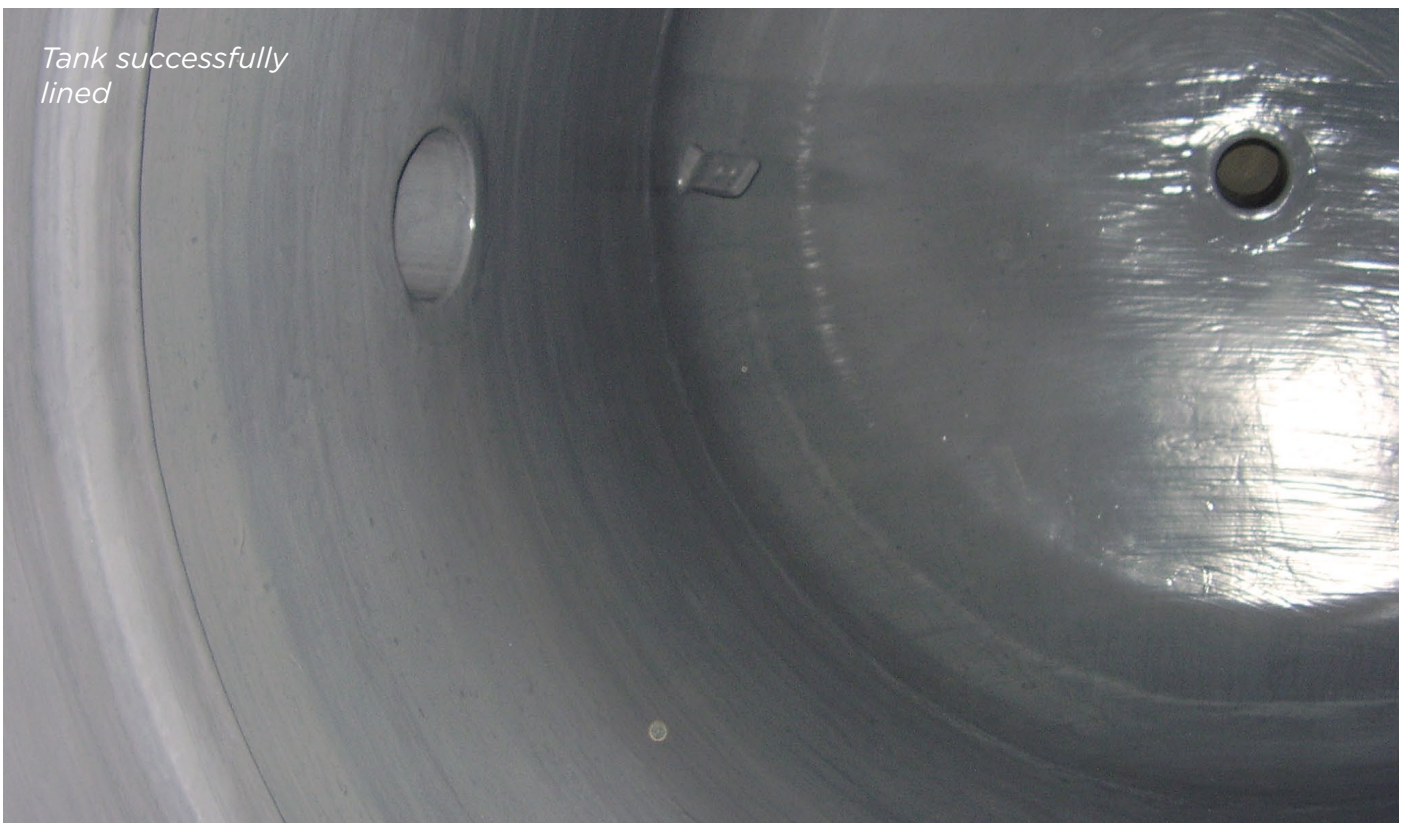
*Tank successfully lined*

The Quality Control Inspection via spark test (4kV) showed no holidays, the specified layer thickness was achieved and the tanks were put back into operation on the ninth day.

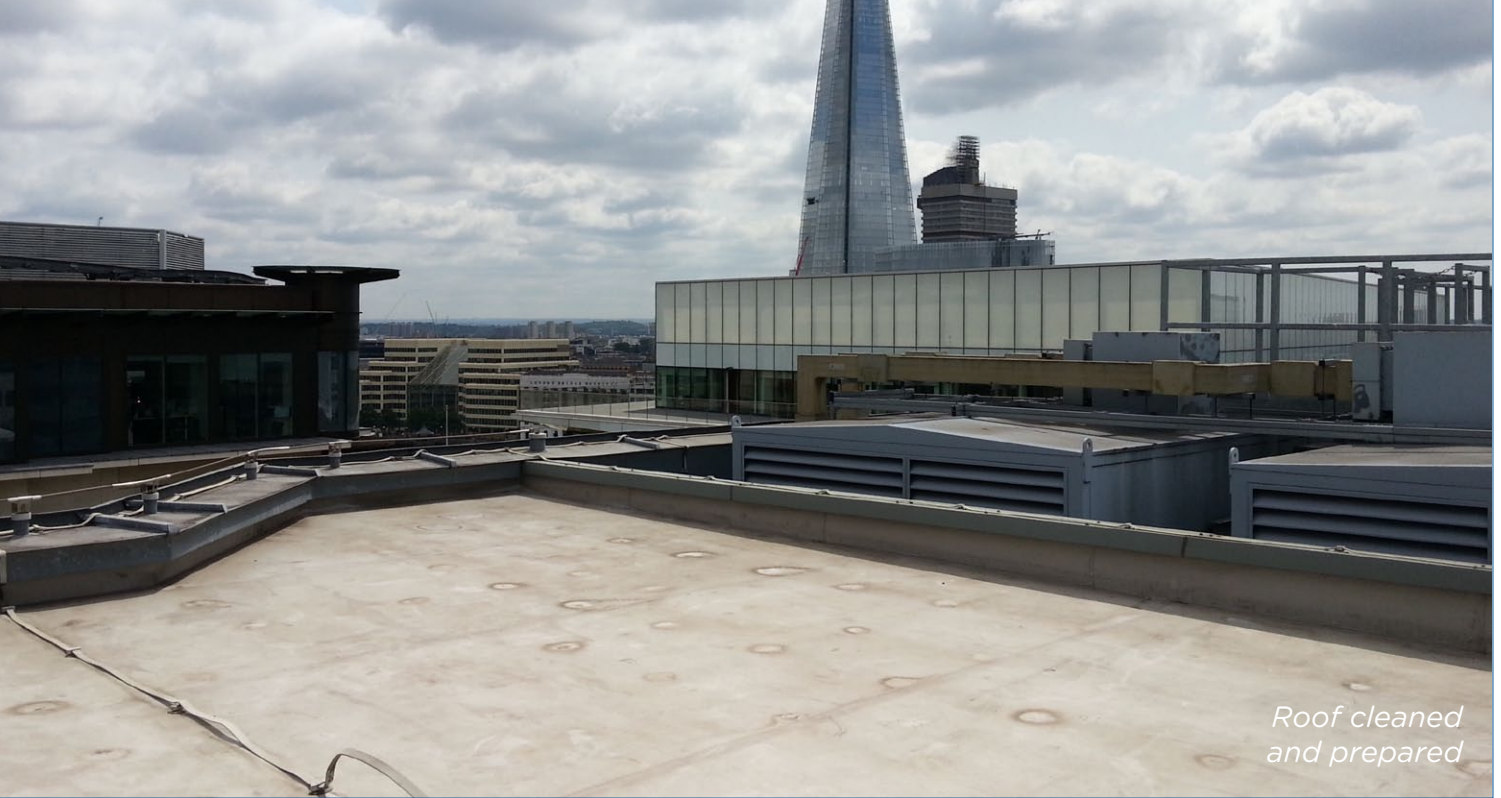
*Roof cleaned and prepared*

For the application, the upper level roof was cleaned and prepared before application of a fully reinforced Belzona 3111 system.

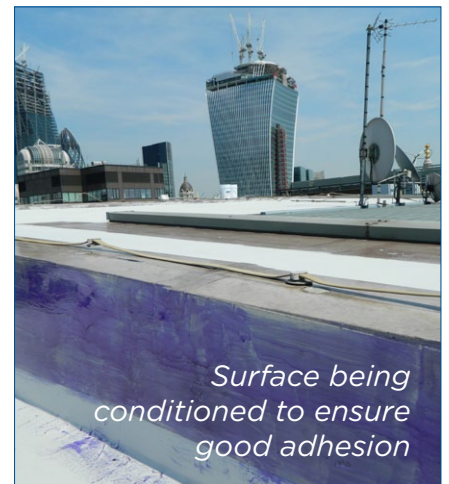
*Surface being conditioned to ensure good adhesion*

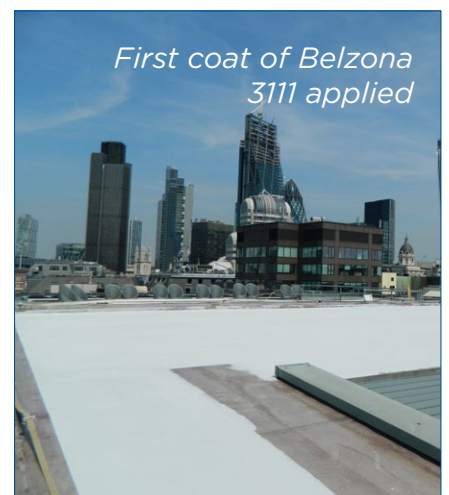
*First coat of Belzona 311 applied*
