IN FOCUS: Pumps

Issue 1, Spring 2013

BELZONA SOLUTIONS FOR PUMPS

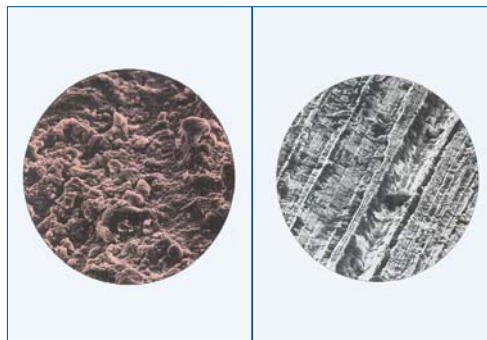
Even seemingly smooth metal surfaces are found to be relatively rough when examined under high magnification...

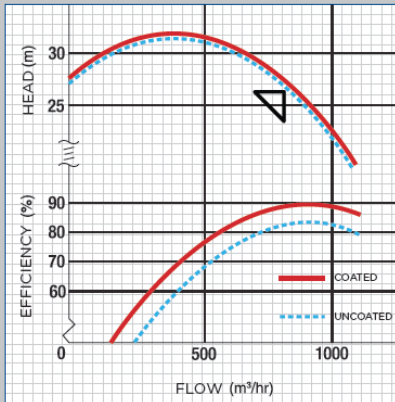
INDEPENDENT FLUID FLOW TEST BY THE BRITISH NATIONAL ENGINEERING LABORATORIES (N.E.L.):

For this test, a single stage, end suction centrifugal pump with 10 inch suction and discharge branches was chosen. In uncoated condition and running at 1300 rpm, the pump was found to deliver 875m³/hr at 26.5 meter head with an overall peak efficiency of 83.5%.

Testing of the same pump coated with Belzona 1341 (Supermetalgilde) gave a 6% increase at peak efficiency, resulting in a power reduction of 5.1kW at duty point. Assuming a 5,000 hour operating cycle/ annum, the power saving over this period would amount to 25,500kWhr.

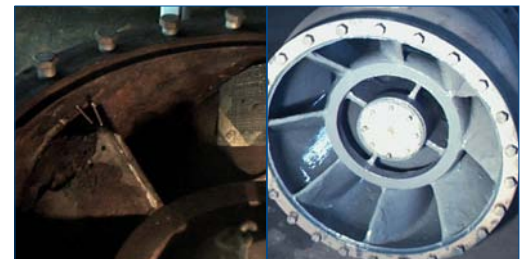
Diffuser vanes with steel gauze in place Completed application

In areas suffering severe damage (e.g. where part of the substrate has been removed by impact), a framework can be built to give mechanical strength back to the substrate. This framework can be built either by bolting or bonding on steel plates/gauze. The repair is then completed by filling the framework with the Belzona material to recreate the original profile.

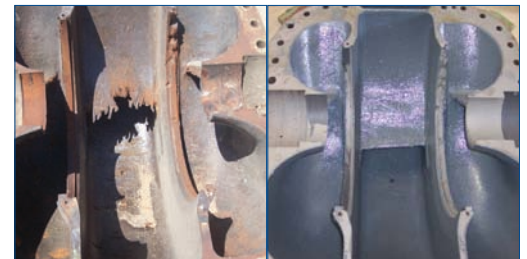
Typical effects of erosion-corrosion on a centrifugal pump cutwater After rebuilding and coating with Belzona

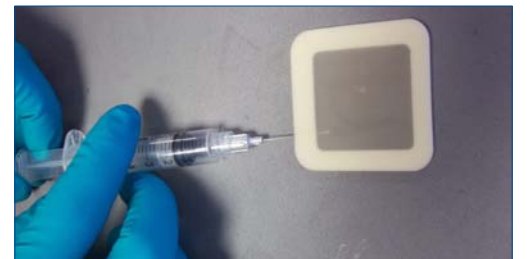
Thorough inspection for salt contamination (including chloride concentration measurement) ensures optimum surface preparation

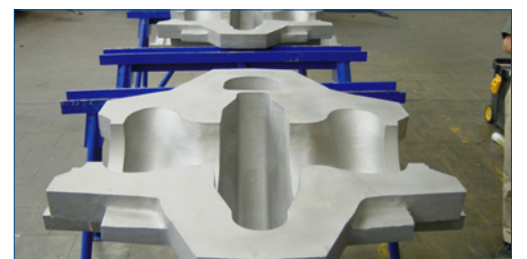
Belzona 1341 (Supermetalgilde) used by an OEM

Having proven its benefits for used pumps, Belzona 1341 (Supermetalgilde) is also used by an increasing number of customers on new equipment to prolong service life and save

on energy costs. It is also becoming more common practice to coat new equipment with Belzona 1341 (Supermetalgilde) to avoid lengthy fine machining and polishing time when the construction does not meet the original design specification in terms of efficiency.

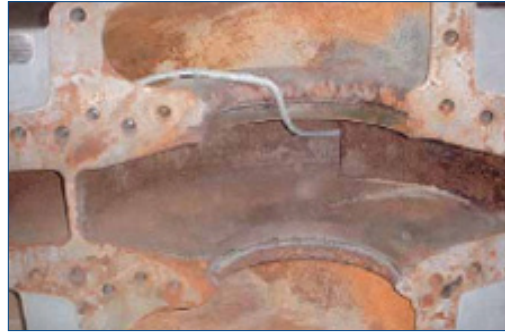
Corroded and cavitated pump

The water supply company in this example had to deal with a problem of two badly corroded/cavitated centrifugal KSB water supply pumps, whose output had drastically decreased by 11%. In addition to erosion caused by cavitation, general and bi-metallic corrosion had caused leakage at the wear rings, which contributed to the significant loss in efficiency.

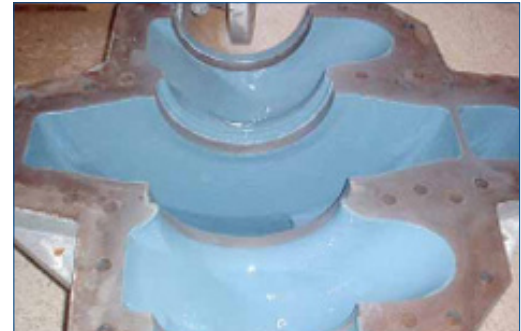
Completed repair

It was decided to restore the neck ring seats by a forming technique, using the neck rings as formers. First, the interior of the cast iron pump was grit blasted to the required surface preparation standard and the neck rings treated with release agent so that they could later be removed. Next, Belzona 1111 (Super Metal) was gradually built up on the prepared neck ring area. Immediately afterwards, the impeller of the pump (including the released neck rings) was lowered into position and all excess Belzona material that exuded from beneath the forming surfaces was removed. Correct height and alignment of the forming part is ensured by the correctly mounted and positioned bearings.

The same technique was then used to repair the other half of the casing. After cure, the impeller was removed and the repair dressed.

Finally, the pump was coated with Belzona 1341 (Supermetalgilde) to prevent corrosion and slow down future erosion damage. The result: The flow rate of the repaired pump was now 540l/sec, an increase of more than 12% over the corroded pump.

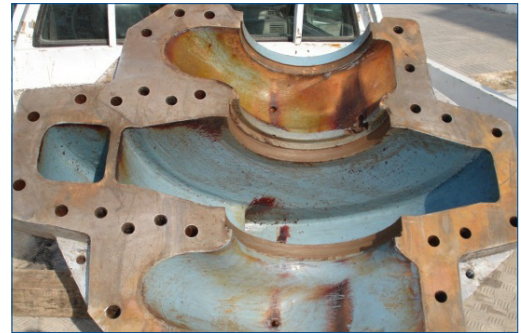
Coating in good condition after 3½ years in service

3½ years after the application, the pump was inspected and the flow rate was still found to be 530 l/sec, an increase of more than 9.5% over the corroded pump. ■
