Replacing an HP/IP Rotor

Sealing Transformer Oil and SF6 Leaks Quickly and Effectively

When to Use an Oil Skimmer

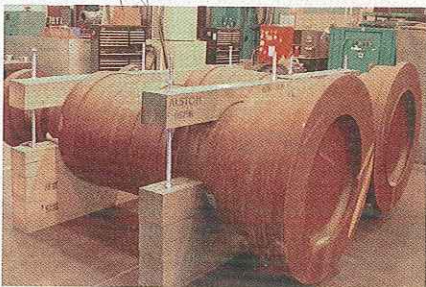
1. Two become one. The two forgings used for HP/IP rotor replacement were welded into a single rotor after rough machining to avoiding ordering a custom, long-lead-time forging. *Courtesy: Alstom Power*

Alstom was contacted and was asked for a proposal for a new high-pressure/intermediate-pressure (HP/IP) rotor, manufactured by join welding and modifying and welding multiple stock rotor forgings (Figure 1). The replacement rotor proved to be more cost-effective as a permanent repair and faster than replacement of the entire turbine monoblock forging. Essentially, raw forgings were welded together to form the skeleton of a replacement rotor, but in a fraction of the time necessary for an original forging to be procured.

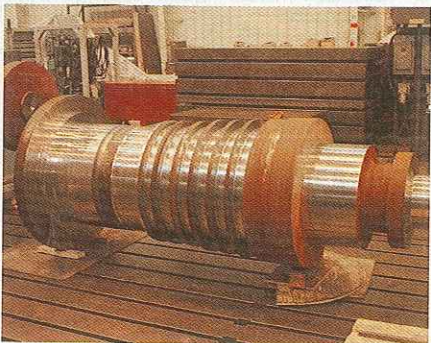
2. Less is more. Forgings for the IP (shown here) and the HP sections were rough-machined prior to final weld preparation. *Courtesy: Alstom Power*

The rotor forging sections were brought into the Richmond facility, set up and machined in the mill, and then the lathe was used to produce the join welding surfaces. After heat treatment of the welded rotor forging, the rotor's wheels, dovetails, gland seals, and journals were completely machined. The coupling, balance weight holes, and steam balance holes were machined as part of the milling work (Figure 2).

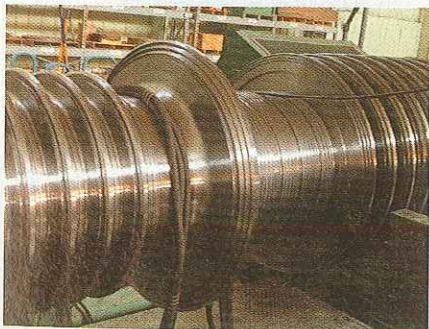
3. Final touches. Final machining of the complete rotor is in shown in progress. *Courtesy: Alstom Power*

The rotor dovetails were then shot-peened. The newly manufactured blades were installed, shrouds were manufactured and installed, and shroud covers were machined. The rotor was first balanced at operating speed and then at 20% overspeed. The replacement rotor was rebuilt from scratch in only six months, and the unit was quickly restored to service (Figure 3).

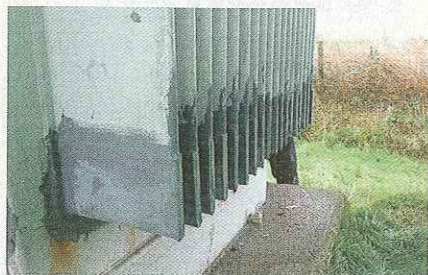
4. Transformers corrode and leak.

Over time, the fins on a transformer can corrode and leak oil into the environment. *Courtesy: Belzona Polymerics Ltd.*

Radiator fins are a common area for oil leaks. Fins are made from thin metal to aid heat transfer. The downside of that thinness is that internal corrosion due to water ingress and separation or external environmental corrosion can quickly penetrate and spill the oil (Figure 4). Traditionally, the only solution for repairing this in-situ without severely compromising the fins' ability to transfer heat and cool the transformer has been to weld the leak. This requires the transformer to be taken offline and drained before it can be welded, which can potentially inconvenience customers and is costly.

Preventing leaks is as important as sealing them, as the area most likely to be damaged is situated at the bottom of the transformer. Bonding thin metal plates to the affected areas is a highly effective method for repairing and protecting such fins without having a dramatic effect on their ability to transfer heat. If the bonding agent has good adhesion to the substrate, it will prevent further corrosion of the fin and seal any potential leaks. However, because the fins are very close together, it is almost impossible to get the surface clean and sufficiently abraded; most adhesives are unable to perform in this situation.

In one case, Belzona 1831 (Super UW-Metal) was used to bond preformed plates as thin as 1 mm (0.04 inch) to repair corroded fin areas. This is a straightforward repair easily undertaken by anyone on site.

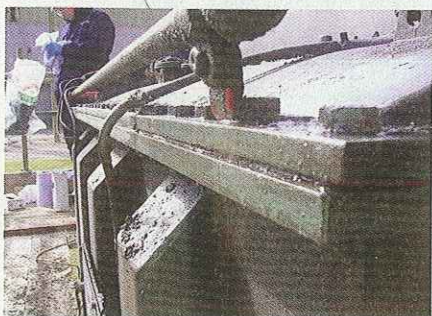
5. Seal an active leak.

A leaking gasketed surface can also be repaired in place, without draining the oil from the tank. *Courtesy: Belzona Polymerics Ltd.*

In another example, the gasket between the lid and body of the 11-kV transformer had been leaking for some time (Figure 5). For this application the surface was prepared using an MBX Bristleblaster to clean and profile the surface. Belzona 1831 was applied

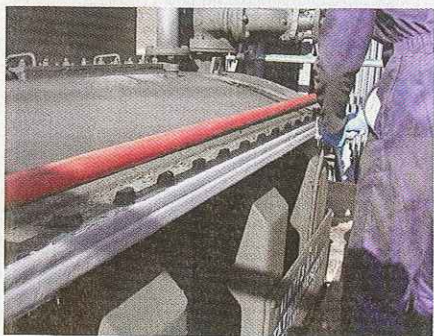
6. Prep and apply.

After the surface was prepped, a reinforcing sheet to add strength was applied. Then a final coat was applied to the gap to stop the leak. *Courtesy: Belzona Polymerics Ltd.*

to the prepared area (Figure 6) using the Belzona 9341 reinforcing sheet to add extra strength, as a gap was being bridged here. This repair was carried out quickly and without any other special equipment. In similar applications where leaking is more extreme, the bolts have also been sealed.

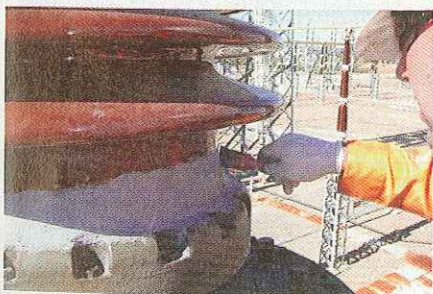
7. Stop gas leaks.

The same sealant has been successfully used to stop SF6 leaks in switchgear. *Courtesy: Belzona Polymerics Ltd.*

detected, it is imperative that the leak be sealed very quickly, on site, without waiting for a specialist team. The same technology used for sealing transformer oil leaks can also be used to quickly and effectively seal SF6 leaks, as it will bond very well to steel and porcelain insulators (Figure 7).

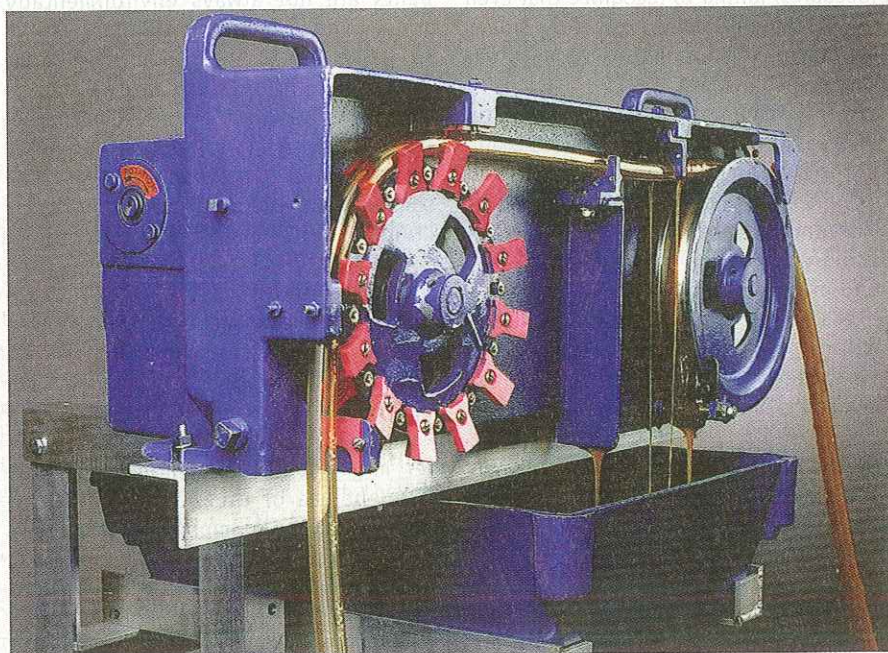
8. Skimming oil. Oil in plant sumps and other wastewater containment areas can be economically removed using an oil skimmer. In this design, a polymer hose passes through the sump to collect oil that is continuously skimmed from the surface of the hose and collected as illustrated. *Courtesy: Oil Skimmers Inc.*
