BELZONA® 4181 TAKES THE HEAT

Chemical plant, Memphis, Tennessee U.S.A.

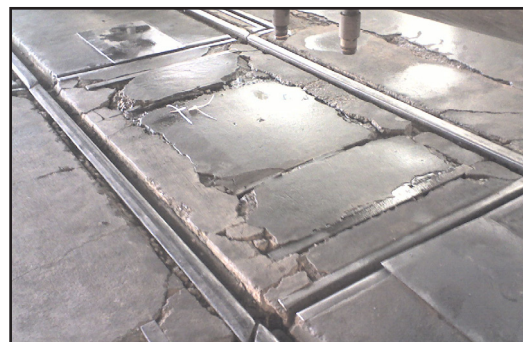
1. Overview of the rail car unloading station
2. Eroded concrete in the sump
3. Belzona® 4181 being troweled onto the concrete surface

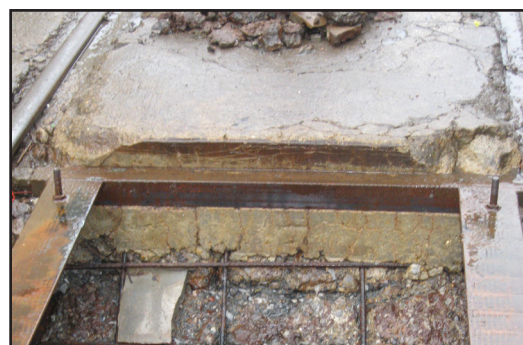
Concrete was eroding away due to steam and chemical wash downs.
