## BELZONA® COATS STACK WHILST IN SERVICE

North American Galvanizing

Vent stack for hot gases operating between 300 & 550°F (150 & 280°C) internal temperature.

External corrosion protection required but stack could not be taken out of service.

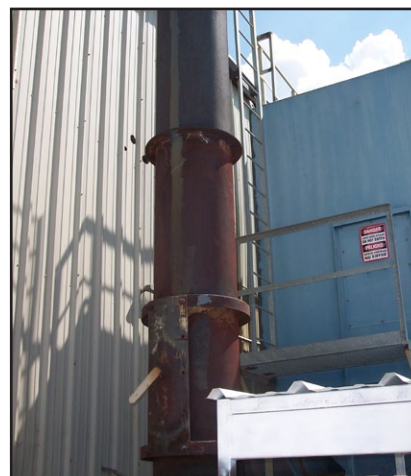
1. Original chimney
2. Test strip - top portion, bottom - burned portion
3. Final application - 4 months later
