BELZONA® 5851 HELPS AVOIDS SHUT DOWN

Production Rig, North Sea

May 2007

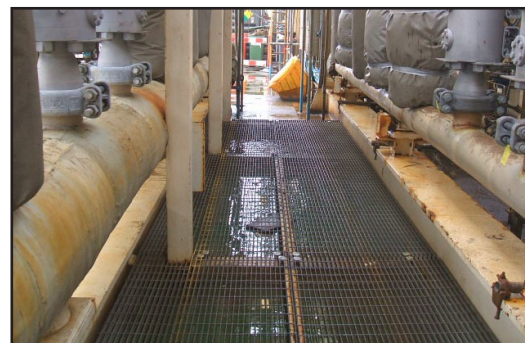
Weathering of the original paint system on high temperature Duplex lines.

The loss of the original paint system exposed the pipe work to a risk of Stress Corrosion Cracking whenever the Fire protection Deluge system were tested.

1. Manifold showing weathering of paintwork
2. Belzona® 5851 applied to exposed pipe work
3. Belzona® 5851 applied to exposed pipe work
4. Belzona® 5851 applied to the Manifold

Application carried out in accordance with modified Belzona System Leaflet VPF-2. The pipe-work was wet-blasted to remove poorly adhering paintwork and any salts from the substrate.
