BELZONA TACKLES SEVERE CUI ON COLUMN

Refinery, UK

Severe Corrosion Under Insulation (CUI) on columns

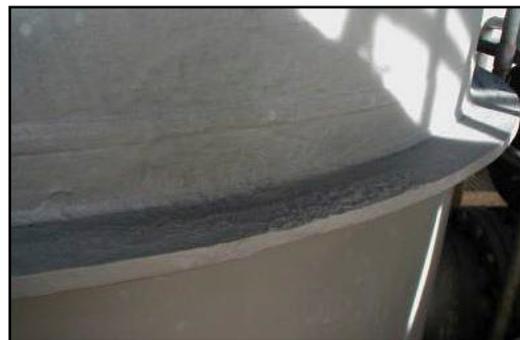
1. General view of refinery
2. Application area after grit-blasting
3. Completed application
4. Completed application

Application was carried out in accordance with Belzona Know-How System Leaflet TCC-5. The Belzona® 5851 was hand applied as a two coat system to grit blasted 8m sections of the column that were then re lagged before moving on to the next section. Vessel remained in service throughout the application.
