## BELZONA® PROTECTS FRACTIONATOR TOWER

Refinery in Singapore

Fractionator tower in cracker unit.

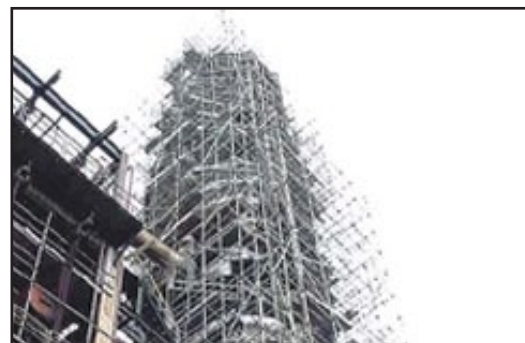
1. General view of the tower.
2. The degree of corrosion clearly evident on the support rings.
3. Application underway.
4. Application complete.

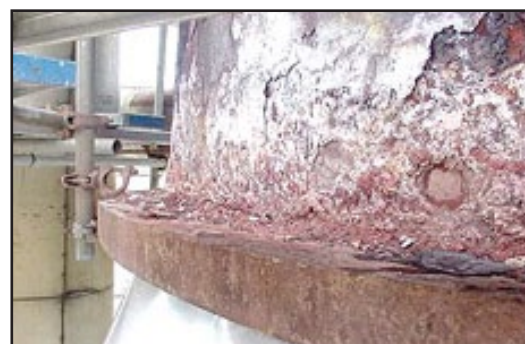
2.

CUI (Corrosion Under Insulation) particularly around the support rings where moisture had accumulated.

The application was carried out in accordance with Belzona Know-How System Leaflet TCC-5. The insulation was removed from affected areas, substrate prepared and Belzona® 5851 (HA-Barrier) applied to the hot substrate.
