BELZONA® RESTORES CORRODED PUMP HOUSING

Drinking water supplier, Lisbon region, Portugal

Horizontal split case centrifugal water distribution pump.

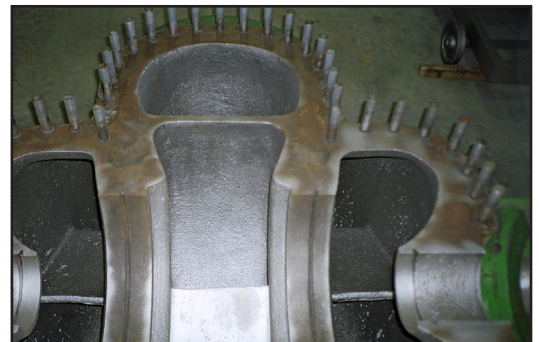
The pump had extensive corrosion.

1. Corroded pump housing.
2. Corroded pump outlet.
3. Application of Belzona® 1341.
4. Completed application.
