## Imitation is a Risky Business

Cement Company,  
Philippines

Coal cyclone and pipes

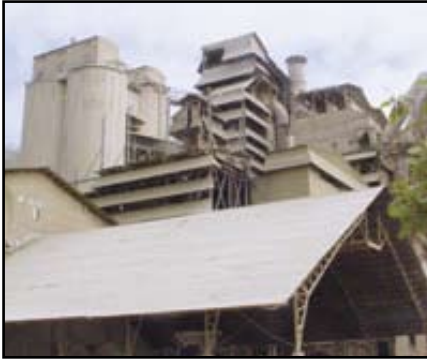
*View of the cement facility*

Coal cyclone wears out fast due to avrasive action of coal particles at high velocity and temperatures of around 100 degrees Celsius

Field and test results have shown that Belzona® 1812 has excellent wear resistance against abrasive action of coal particles. The cyclone previously was coated with other imitators but those have worn quickly away.

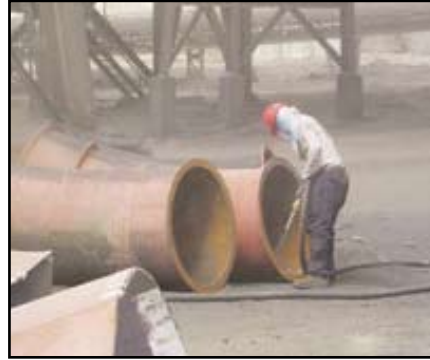
*Agressive blasting surface preparation in process*

Application was done in accordance with Belzona Know-How System Leaflet SHM-8.

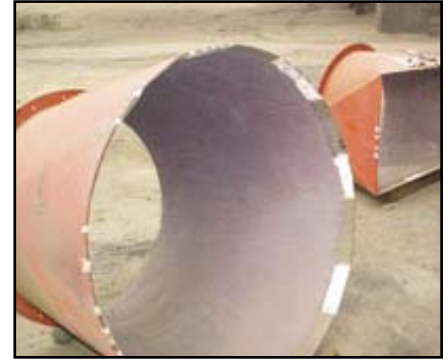
*Belzona® 1812 applied*
