Product Data

ISO/ASME/DOT Compliant Composite Repair System

Belzona® SuperWrap is a qualified composite repair solution that returns strength to weakened or holed metallic substrates.

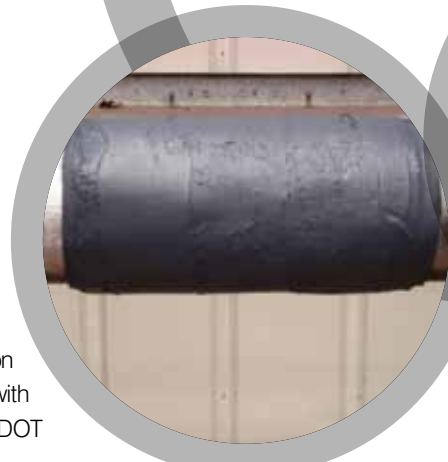
Straights

Belzona® SuperWrap is suitable for thin-walled and through-walled defects on Class 1 water systems, Class 2 safety critical systems, Class 3 hydrocarbon systems and storage tank walls, and complies with ASME PCC2 Article 4.1, ISO/TS 24817, and US DOT requirements.
