Composite Repair System

Belzona SuperWrap II is a fully ISO/ASME compliant composite repair solution designed to restore strength to weakened or holed metallic substrates. Developed for applications on pipes and process vessels, it is also suitable for safety critical and pressurised systems, and can be used on bends, tees and other complex geometries.

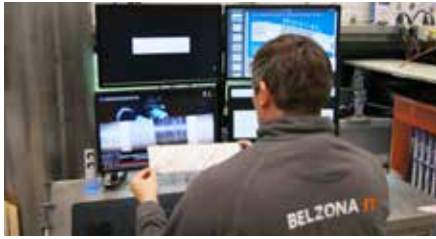
1. Design and Resin Selection

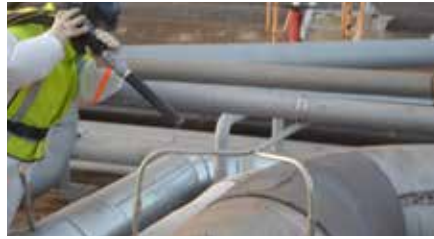
2. Surface Preparation

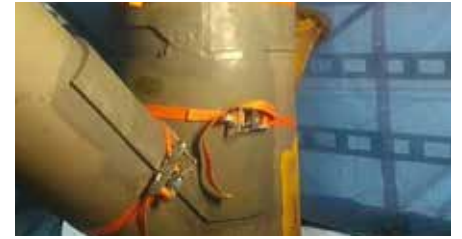
3. Rebuild and Repair

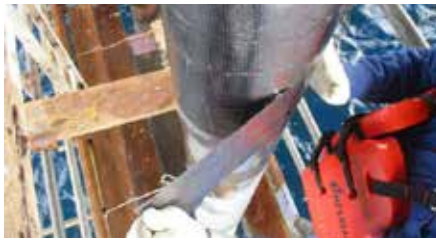
4. Application

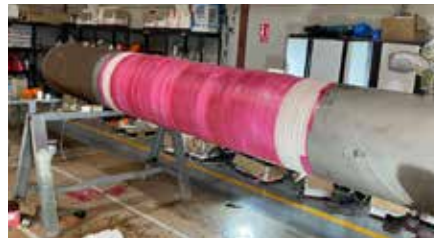
5. Consolidation and Cure

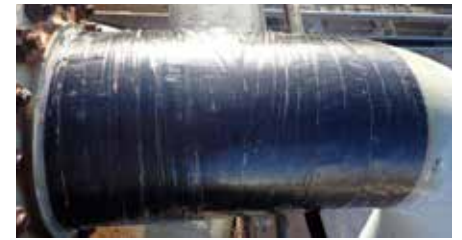
6. Inspection and Full Service
