Bulkfill Composite for Large Areas of Damaged Concrete and Other Surfaces

BELZONA
4154

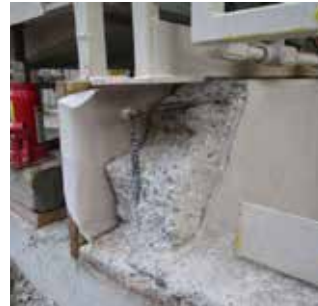
Before

Belzona 4154 used to repair the wall of a secondary containment area.
