Coating for Protection of Surfaces Subject to Hot Aqueous and Hydrocarbon Immersion

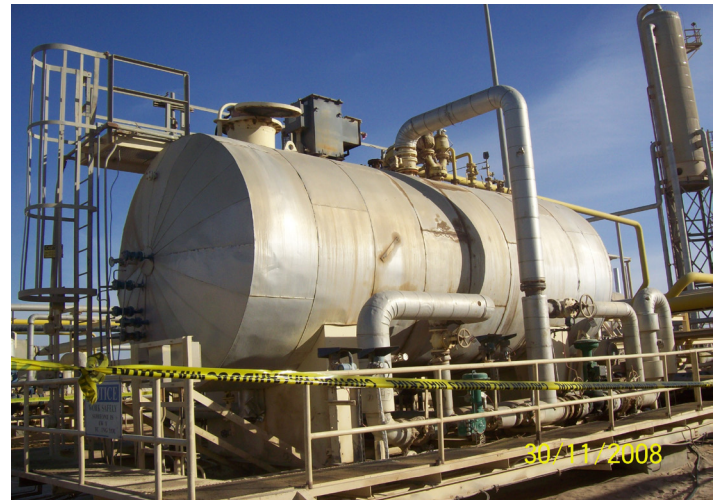
Belzona 5892 used to line a desalter
