# Product Data

## Heat Activated Repair Compound for Application to, and Repair of, Hot Surfaces

## Belzona® 1251

HA-Metal

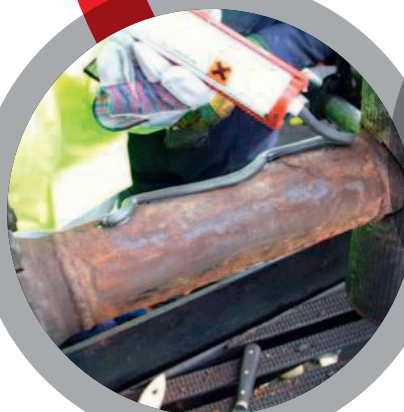
Bonding Doubler Plates

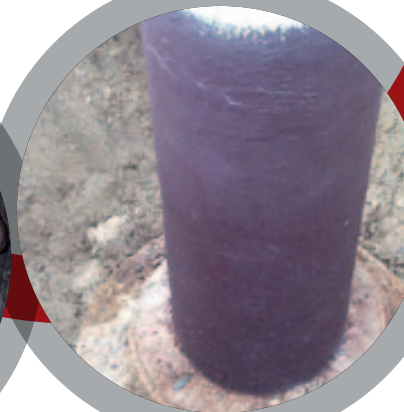
Repair of Thin Wall Defects

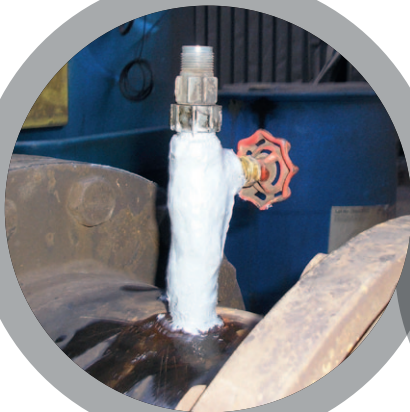
Leak Sealing of Pipework

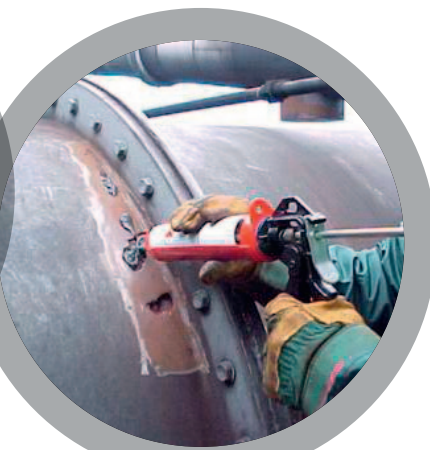
Infill of Corrosion Pits

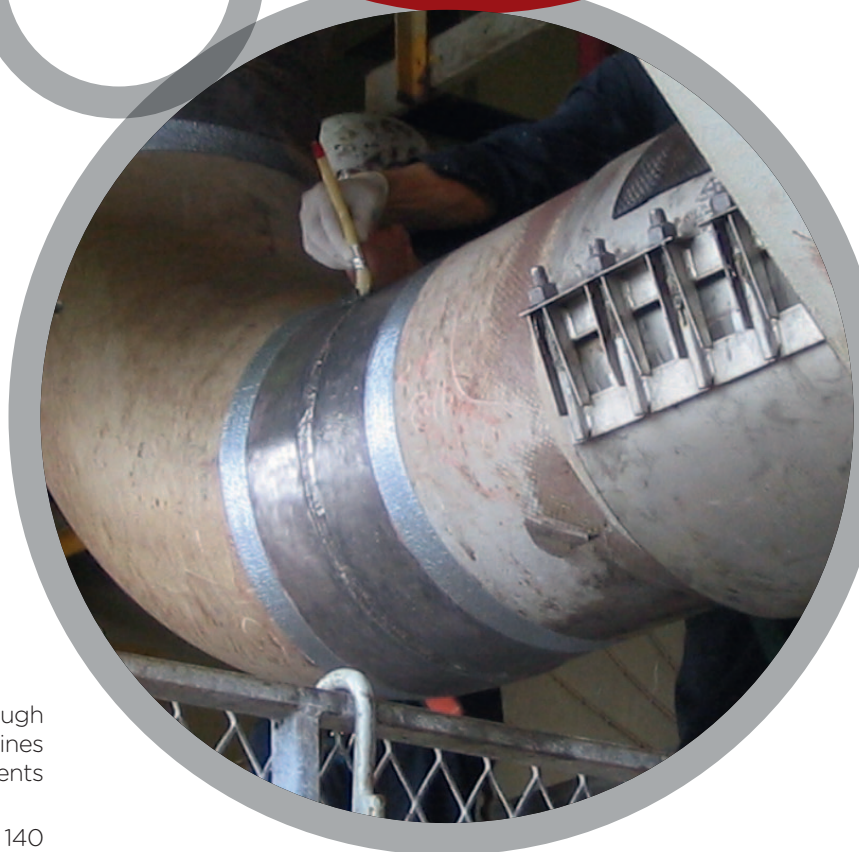
Local Repairs
