Spray-Applied Protective Coating for Process Equipment Operating at Elevated Temperatures

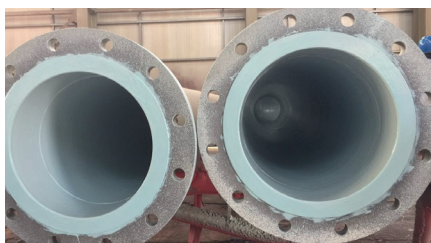
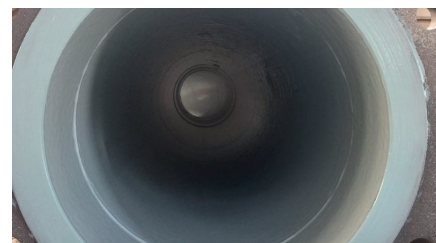
The light colours of Belzona 1523 allow easy visual inspection in vessels.
