# Lightweight Repair System for Rebuilding Vertical and Overhead Surfaces

# 4141

Belzona 4141 (Magma-Build) is a two-component, lightweight repair composite for the rebuilding of damaged vertical and overhead concrete surfaces. This high-build system simplifies applications whilst providing long-term protection.

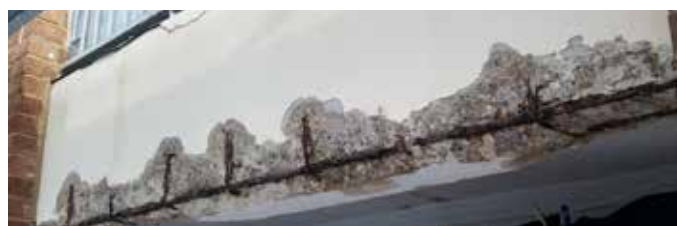
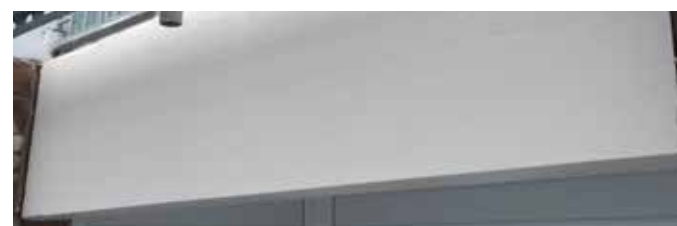
Before

After
